WMSC Inspection Report 20241226

Title: Observation of WMATA Metro Center Winter Shutdown

Location: Metro Center (C01) to McPherson Square (C02)

Date: 12/26/2024

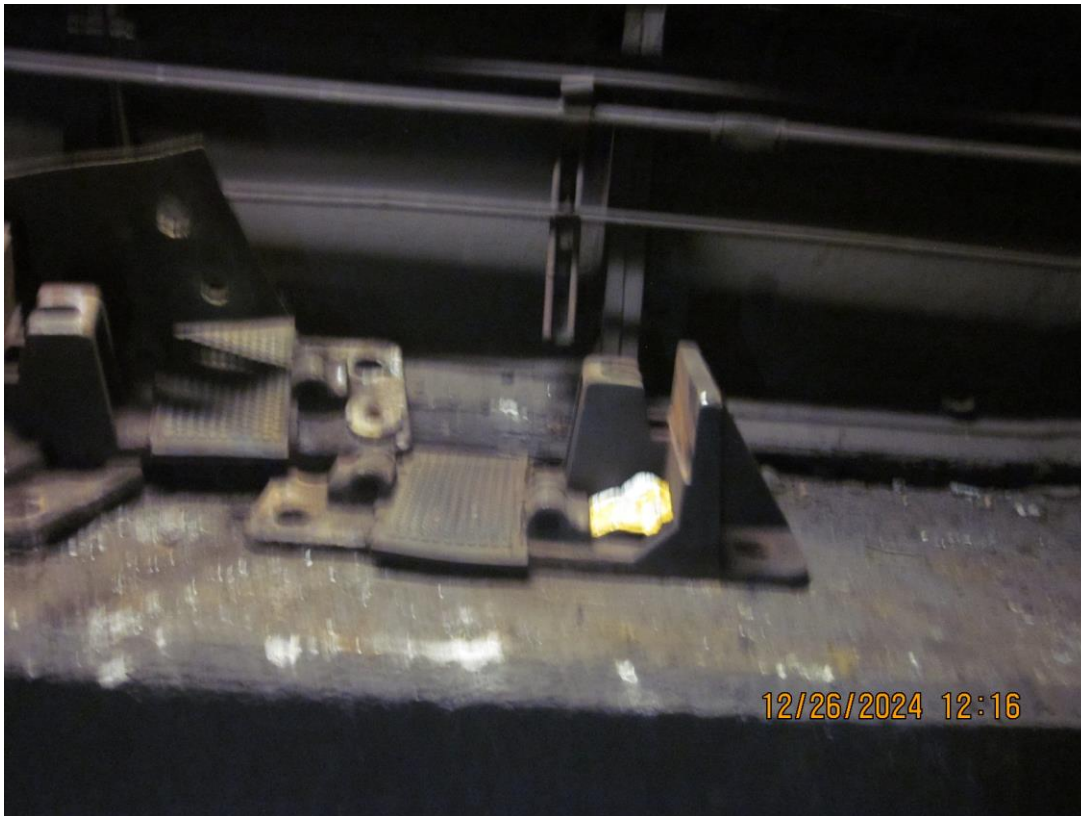
Track and Catwalk Walking Obstructions

Both tracks and catwalks were cluttered with the track components that had been removed during this shutdown. There were 39-foot-long restraining rails, restraining rail chairs, plates, and fasteners scattered around the work sites. These materials were obstructions to

walking through the work site, accessing the work train and accessing the work site when the work train was on site.

Additionally, the inspector noted segments of the catwalks that were unusable for walking. Employees could clear up on the catwalk to allow the work train to pass, but in some scenarios, employees had to climb over the materials on the work train to gain access to the work site on the other end of the work train. TRST should consider methods and practices to remove materials from the work site to provide safer access to the work site for employees.

Obstructions (Removed track materials)
