WMSC Inspection Report 20250113A

Title: 3K SMP Overhaul Process Phase I at Greenbelt Service and Inspection Shop

Location: Greenbelt Yard (E99) and Greenbelt Service and Inspection Shop

Date of Inspection: 01/13/2025

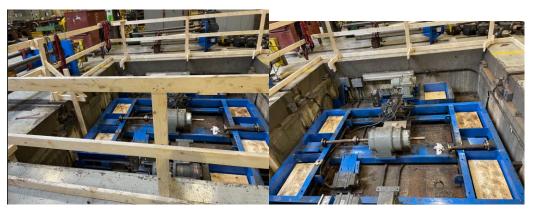
The Greenbelt S&I Shop has also started a project to upgrade the capacity of floor lifts to be able to support the higher weight of 7K railcars and add additional space to support the overhaul process.

Photos #2 and #3 - The Greenbelt S&I Shop has started a project to upgrade the capacity of floor lifts to be able to support the higher weight of 7K railcars.

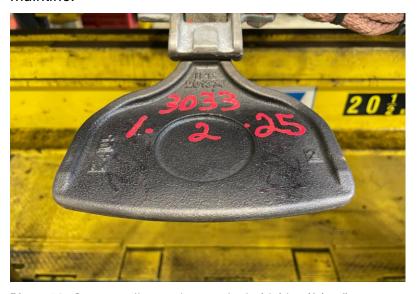
Current collector shoes are being marked with the railcar number and location on the truck to be able to identify the railcar if the shoe is broken off or found on the mainline.

Photo #4 - Current collector shoe marked with identifying figures.

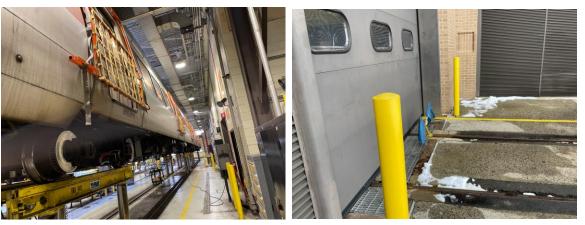
Blue flag protection and side door fall protection was in use.

Photos #5 and #6 - Blue flag protection and side doors fall protection

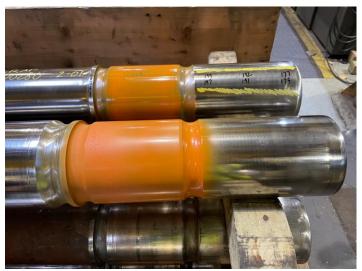
Re-used axles are being inspected for compliance with taper requirements. Out of compliance axles are painted orange for verification, then they are re-inspected and discarded. New axles and wheels are being inspected by a third-party consultant before they are used by Office of Car Maintenance (CMNT).

Photo #8- Re-used axles are being inspected for compliance with taper requirements. Out of compliance axles are painted orange for verification, then they are re-inspected and/or discarded.
