WMSC Inspection Report 20250127

Title: 7000 series Scheduled Maintenance Program (SMP) at Brentwood

Location: Brentwood Service and Inspection (S&I) Shop, Brentwood Yard (B99)

Date of Inspection: 1/27/2025

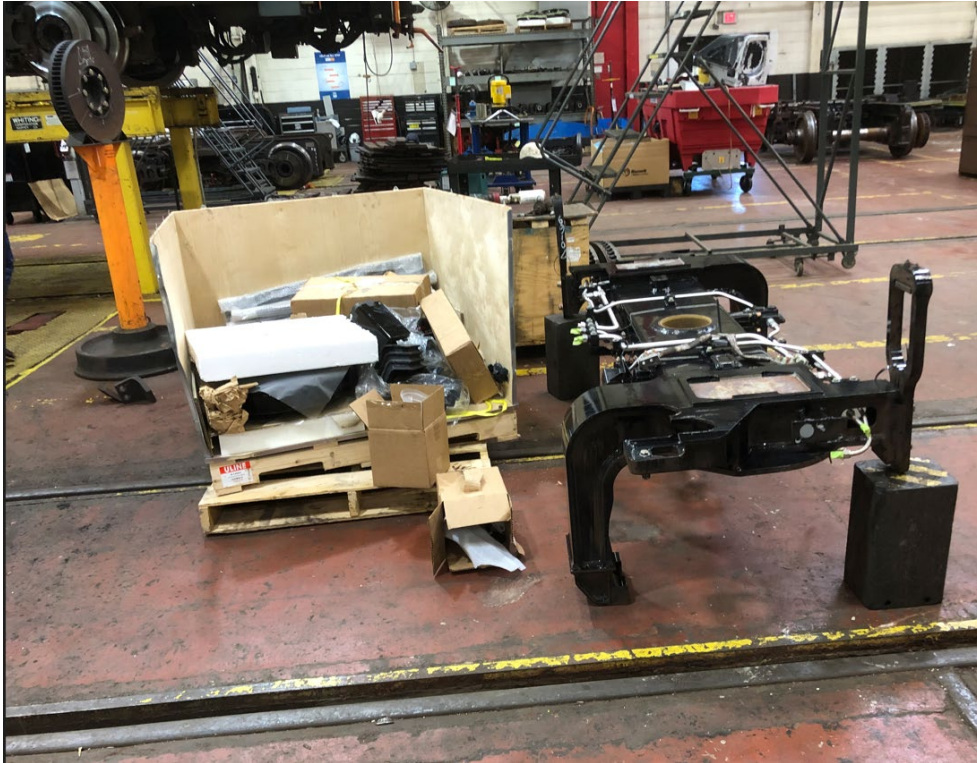
Inspectors were shown various truck components that are being overhauled and replaced during the scheduled maintenance program. No defects were observed.

Fig 3 shows truck components being overhauled during the scheduled maintenance program

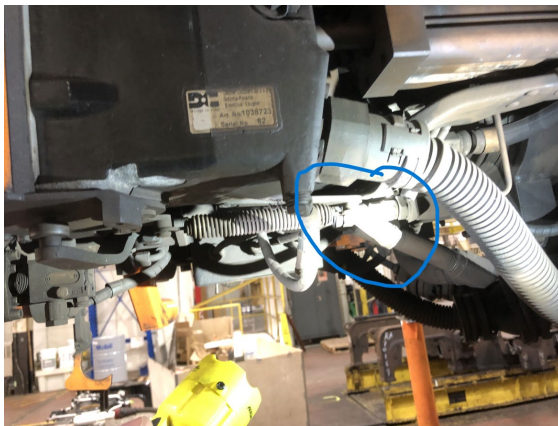
Inspectors observed overhauled couplers with incorrect air filters. WMATA is aware of this issue and is working with the original equipment manufacturer (OEM), Dellner Inc., to correct the issue.

Fig 4 shows overhauled couplers with the incorrect air filters on the couplers

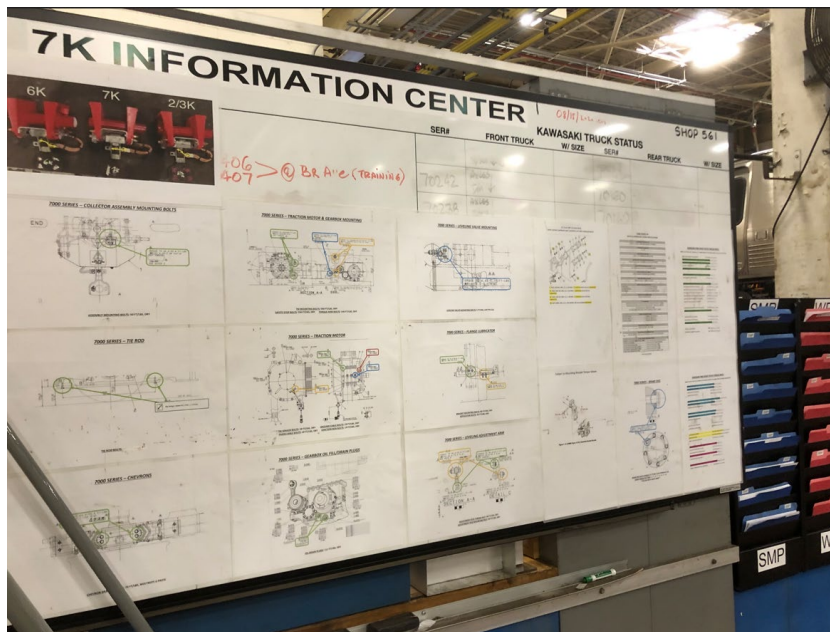
Brentwood Yard uses a 7000 series scheduled maintenance program information center to assist personnel from inadvertently confusing different collector shoe assemblies from the different railcar series. Diagrams of the collector shoe assemblies for the 6000 series, 2000 series/3000 series, and 7000 series were displayed. After the railcars are completed, each is tested without passengers, and a periodic inspection is performed before the car is placed back into revenue service.

Fig 5 Brentwood 7K SMP process information center
