W-0359 – Improper Door Operation – Greenbelt Station – June 29, 2024

Washington Metropolitan Area Transit Authority
Department of Safety (SAFE)
Office of Safety Investigations (OSI)
FINAL REPORT OF INVESTIGATION A&I E24499

Greenbelt Station – Improper Door Operation

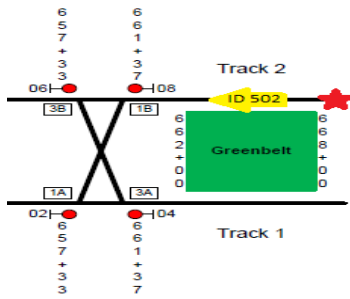
Field Sketch/Schematics

Greenbelt Station, Track 1

The above depiction is not to scale.

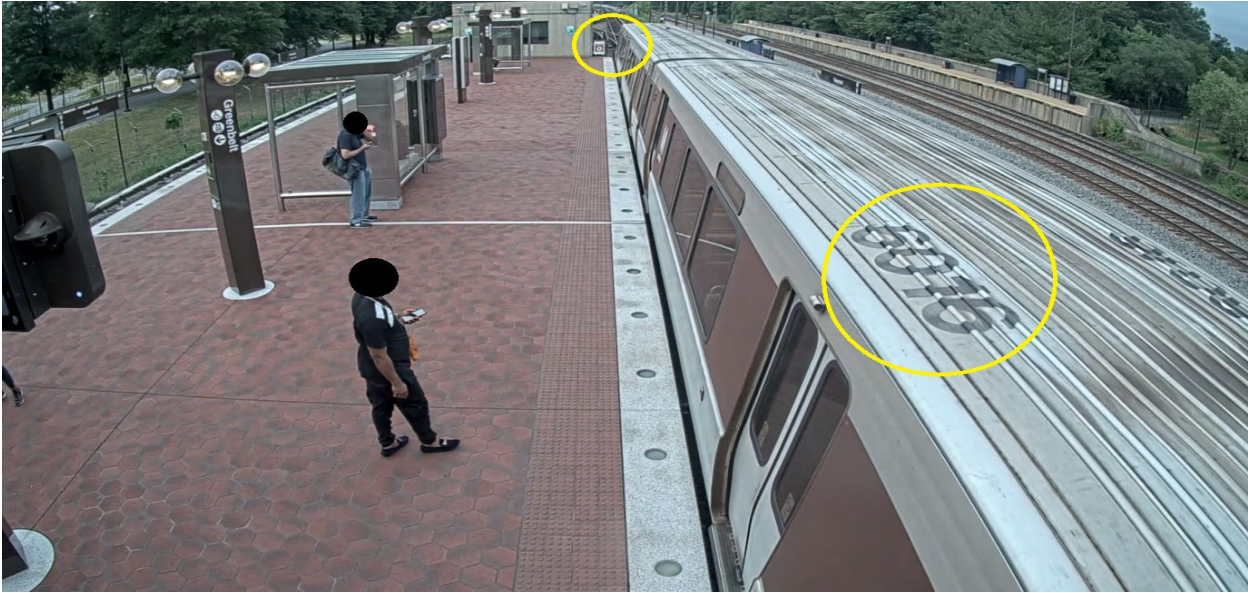
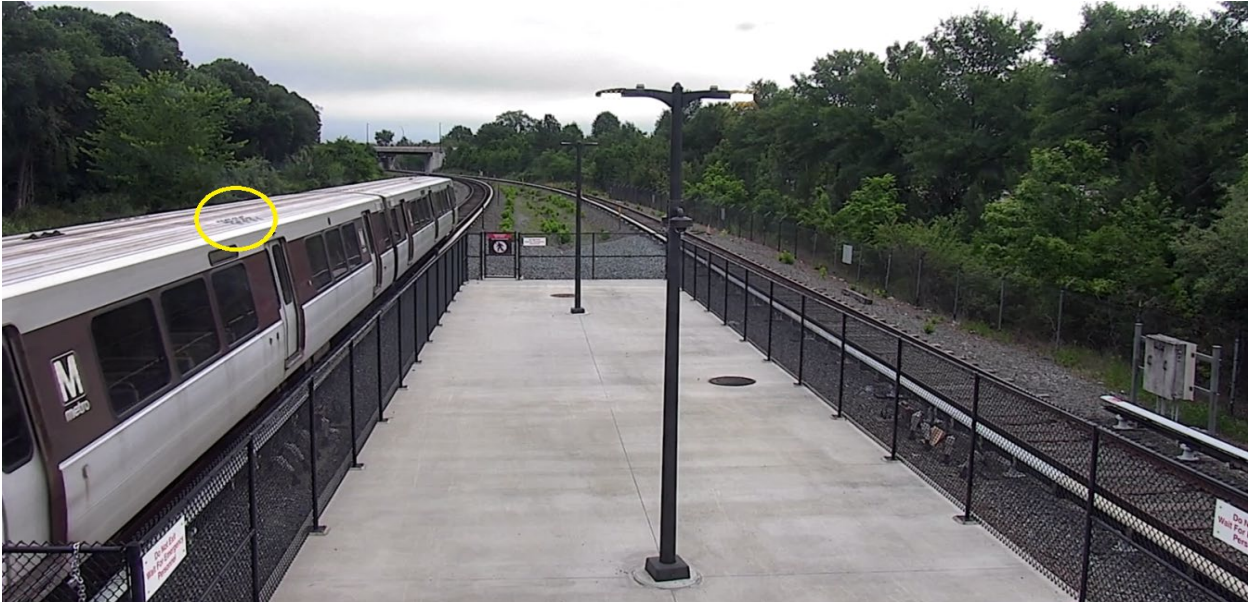
Images 1 and 2 - Train ID 502 arrived at Greenbelt Station on Track 1 at approximately 06:54 hours with ten-cars.

At 06:54 hours, CCTV and SPOTS determined that Train ID 502 arrived at Greenbelt Station on track 2 with a ten-car consist.

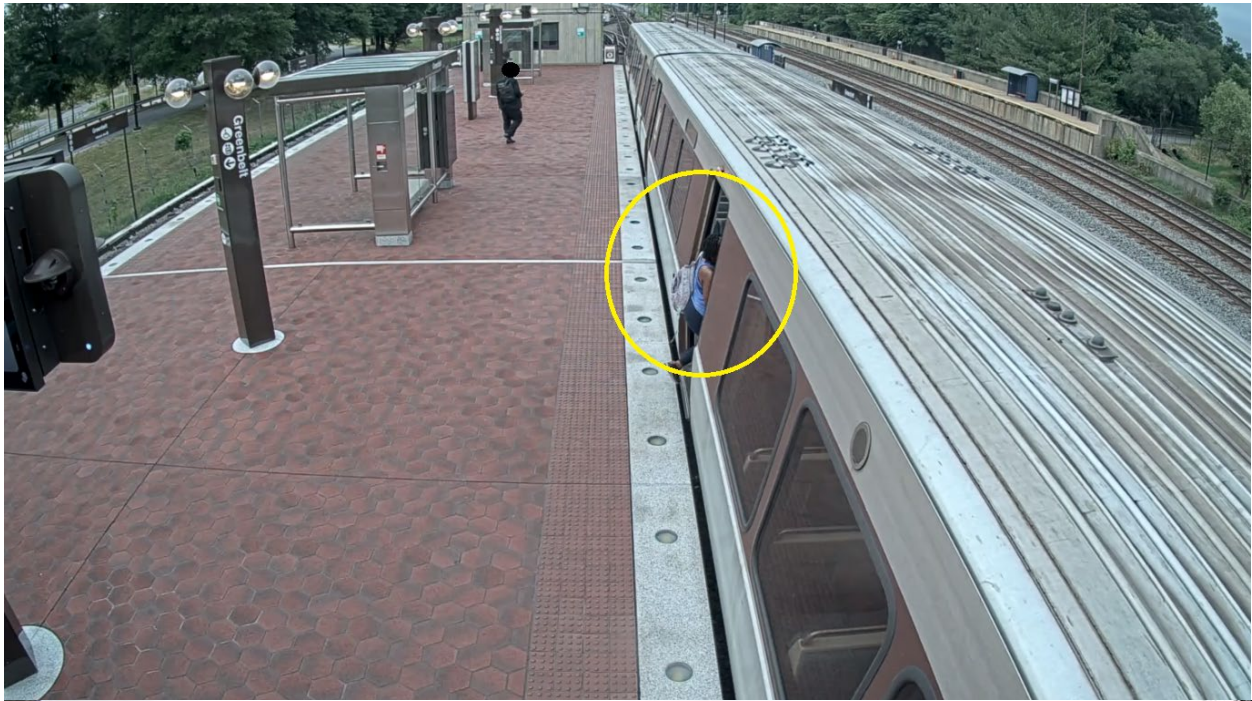
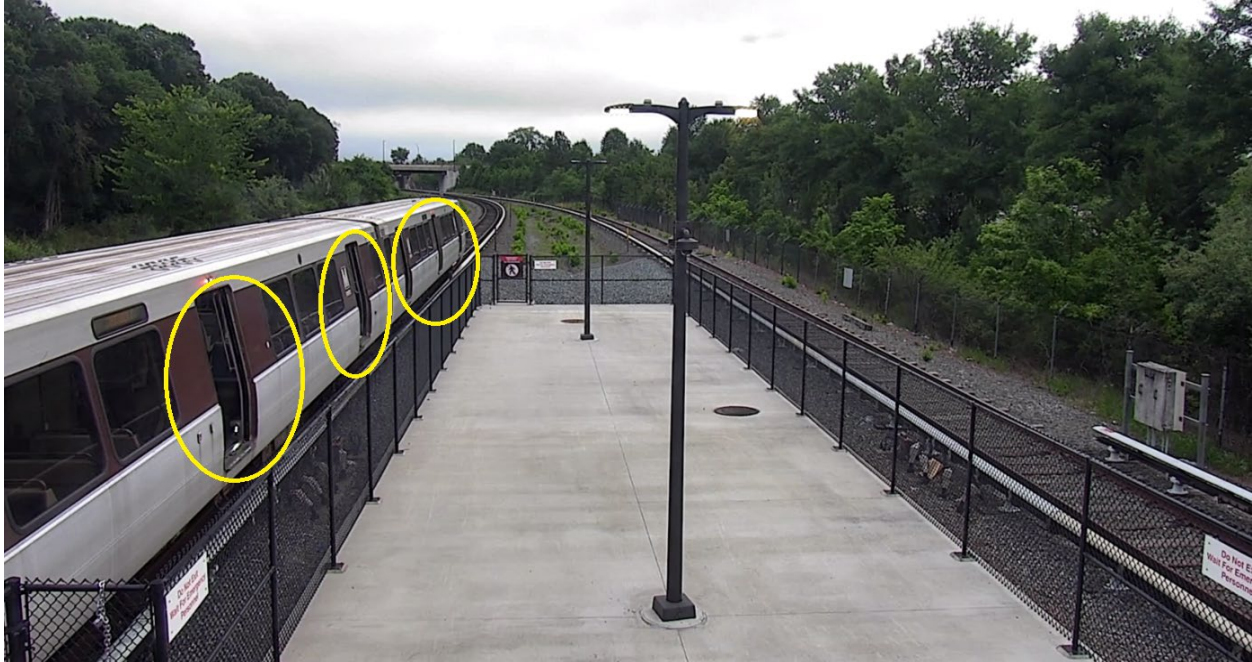
Images 3 and 4 – The platform side doors of Train ID 502 open with two cars outside the platform limits at 06:55 hours.

At 06:55, the platform side doors on Train ID 502, including the two cars outside the platform limits, were observed opening.

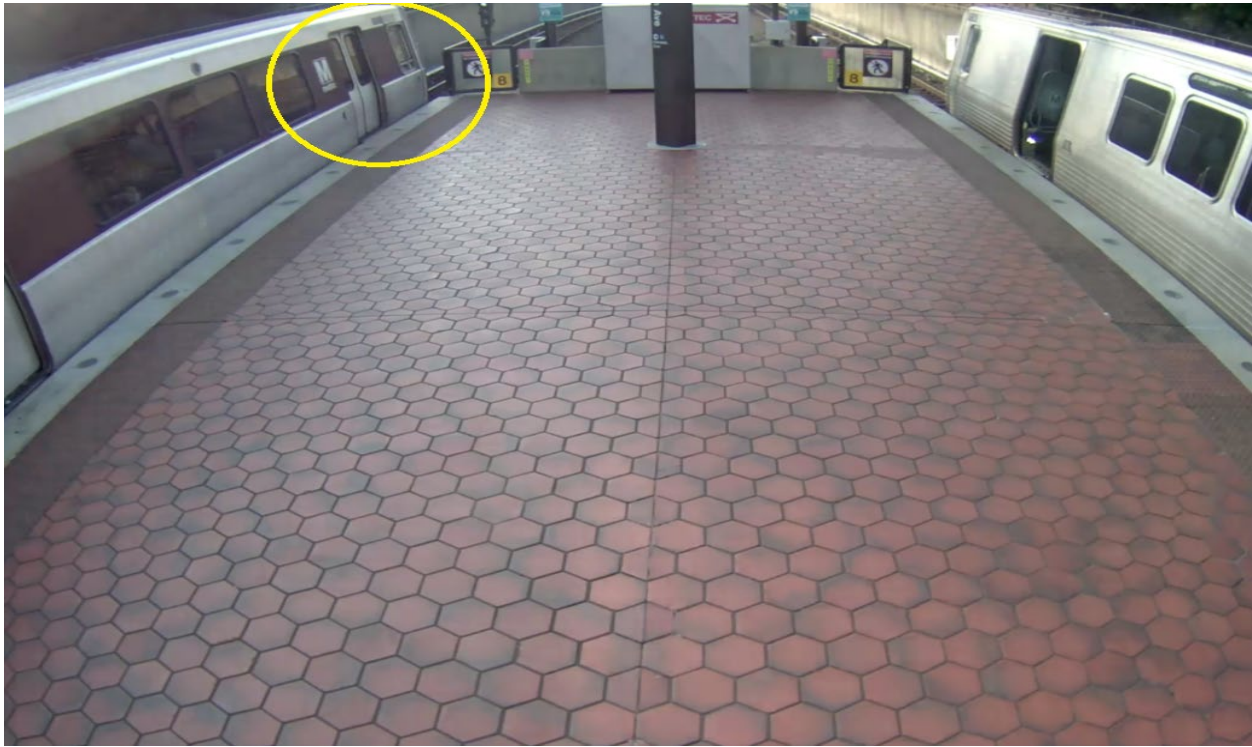
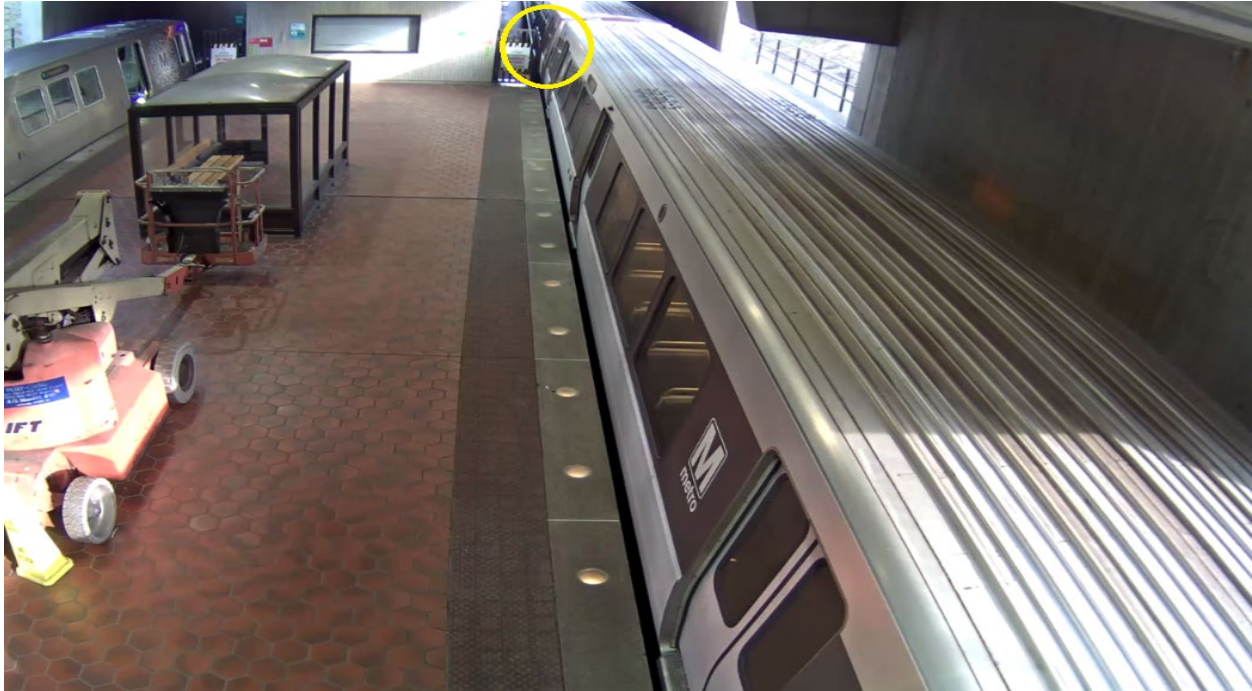
Images 5 and 6 - Train ID 502 located at Branch Avenue Station at 07:52 hours.

At 07:52 hours, Train ID 502 arrived at Branch Avenue Station. As Train ID 502 approached the station, the Branch Avenue Terminal Supervisor, noticed the additional two (2) cars outside of the platform limits fouling the interlocking. The Branch Avenue Terminal Supervisor advised the Button RTC that Train ID 502 was comprised of ten cars. The Button RTC instructed the Terminal Supervisor to remove Train ID 502 from service.

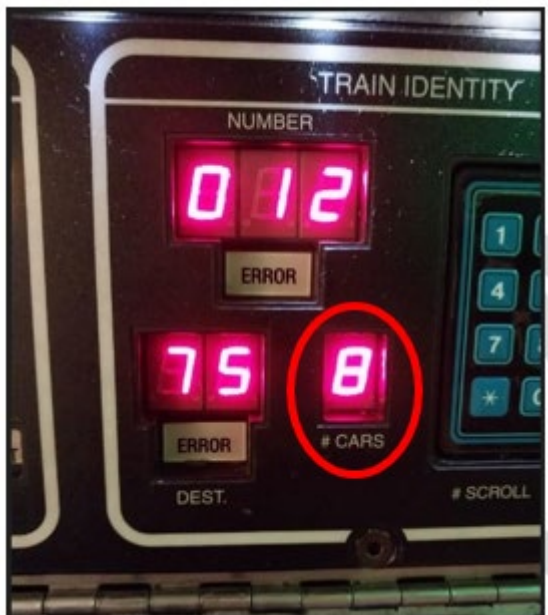
Image 7 – The Console Display Unit (CDU) shows a maximum number of 8 cars, although 10 cars were coupled together.

- The Rail Vehicle Operator stated they observed the CDU display the total cars in the consist as “eight,” but were also aware that the CDU would not display any more than eight cars if additional cars were present.

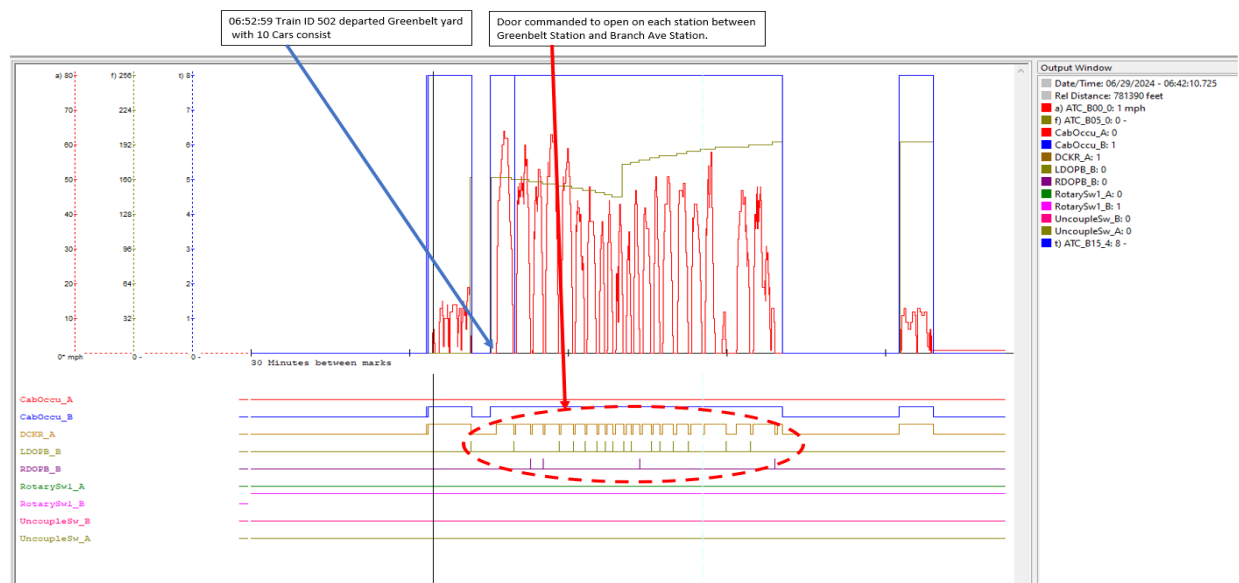
Lead Car 6017 VMS Graph:

Figure 2 – VMS Graph of Car 6017.

Based on VMS data and the RPM Car reports, Train ID 502 was running in service with 10 cars in the consist, and doors were opened on trailing cars 6035/6034 outside of the platform limits

The consist was made into a ten-car consist at E99-Greenbelt Yard on 06/28/2024 at 16:23:58.7 and departed the yard for the revenue service as ten-car consist on 06/29/2024 at 06:52:59.

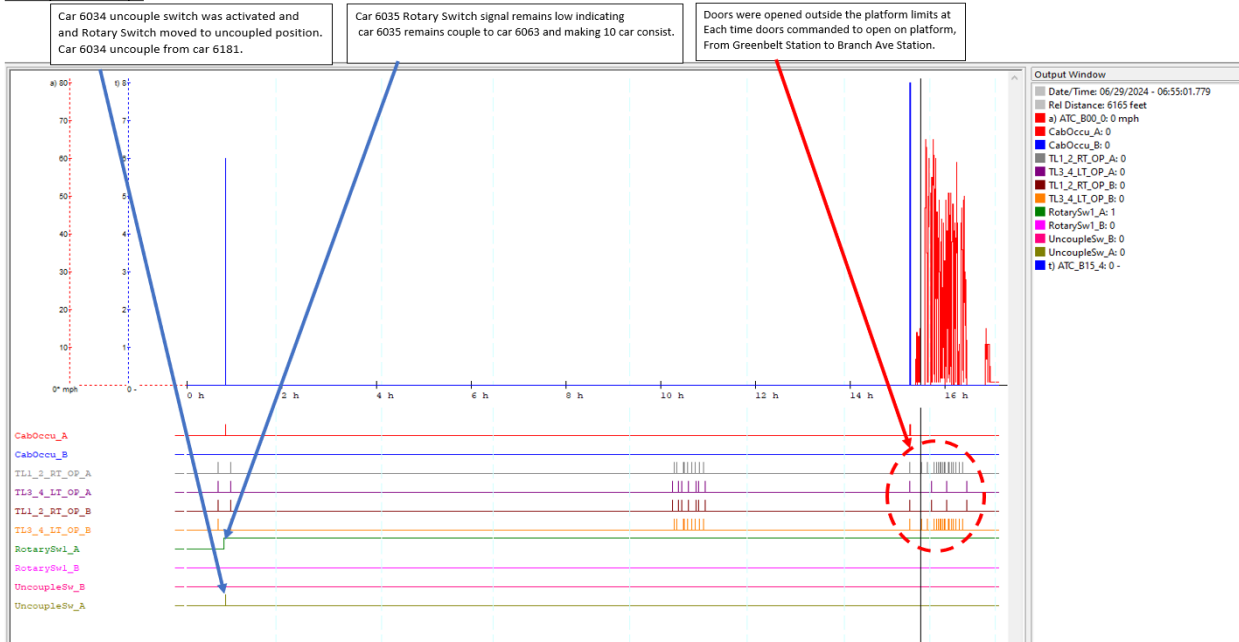
Car 6034/6035 VMS Graph:

Figure 3 – VMS Graph of Car 6034

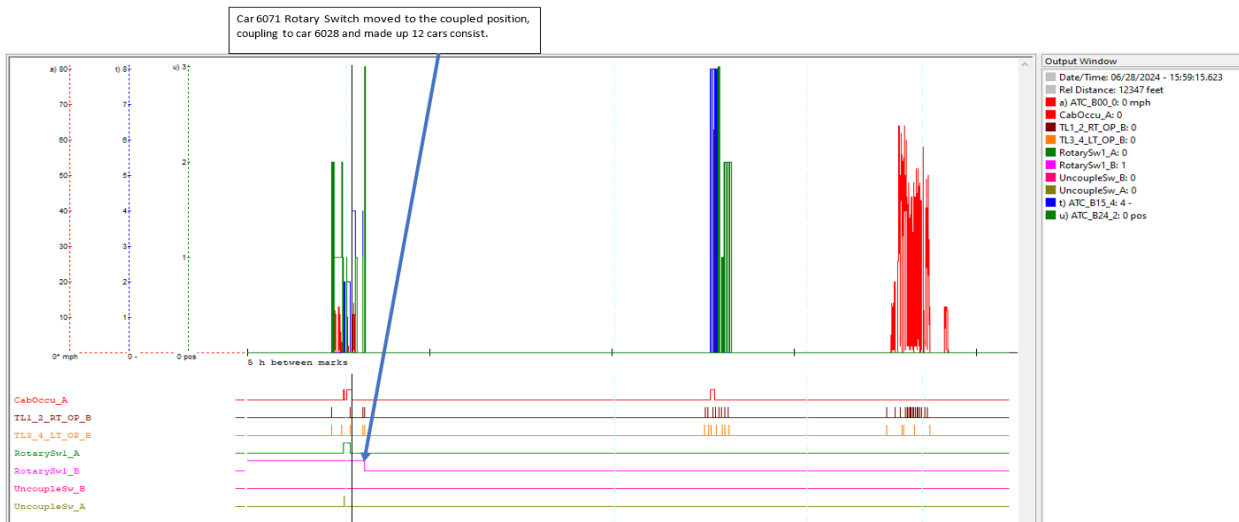
Car 6070/6071 VMS Graph:

Figure 4 – VMS Graph of Car 6070.

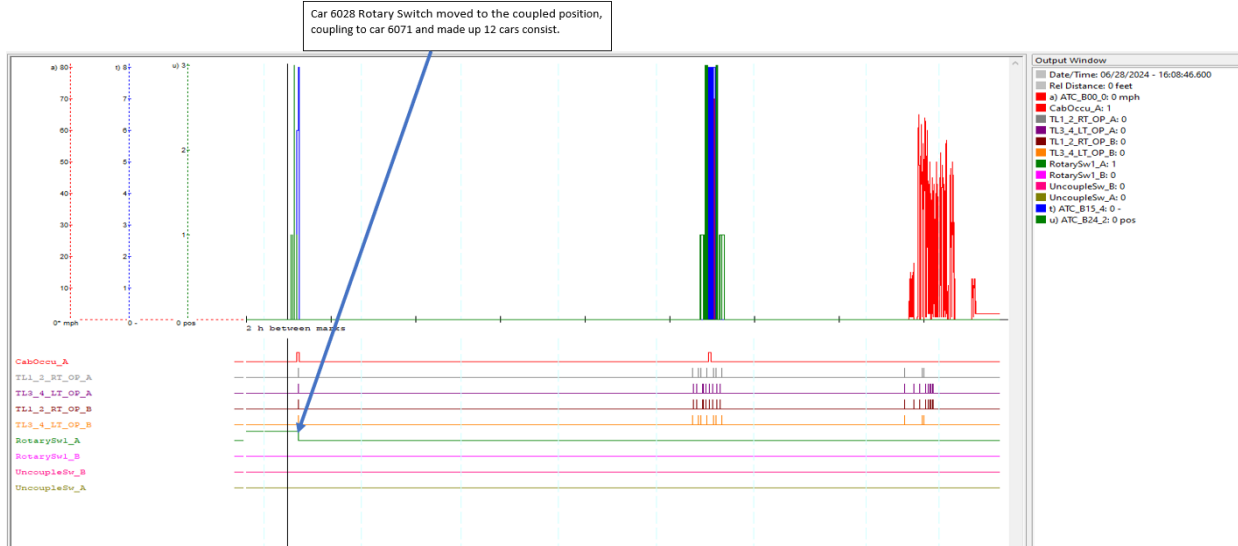
Figure 5 – VMS Graph of Car 6028.
