Inspection Form

Washington Metrorail Safety Commission

Inspection Date	YYYY/MM/DD 2024/02/29	Report Number	20240229-WMSC-FJD-1
Rail Agency Name	Washington Metropolitan Area Transit Authority	Rail Agency Department	Name
Rail Agency Department	POWER	Contact Information	
Inspection Location	RED Line Station B-35 NoMa Gallaudet Univ.

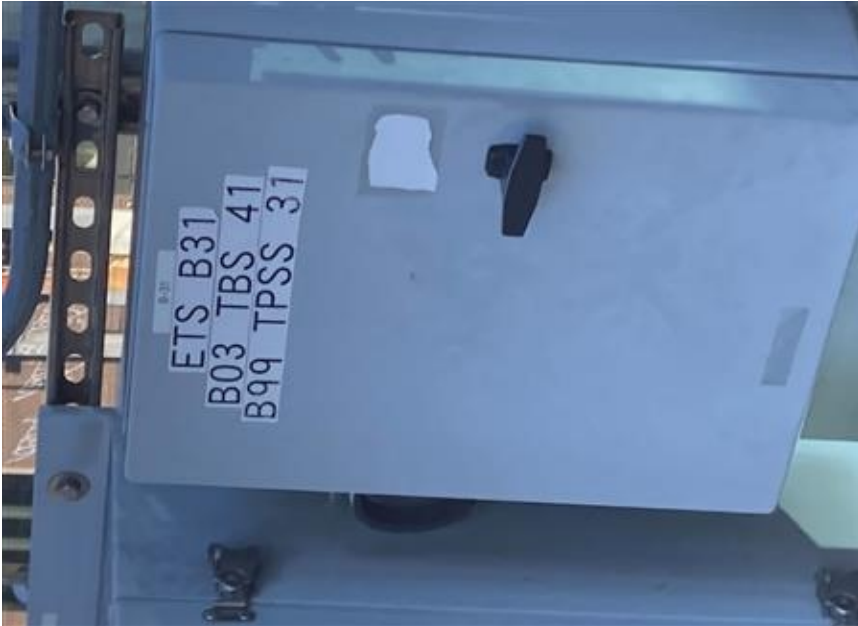
B35_ETS_B31.jpg

Description	ETS Box B31 and others had incorrect 3rd rail power removal maps. B-35 was built as a fill in station, the map did not reflect the location of the station and was not updated when the station was built.	Number of Defects	1
		Recommended Finding?	Yes
		Remedial Action Required?	No
		Recommended Reinspection?	Yes
Remedial Action
