# **Inspection Form**

# Washington Metrorail Safety Commission

Increation Date	YYYY/MM/DD	Donart Number	20240605-WMSC-DLB-3				
Inspection Date	2024/06/05	Report Number	20240003-WW3C-DLD-3				
Rail Agency Name	Washington Metropolitan Area Transit Authority	Rail Agency Department	Name				
Rail Agency Department	Rail Operations	Contact Information					
Inspection Location	New Carrollton Rail Yard	•

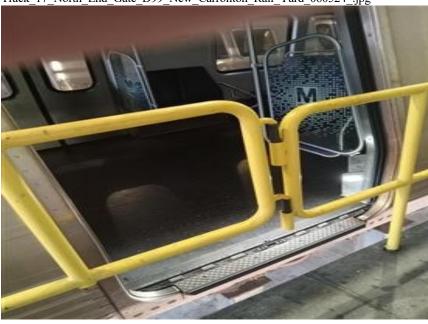
Track\_17\_North\_End\_Gate\_D99\_New\_Carrollton\_Rail\_Yard\_060524\_.jpg

Inspection Activity #	1	Insp	ection Sub	Corrective Action Compliance Inspection			Activity Code			OBS-RTRA-PI						
Job Briefing Employee Name/Title	Supervisor - S&I Facility			Accompanied Inspector?			No	Out Brief Conducted	Yes	Time		08:15 AM		Outside Shift	Yes	
Related Reports				Related CA	APS / Findin	gs		TOC-OTR-15-00	06 TOC-COL-15-003-A							
Related Rules.	Ref			Rule or SOP S			Standard		Other / Title				Checklist Reference			
SOPs, Standards, or Other	N/A.			N/A.			N/A.		N/A.				N/A.			
Inspection Location	Main Track	Yard	Station	occ	RTA Fa	cility	WMSC Office	Track Type	At-grade Tuni		Tunne	iel Eleva		ted N/A		
		Х	Х		Х	<u> </u>										
Line(s) & Track	New Carroll	New Carrollton Rail Yard						From					То			
Number		Station(s) N/A.					N/A.	N/A.								
Vehicles		Head Car Number   Number of Cars				N/A.										
								-A. As quoted	Number of Defects					:	1	
	from the corrective action Metrorail was required to, "Design and install a new railing system that reduced the number of openings and eliminates the ability of the handrails to swing into the direction of the dynamic envelope of the rail car, in shop locations								Recommended Finding?					Ye	Yes

Remedial Action Required?					Ye	Yes	
Description	and rail facilities to replace the sectional type of railing system currently installed."  The corrective action was closed after review of the mitigations and design drawing for the proposed slide gate. An Inspection was conducted by the WMSC to verify the installation and presence of the above-mentioned guardrails installed in the shop at D99 New Carrollton Rail Yard. The corrective action was closed as Metrorail provided the necessary mitigations and design schematic diagram of the slide gate. METHOD: The WMSC Inspectors performed the inspection via visual means. Photos were taken to support the observations and findings where appropriate. OBSERVATIONS/FINDINGS: The WMSC Inspectors did not verify any of the proposed slide gates implemented for the open pit sections of the S & I shop at D99 New Carrollton Rail Yard. Metrorail has implemented an interim mitigation instead. The mitigation used by Metrorail is a welded steel plate. The function of the steel plate is to remove the possibility of an inward swing that would create a safety hazard for any rail vehicle by fouling the dynamic envelope. Metrorail management was out briefed concerning the details of the inspection. Future inspections should continue at this and other Metrorail locations.							ended Rein	spection?			Yı	es

Remedial Action	Design and install a new railing system that reduced the number of openings and eliminates the ability of handrails to swing into the direction of the dynamic envelope of a rail car.							e of a
