WMSC Inspection Report 20250411A

Title: New Carrollton Yard (D99) Car Wash

Location: New Carrollton Yard (D99)

Date of Inspection: 4/11/2025

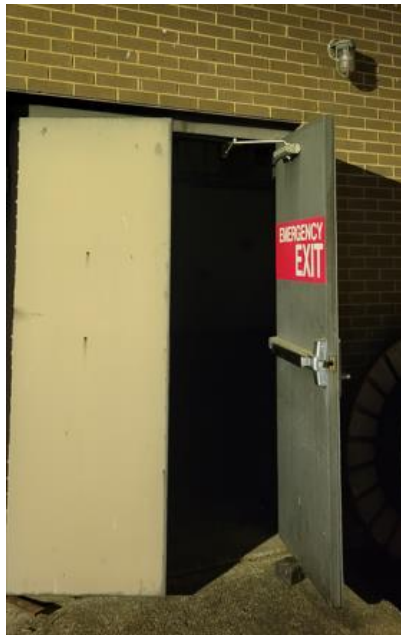
Three of the four emergency exit doors of the car wash were open, wedged open, or broken. The unsecured exterior carwash personnel doors at New Carrollton Rail Yard were previously identified as an imminent safety concern by the WMSC and documented in report 20240605-WMSC-DLB-2.

Fig 1 – open wedged emergency door

During this inspection, the WMSC Inspectors stopped the inspection to communicate an issue or hazard that posed an urgent safety concern to WMATA personnel. At the vehicle car wash facility, three of the four emergency exit doors (installed for WMATA staff to use for emergency egress inside the car wash building) were open so any person could enter the car wash through those doors at any time. One of the doors was noted as broken Because it would not close or lock in the closed position. Another door was noted to be wedged open. As per the WMSC Program Standard, the WMSC Inspectors stopped the inspection and immediately notified the WMATA Safety Officer on Duty of the door defects and the danger they posed. The Safety Officer on Duty conveyed this would be fixed as soon as possible. The WMSC Inspectors also called the emergency safety hotline and conveyed the safety concerns.

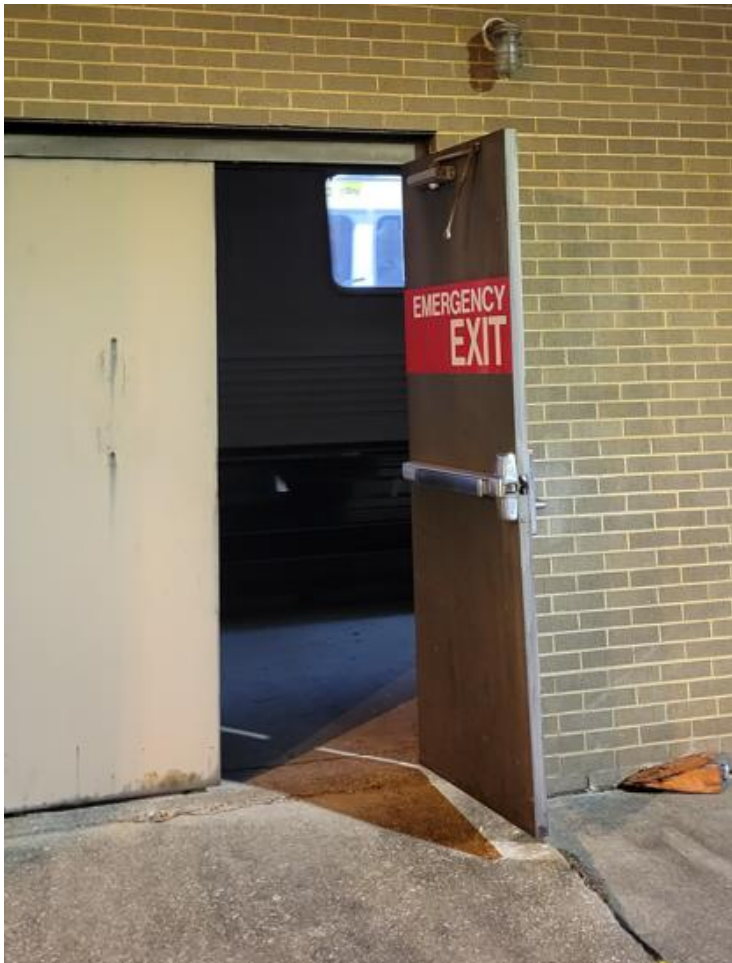
Fig 3 – open and broken emergency door – wide angle

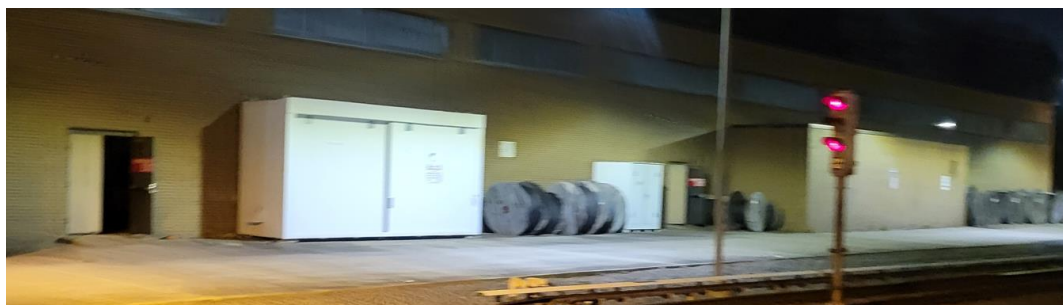
Fig 4 – wide angle of broken emergency car wash doors

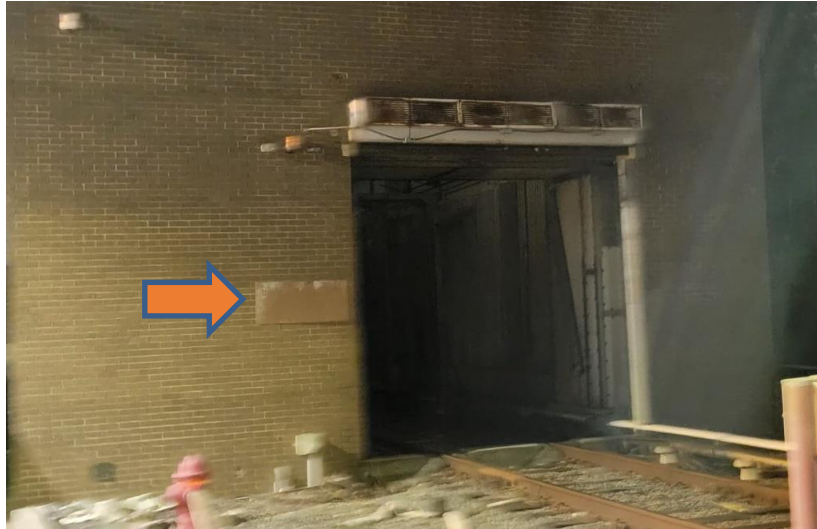
Operational signs are posted for rail vehicle operators at both rail vehicle entrances to the carwash. Those signs are no longer legible.

Fig 6 – unreadable operational sign at car wash facility
