## WMSC Inspection Report 20250530

Title: ATO Inspection Red, Blue, Green and Yellow Line

Location: Red, Green, Yellow, and Blue lines

Date of Inspection: 5/30/2025

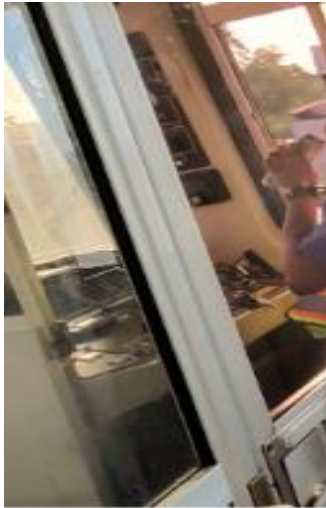
One rail vehicle operator was observed drinking from a container while operating a rail vehicle. The Metrorail Operating Rulebook lists this as a prohibited behavior.

Train ID - 101

Lead Car - 3283

Location - Rhode Island Ave Station

Time - 0800

Mode of operation - Automatic (ATO)

1.8.2.2 Eating or drinking in trains, train cabs, station kiosks, or in the paid areas of stations, as well as any other areas where these actions are prohibited

**Hazard Rating: 4C**

*Fig 1: RVO with open container*
