W-0377 – Improper Roadway Worker Protection – Southern Avenue Station – August 25, 2024

FINAL REPORT OF INVESTIGATION A&I E24676

Southern Avenue Station – Improper Roadway Worker Protection

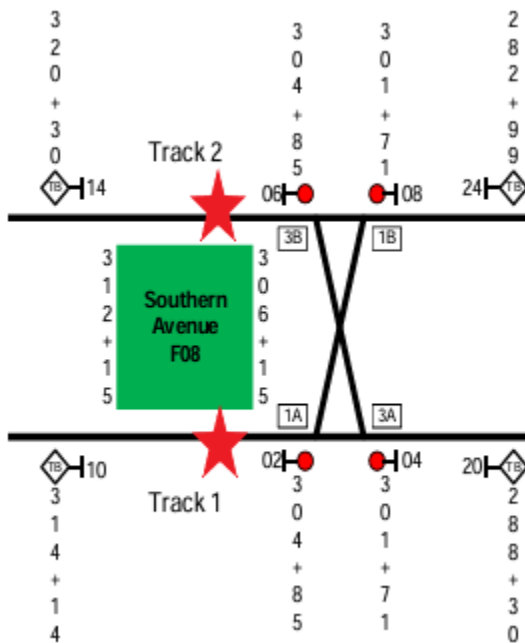
Figure 1 - depicts the locations where shunts were placed at Southern Avenue Station (F08). The above depiction is not to scale.

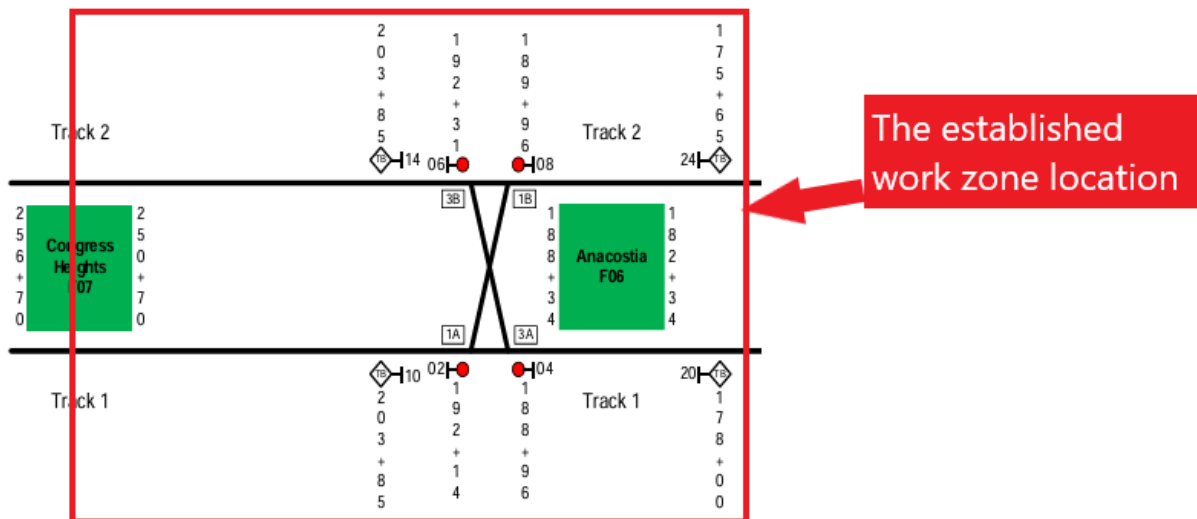
Figure 2 - depicts the work zone location under ETO protection. The above depiction is not to scale.

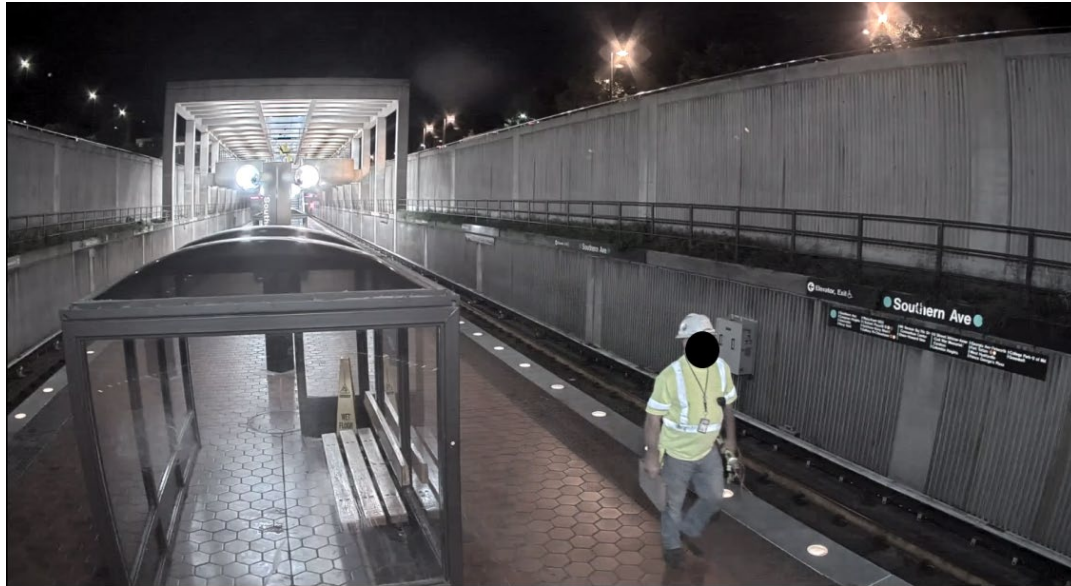
Figure 3 - depicts the Structures Supervisor at Southern Avenue Station.

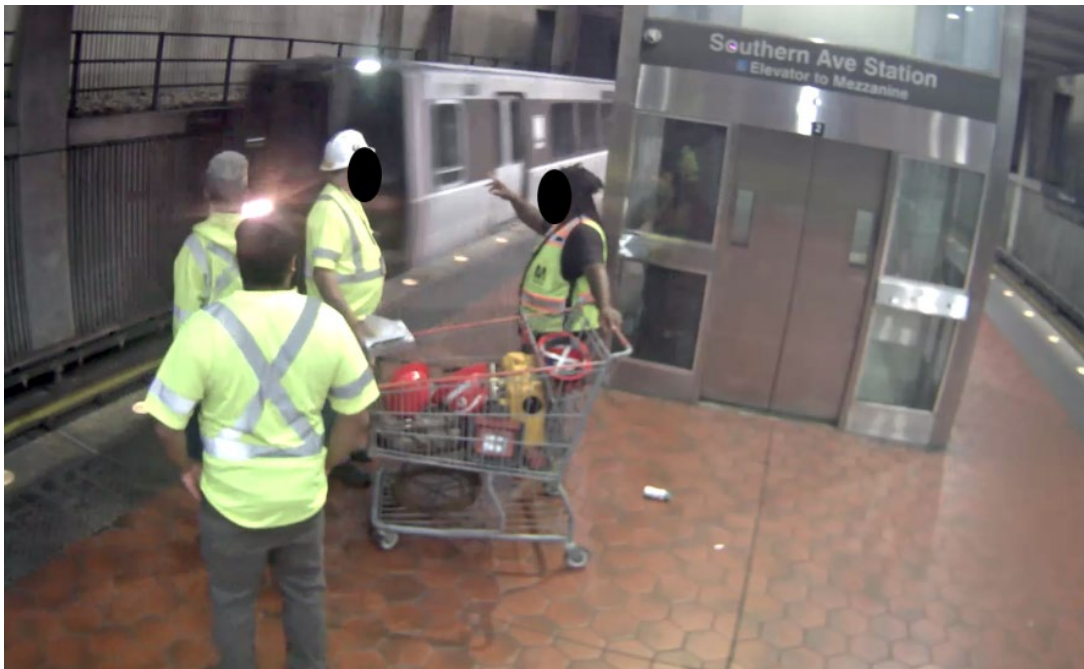
Figure 4 - depicts Train ID 711 passing F08 - Southern Avenue Station at 02:03 hours with TRST crew standing by on the platform. The TRST crew was granted ETO protection for F06 – Anacostia Station.

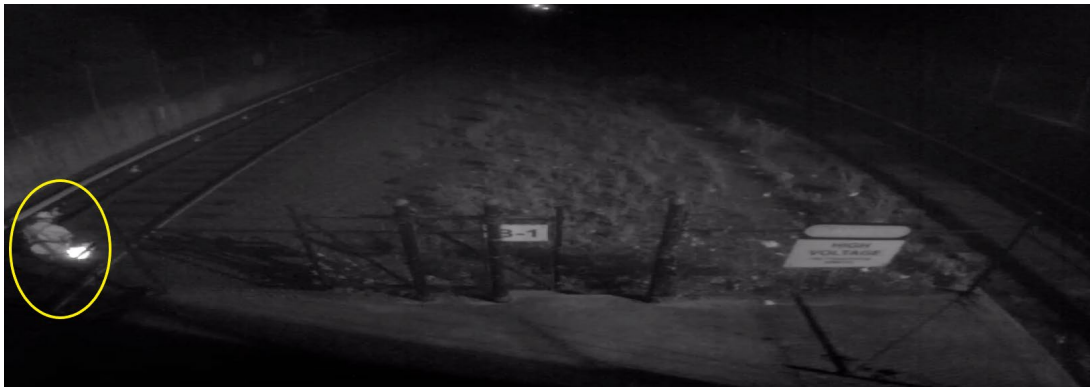
Figure 5 - depicts the RWIC placing a shunt on Track 1 at Southern Avenue Station at 02:12 hours.

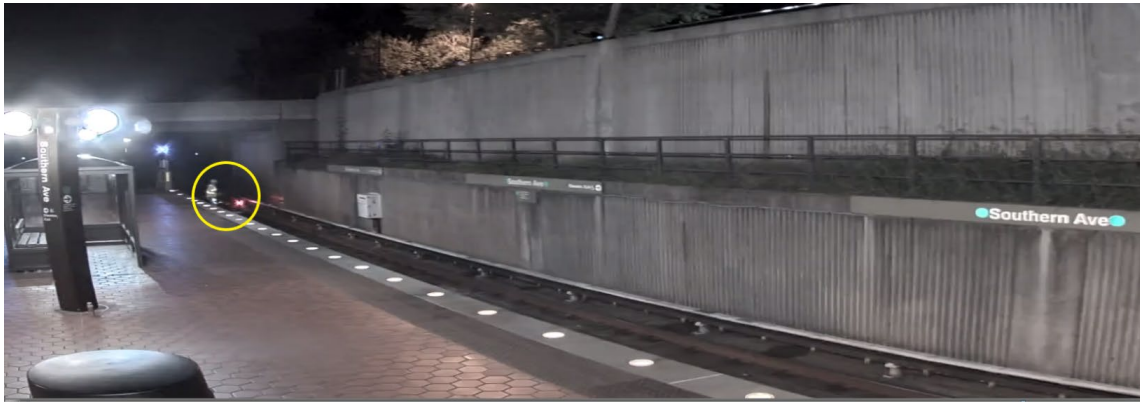
Figure 6 - depicts the RWIC placing a shunt on Track 2 at Southern Avenue Station at 02:13 hours.

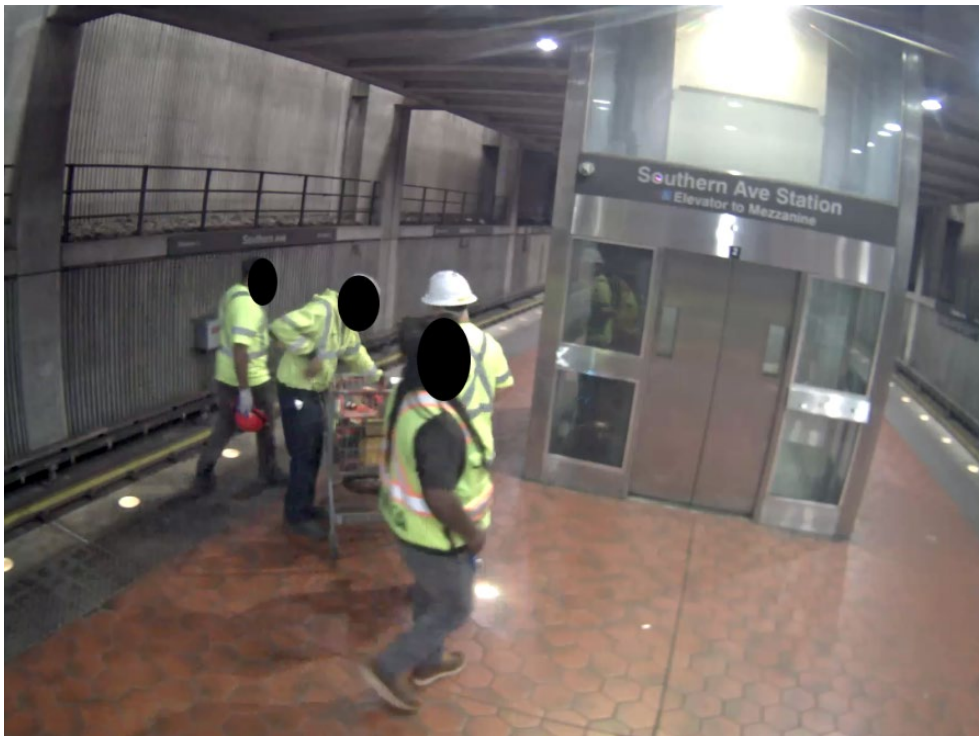
Figure 7 - depicts all personnel and equipment cleared from the Southern Avenue Station roadway at 02:24 hours.
