## WMSC Inspection Report 20250809

Title: Green Line Weekend Shutdown Work and RWP Inspection

Location: Branch Ave (F11) to Congress Heights (F07)

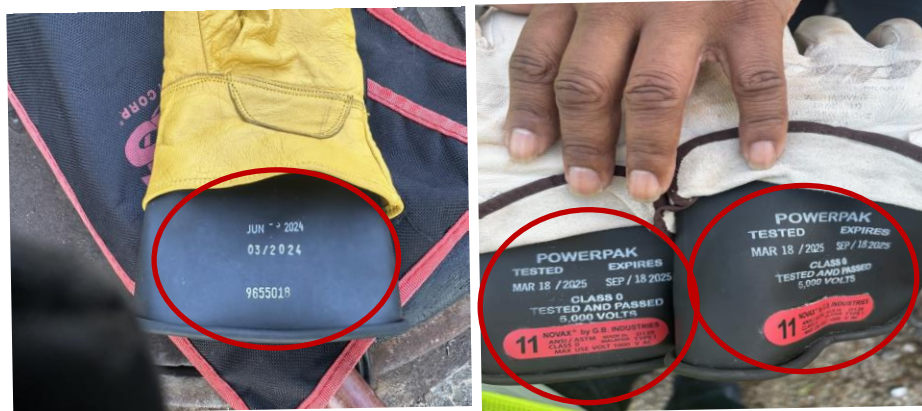
WMSC inspectors observed that a crew leader from the Metrorail Communications and Signaling radio team at the Branch Avenue (F11) location removed a brand new insulated third rail glove from its packaging, which had a stamped date of June 2024. Metrorail policy states if the package remains unopened, the gloves expire one year from the stamped date, which meant an expiration date of June 30, 2025 (see photo 1). Additionally, personnel had a current insulated glove on hand that was in compliance (see photo 2).

Photo 1 (left). Yellow insulated glove expired June 30, 2025.

Photo 2 (right). White insulated gloves were in compliance.

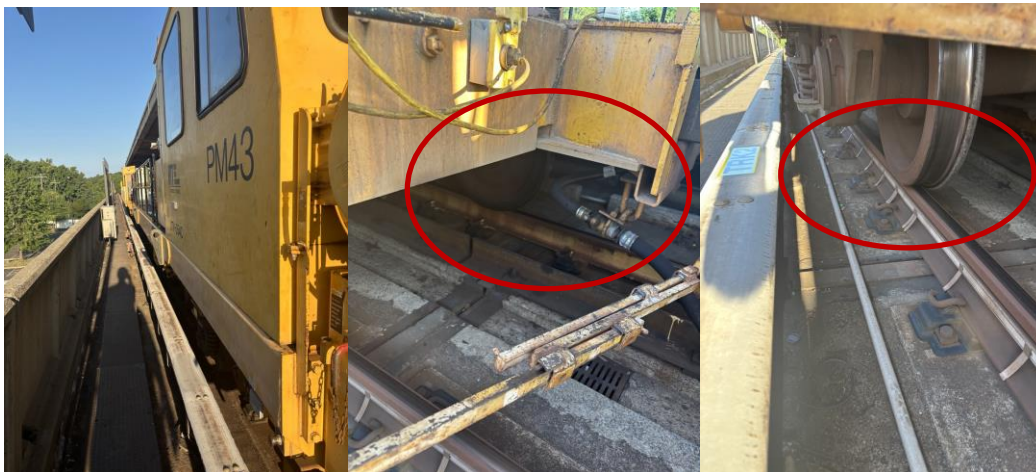
WMSC inspectors noted that Prime Mover 43, located at Naylor Road (F09) platform, track 2, was parked and unattended with no chocks on the wheels (see photos 4 and 5). Metrorail Operating Handbook section 11.12.1-5 (Securing Roadway Maintenance Machines) states “Operators shall secure Roadway Maintenance Machines while they are stopped in the work area...by placing wheel chocks, stops and by applying handbrakes.”

Photo 3 (Left). Prime mover 43 stored at Naylor Road platform.

Photo 4 (Middle). No wheel chocks applied to the prime mover 43.

Photo 5 (Right). No wheel chocks applied to prime mover 43.

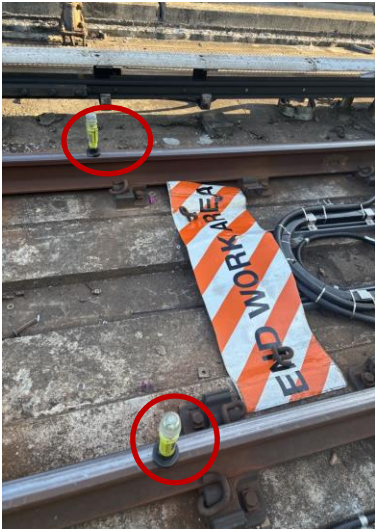
WMSC inspectors noted that red lanterns were not illuminated at the beginning of the work zone set up at Naylor Road (F09). However, personnel did have batteries on site to mitigate the issue.

Photo 6. Red lanterns were not illuminated. Issue was mitigated onsite.
