WMSC Inspection Report 20250903A

Title: New Carrollton Yard (D99) Carwash Re-inspection

Location: New Carrollton Yard (D99)

Date of Inspection: 9/3/2025

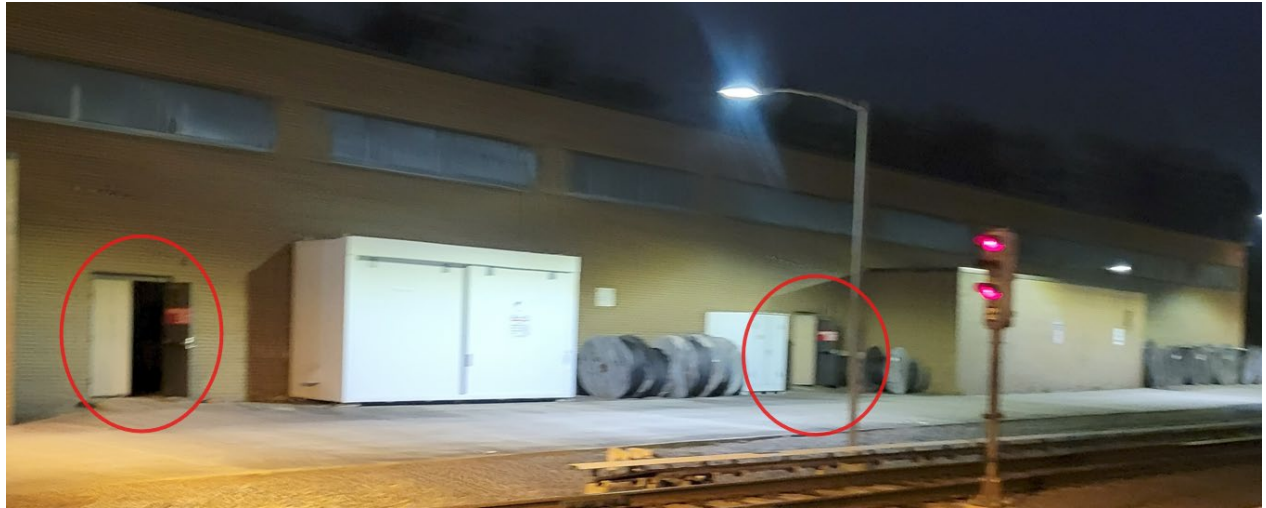
Before

The three emergency exit door hazards that were identified in the April 11, 2025, inspection (three emergency exit doors were either open, broken, or wedged open) are now closed, secure, and functioning properly.

Original Hazard Rating: 2D

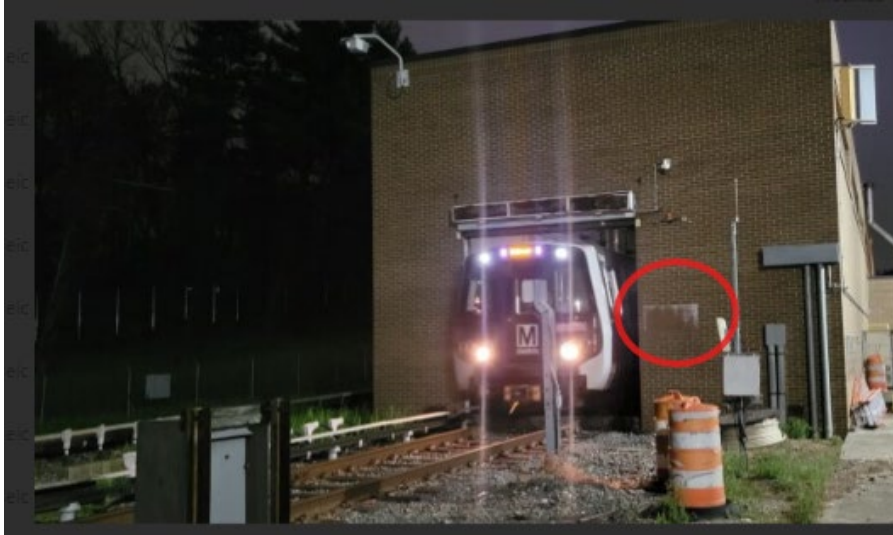
Before

The April 11, 2025, inspection identified the operational signs posted for rail vehicle operators at the entrance and exit of the carwash were faded or damaged so that the signs were not legible. The September 3, 2025, inspection confirmed the signs were replaced and now legible to rail vehicle operators at both locations.

Original Hazard Rating: 3D
