W-0401 - Collision at Anacostia Station, January 23, 2025

FINAL REPORT OF INVESTIGATION A&I E25122

Anacostia Station – Collision

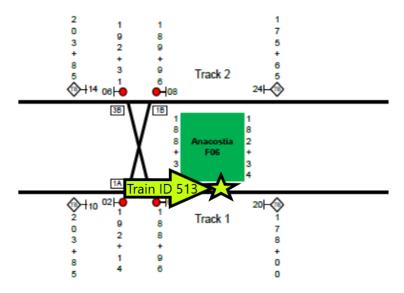
Field Sketch/Schematics

Anacostia Station is a below-ground station with a center platform. The station has direct fixation tracks and there is an interlocking at this station. There are turnbacks on the inbound and outbound ends of the station.

The above depiction is not to scale.

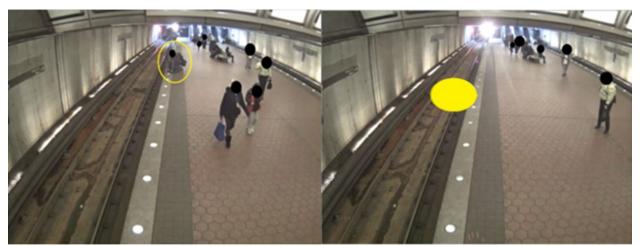
On Thursday, January 23, 2025, at 15:43 hours, the Closed-Circuit Television (CCTV) showed the patron using a motorized wheelchair arriving at Anacostia Station. The patron entered the station and boarded the elevator from the mezzanine and arrived on the platform level. The patron was operating their motorized wheelchair on the center platform of Anacostia Station when the wheelchair veered towards the platform edge on Track 1. At 15:45 hours, the patron and the wheelchair fell onto the roadway between the running rails. Several patrons on the platform were waving at the train for the RVO of Train ID 513 to stop. The RVO initiated the emergency braking after observing the obstruction on the roadway. The train struck the patron, pinning them beneath the lead car before stopping.

Figure 1 - Depicts the patron losing control of their motorized wheelchair and falling into the roadway as Train ID 513 approached Anacostia Station.

The probable cause of the Collision event that occurred on January 23, 2025, at Anacostia Station was the action of the patron, who, for unknown reasons, was unable to maintain full control of their motorized wheelchair. The patron fell onto the rail right-of-way, and was struck by Train ID 513.

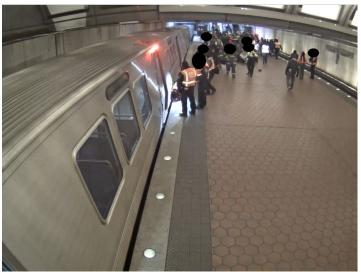
Figure 2 - Depicts DCFEMS arrival as Allied Security SPOs were clearing the station.

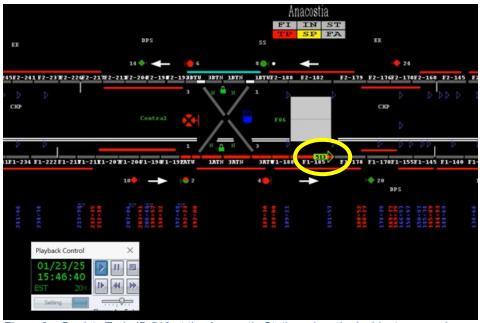
Figure 3 – Depicts Train ID 513 at the Anacostia Station when the incident occurred.

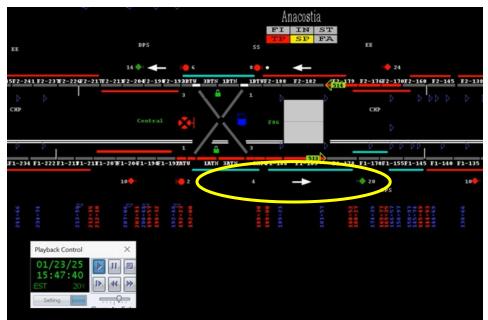
Figure 4 – Depicts Third Rail power de-energized on Track 1 at Anacostia Station.

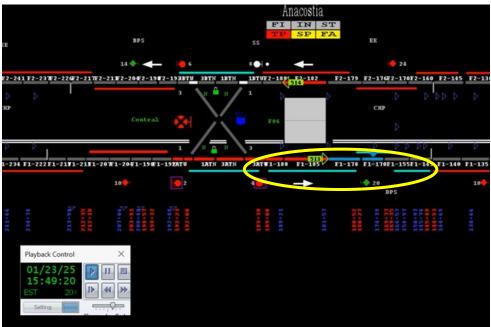
Figure 5 – Depicts Blue Block/ Human Form added to Track 1 at Anacostia Station.

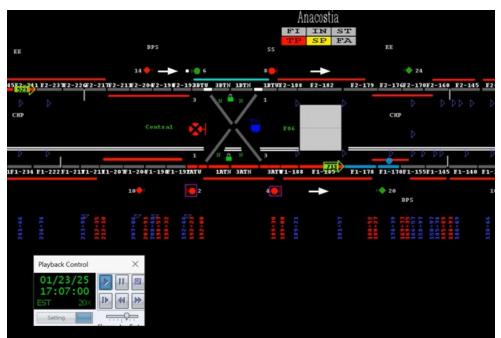
Figure 6 - Depicts Third Rail power restored on Track 1 at Anacostia Station. Blue Block/ Human Form still in place. Train ID 513 ID was changed to 713.

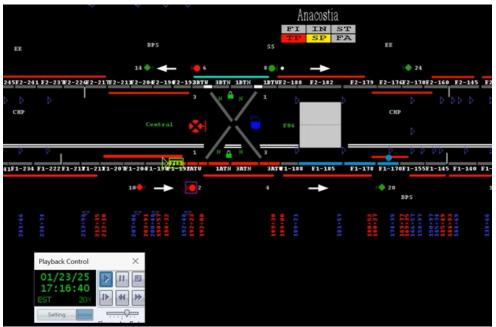
Figure 7 - Depicts Train ID 713 departing Anacostia Station towards Branch Avenue Yard.

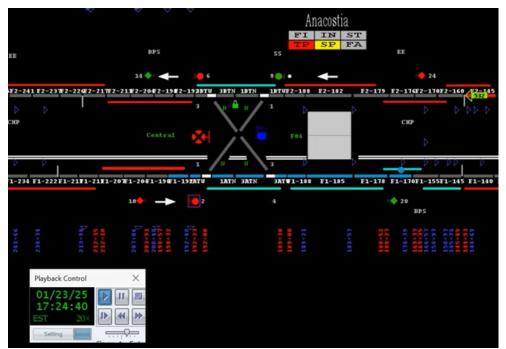
Figure 8 - Depicts Third Rail power de-energized on Track 1 at Anacostia Station. Blue Block/ Human Form still in place.

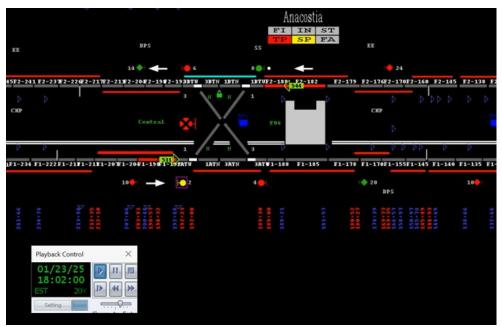
Figure 9 – Depicts Third Rail power restored on Track 1 at Anacostia Station. Blue Block / Human Form removed.

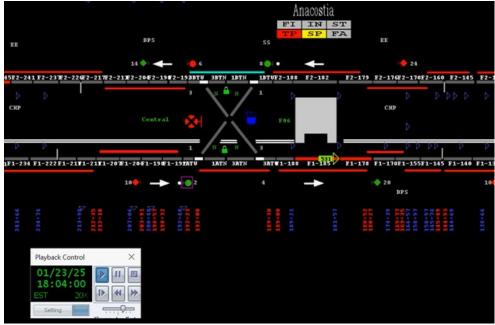
Figure 10 – Depicts Train ID 531 servicing Anacostia Station, Track 1, after the event.

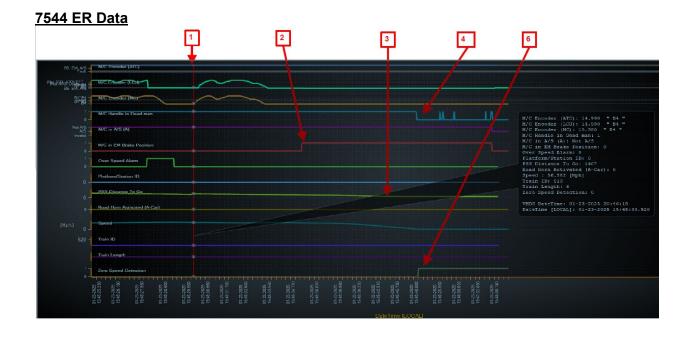
*Note (1): "Events" numbering corresponds to markers shown on the ER Data graphs below.

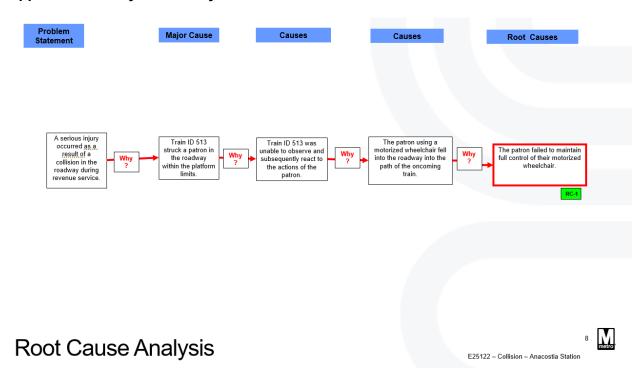
Appendix D - Why-Tree Analysis

- The patron appeared to lose positive control of the motorized wheelchair and veered towards the platform edge.
- The RVO observed what they believed to be a bicycle in the roadway and initiated Emergency braking.
- Train ID 513 struck the patron and motorized wheelchair before coming to a stop with two (2) cars on the platform.
- DCFEMS found the patron underneath the train exhibiting signs of life and started rescue operations.
- The patron was transported to MedStar Hospital.

The probable cause of the Collision event that occurred on January 23, 2025, at Anacostia Station was the action of the patron, who, for unknown reasons, was unable to maintain full control of their motorized wheelchair. The patron fell onto the rail right-of-way, and was subsequently struck by Train ID 513.
