**W-0402 – Serious Injury at Capitol Heights Station –August 16, 2024****Document Purpose**

**FINAL REPORT OF INVESTIGATION A&I E24651**

## Capitol Heights – Serious Injury

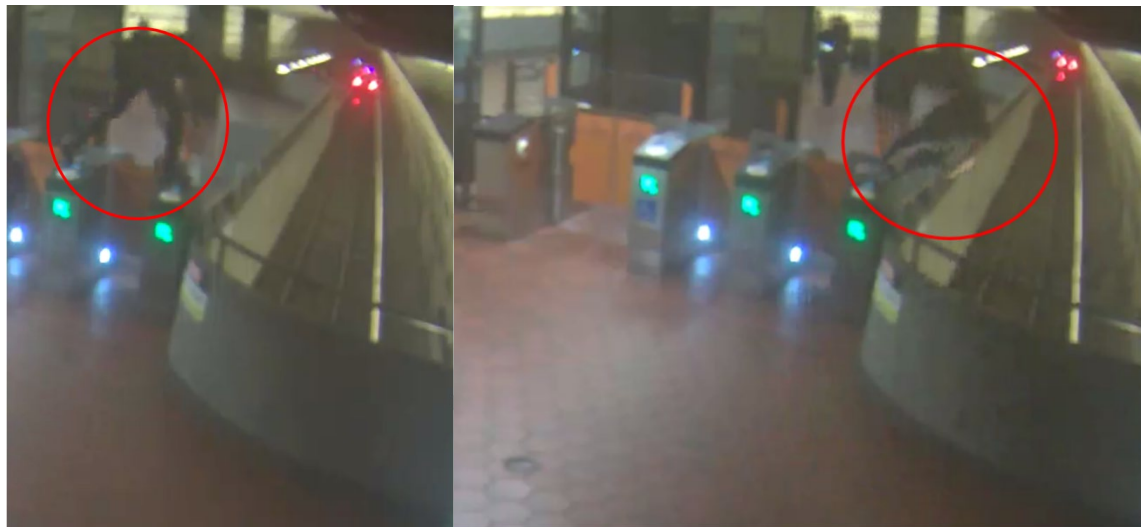
The customer stood atop the fare gate and lost their balance, causing them to fall onto the roadway below. The customer landed on their head and upper torso, with their legs bridged over the left running rail.

*Figure 2 - At 14:56:51 hours, the customer was standing atop the fare gates, entering Capitol Heights Station on the left. At 14:56:55 hours, the customer attempted to dismount the fare gate by utilizing their right hand on the handrail, losing their balance, and falling to the roadway below.*

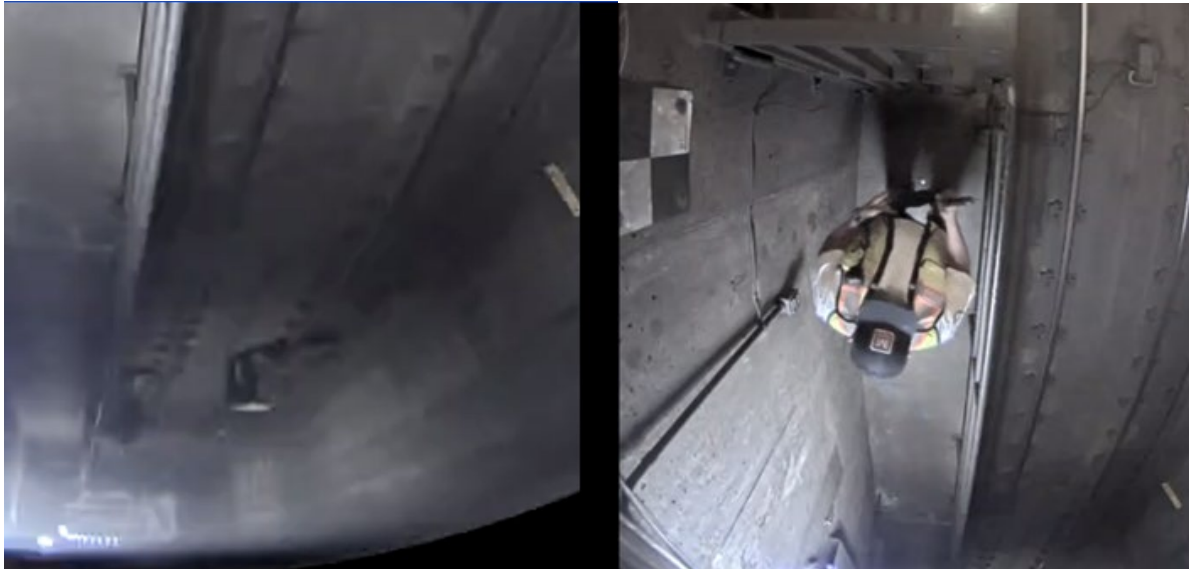
At 15:11:13 hours, MTPD Command received verbal confirmation from rail operations personnel that the third rail power was de-energized, but instructed them to hot-stick the area to ensure safety. At 15:17:15 hours, the RTRA Supervisor was observed hot sticking the third rail near the tunnel's end gate.

*Figure 4 The images above show the RTRA Supervisor hot-sticking and returning to the platform without visible high-voltage gloves.*
