## Collisions

### At Shady Grove Station and West Hyattsville Station

March 26, 2025, and March 12, 2025

**FINAL REPORT OF INVESTIGATION A&I E25440**

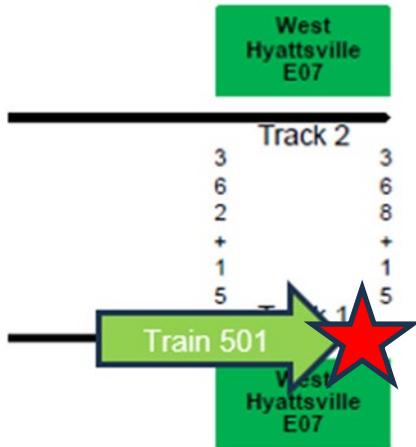
## Field Sketch/Schematics

The above depiction is not to scale. The red star indicates the approximate location of the collision.

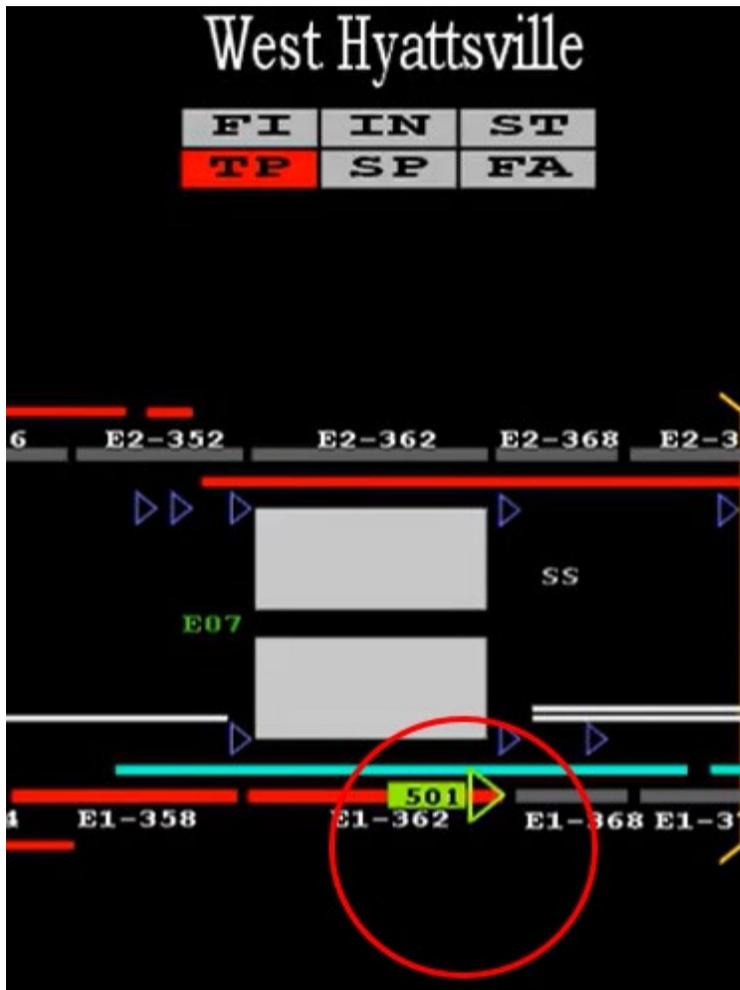
## Advanced Information Management System (AIMS)

Figure 1 Depicts Train ID 501 stopped at West Hyattsville Station.
