# WMSC Inspection Report 20260312B

Title: Alexandria Yard (C99) Car Wash Inspection

Location: Alexandria Yard (C99)

Date of Inspection: 3/12/2026

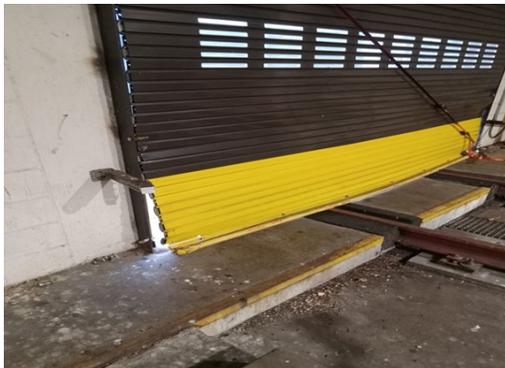
The track one entry door of the car wash was inoperable due to a collision with the door<sup>2</sup>. The broken door is located on the west side entrance. The damaged door is recorded in the interlocking operator’s logbook. A Maximo<sup>3</sup> work order (WO) has been submitted (WO 20139782) to fix the damaged door.

### Hazard Rating: 2D

Photo 1: broken car wash train entry door on track one.

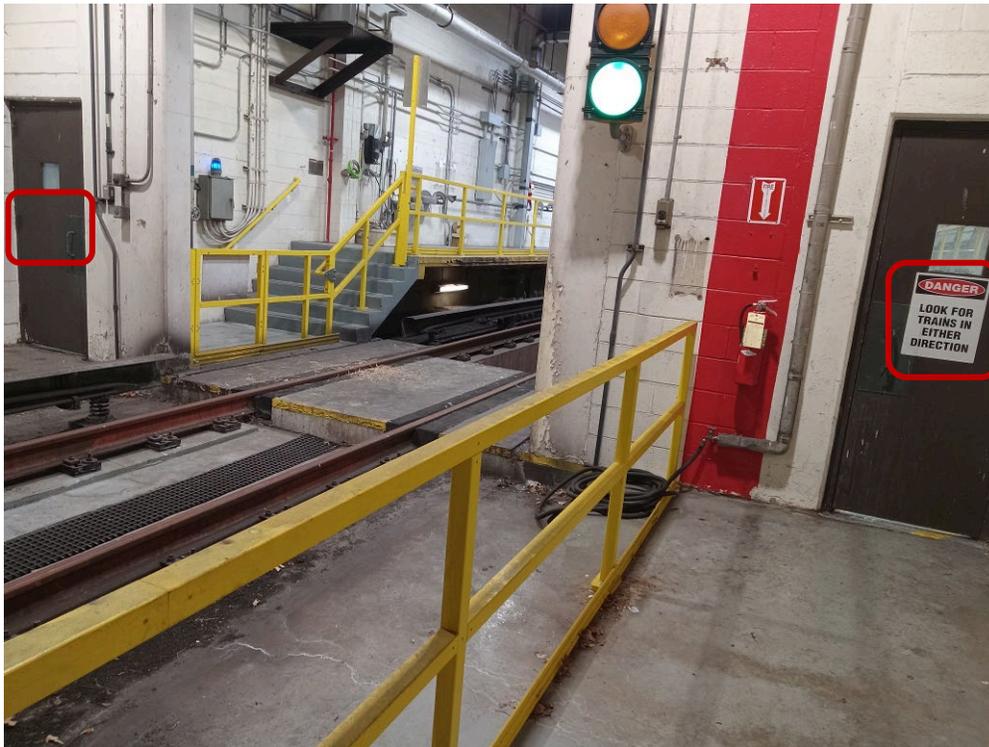
WMSC Inspectors noted one of the doors inside the car wash displayed a “LOOK FOR TRAINS” warning sign while the corresponding door on the opposite side of the car wash was without signage.

**Hazard Rating: 2D**

Photo 2: Signage on one door (right) but not on the opposite side door (left).

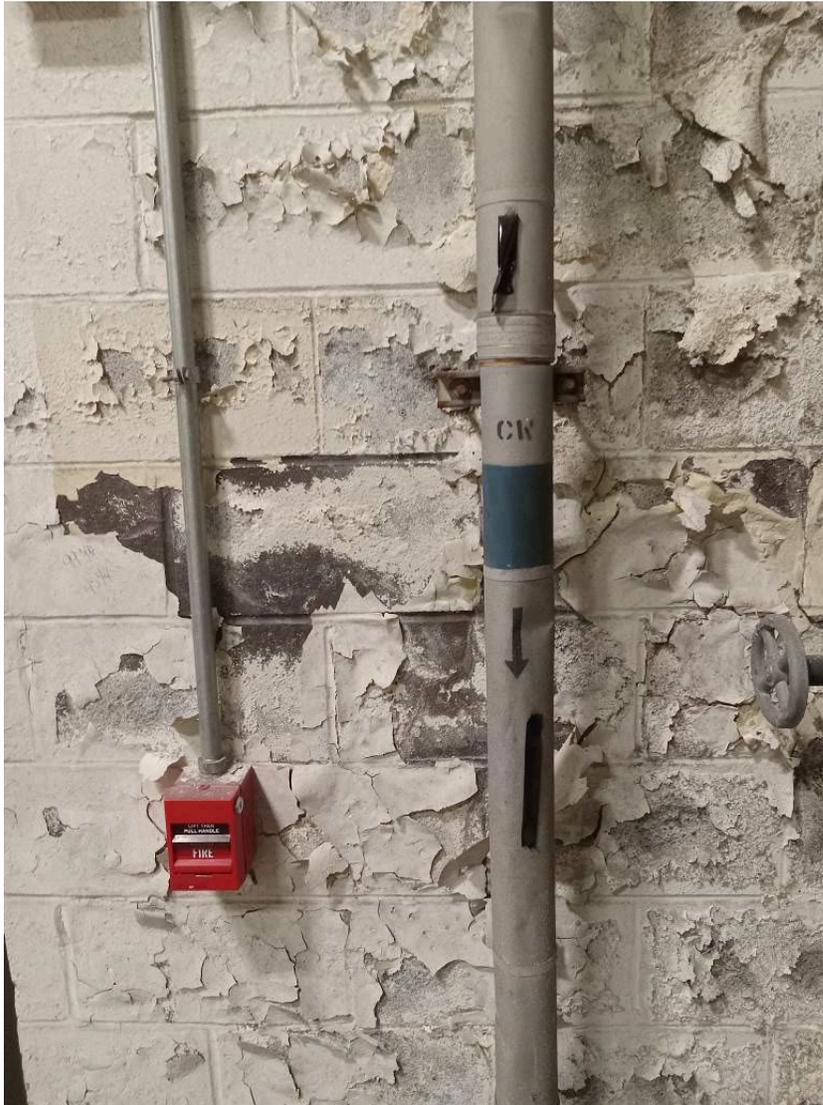
WMSC Inspectors observed peeling paint on walls in multiple locations throughout the car wash. The paint chips and peeling paint could pose a health risk depending on the type of paint initially used.

Photo 3: An example of peeling paint on the interior of the facility.
