# WMSC Inspection Report 20260319

Title: Shady Grove Yard (A99) Car Wash Inspection

Date of Inspection: 3/19/26

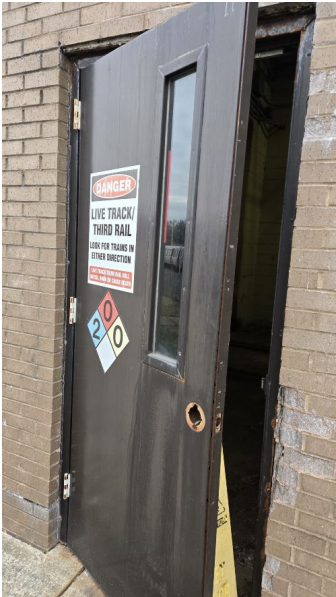
### **Defect 1**

One exterior door on the south side of the car wash appears to be unsecured (missing doorknob or lock mechanism) and was propped open at the time of the inspection.

### **Hazard Rating: 2D**

Photo 1: Exterior door without knob or lock mechanism and propped open.

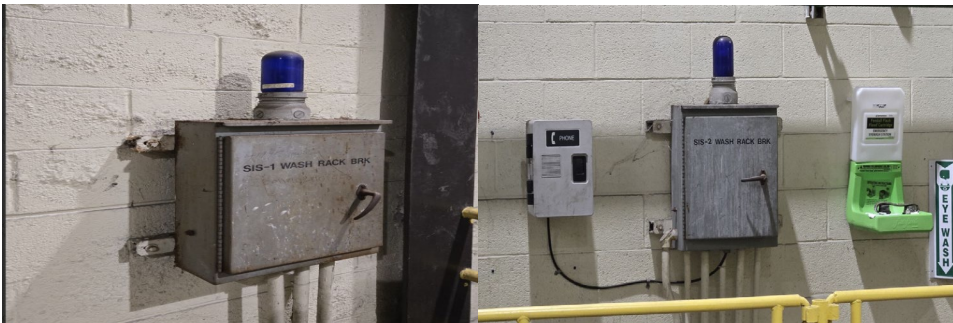
## Defect 2

Inside the car wash, three Emergency Trip Stations<sup>3</sup> (ETS) blue lights were not illuminated. All ETS telephones were checked and are operational (dial tone present).

**Hazard Rating: 2D**

Photos 2 (left) and 3 (right): two of the three ETS boxes without blue lights illuminated.

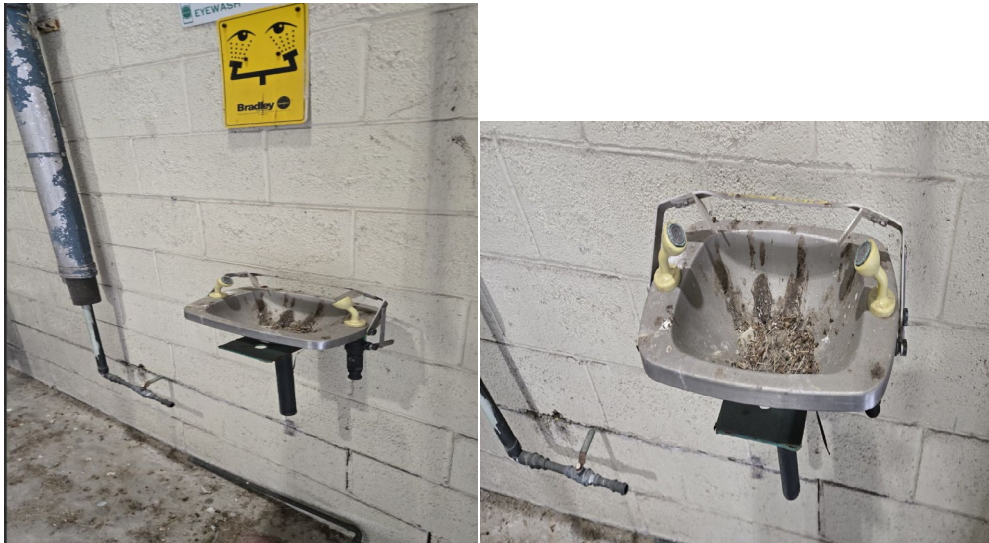
### Defect 3

The plumbed eye wash decontamination station located on the south end of the car wash is broken and filled with debris.

**Hazard Rating: 2D**

Photos 4 (left) and 5 (right): Disconnected decontamination station filled with debris.

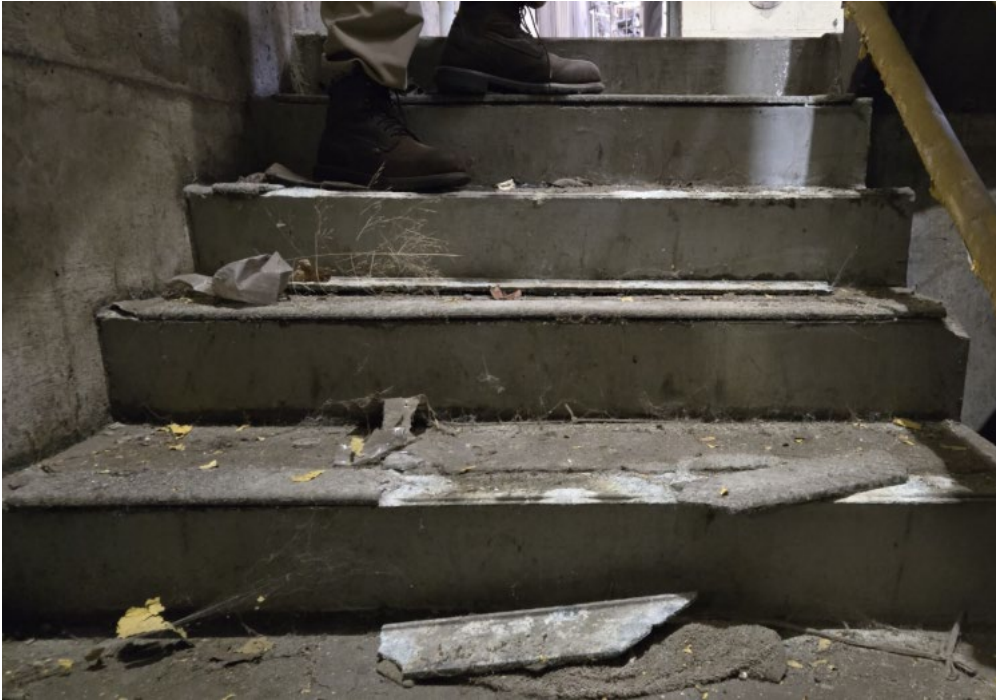
### Defect 7

The stairwell leading from the lower-level pit inside the S&I shop leading up to the car wash is loose with broken material creating a slip, trip, or fall hazard condition.

**Hazard Rating: 2D**

Photo 11: hazardous condition on car wash steps.

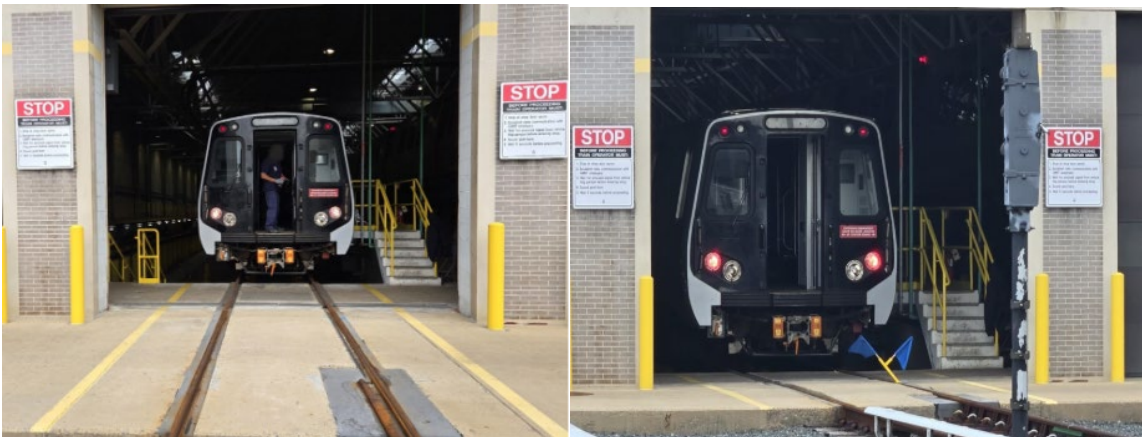
**Defect 8 (mitigated)**

At the conclusion of the inspection, WMSC Inspector identified employees working on a train located within the S&I shop on track 9 south. The workers failed to properly install required blue flag protection (SOP 301.20 - Blue Signal Protection Program). WMSC Inspectors contacted the S&I shop supervisor, and the flags were installed.

**Hazard Rating: 2D**

Photo 12 (left) and 13 (right): work being done on the vehicle before and after the blue flag mitigation.
