WMSC Inspection Report 20260403A

Title: Branch Ave Yard (F99) Roadway Worker Protection Inspection

Date of Inspection: 4/3/2026

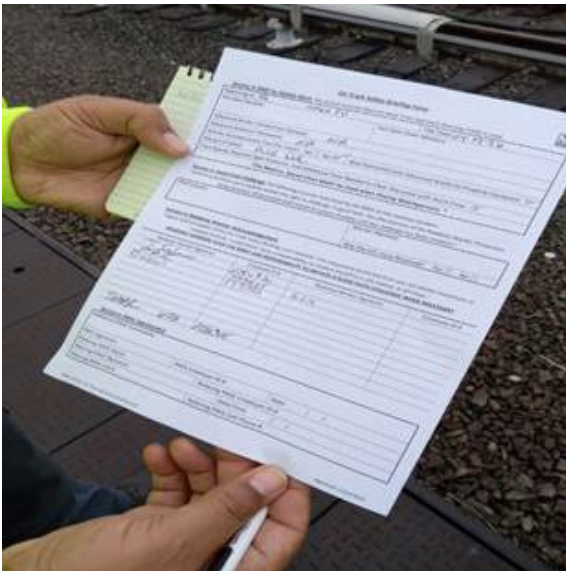
Photo 1: RWPM 1.8.4 On-Track Safety Briefing.

The On-Track Safety Briefing Form presented to the inspection team was not signed by the roadway worker in charge (RWIC). (See Photo 1)

On-Track Safety Briefings are not complete until all members of the roadway work crew sign the briefing and acknowledge understanding the on-track safety being afforded to them, and that all on-track safety concerns have been addressed.

Roadway Worker Protection Manual, section 1.8.4

“On-Track Safety Briefings are not complete until all members of the roadway work crew sign the briefing and acknowledges understanding the on-track safety being afforded to them and all on-track safety concerns have been addressed.”

Roadway Worker Protection Manual, section 1.9.7

“After the current RWIC has verified all the information on the form is accurate, they are to enter the following on the “Signing Off” line:

- Name (printed)
- Signature, and
- Employee Identification Number”

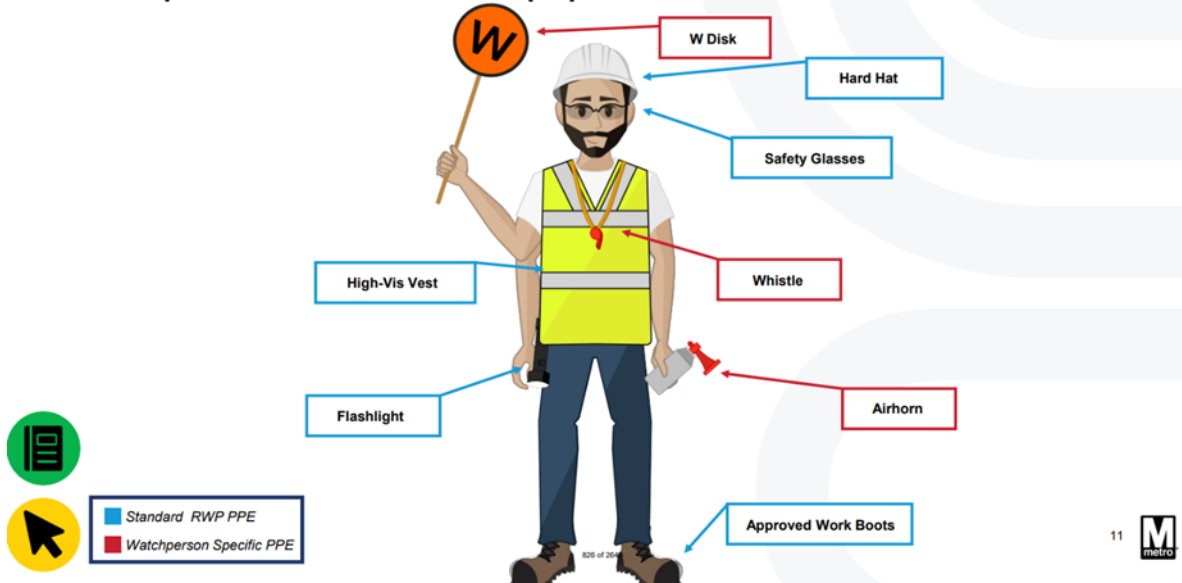
Photo 2: Watchperson PPE and Equipment Training Slide.

The On-Track Safety Briefing identified that the crew was using Train Approach Warning (TAW) as their form of roadway worker protection. TAW requires the use of a watchperson (See section 1.25.6 of RWP Manual “Placement of Watchperson” under 1.25 “Train Approach Warning (Mobile Work Crew)”). The roadway worker in charge identified themselves as the watchperson but was not in possession of the required safety equipment. The watchperson did not have a W-DISK or an Air Horn.

Roadway Worker Protection Manual, section 1.18.2

“Watchpersons must use the whistle board (W-Disk) in conjunction with a whistle, air horn, or physical tap to warn roadway workers of approaching rail vehicles to provide ample time to workers.”

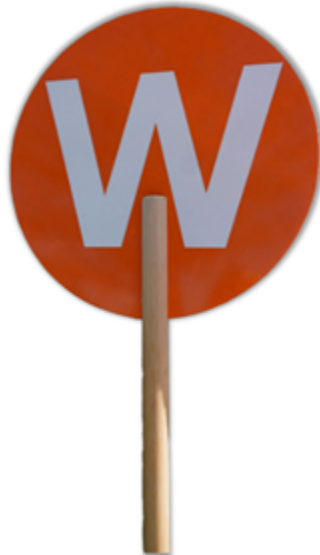
Photo 3: W Disk Training Slide.

Visual warning sign used by **Watchpersons** to warn Roadway Workers of an approaching train or other rail vehicles and signaling them to immediately move to a Place of Safety (POS).

Also used to provide a visual signal to workers letting them know it is safe to resume work.

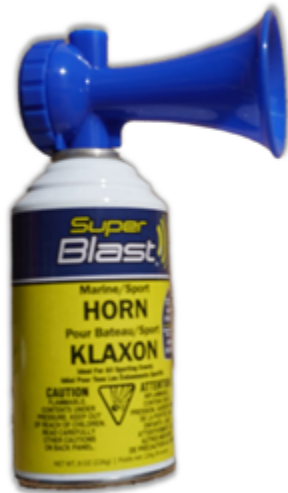
Photo 4: Air Horn Requirement Training Slide.

“Watchpersons must sound the air horn or whistle while holding the whistle board overhead to signal roadway workers of approaching rail vehicle(s) and to clear the track and remain in a place of safety.”

Audible warning used by **Watchpersons** to warn roadway workers of approaching train or other rail vehicles. Signals immediate movement to the Place of Safety (POS).

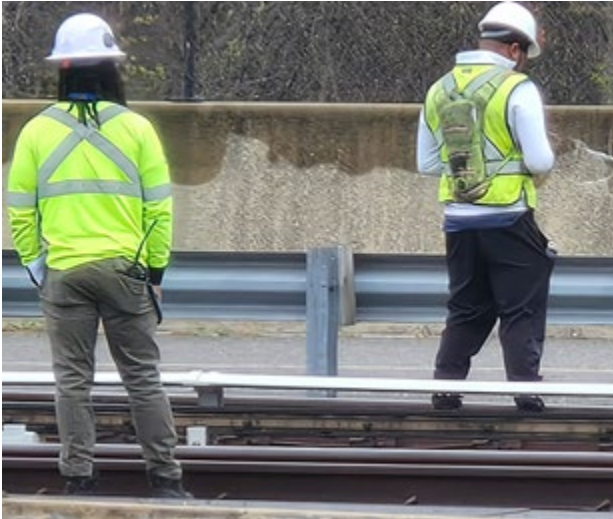
Photo 5: Backpack obscuring the "X" on safety outer wear.

WMSC Inspectors observed a worker in the performance of the job wearing a backpack obstructing the reflective "X" on their safety outer wear (see photo 5).
