# WMSC Inspection Report 20260617

Title: Roadway Worker Protection Overnight Inspection

Location: Woodley Park Station(A04) Track 1

Date of Inspection: 6/17/2026

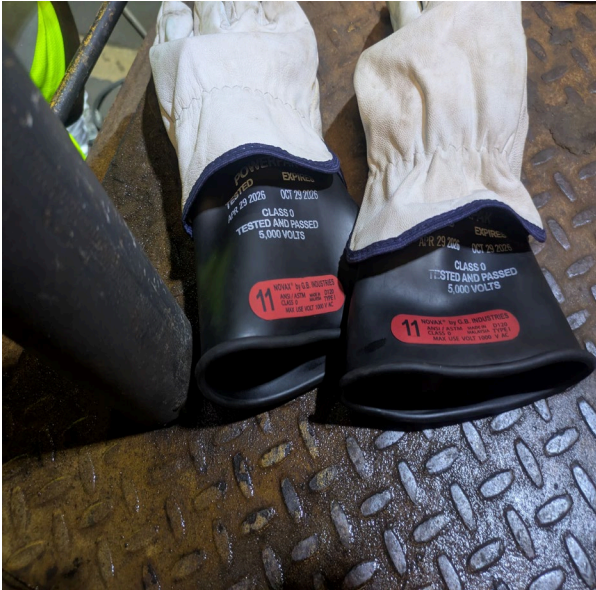
The Roadway Worker in Charge (RWIC) was observed properly using special safety personal protective equipment (PPE) and equipment (Class 0 high voltage gloves), and hot-sticking<sup>3</sup> the third rail to confirm power was down. The RWIC's Class 0 high voltage gloves were also inspected and found to be within permissible expiration date range and were in compliance.

Photo 1: Third rail high voltage gloves in compliance.

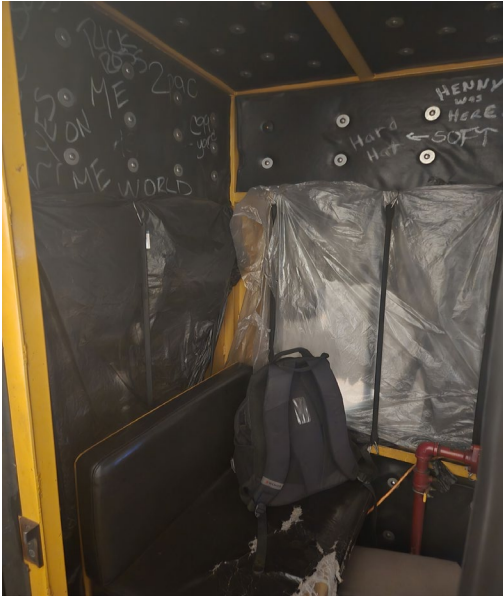
A shade or covering was observed over the windows of the Flagman's booth on Flat 532.

Metrorail Operating Rulebook: 6.1.4

“Employees shall not alter or render inoperative any safety devices on vehicles, equipment, structures and/or any other WMATA property, except as authorized by these rules or other WMATA procedures, and then only when proper measures are taken to safeguard personnel and equipment.”

**Hazard Rating: 1B**

Photo 2: Windows covered in Flagman's booth.

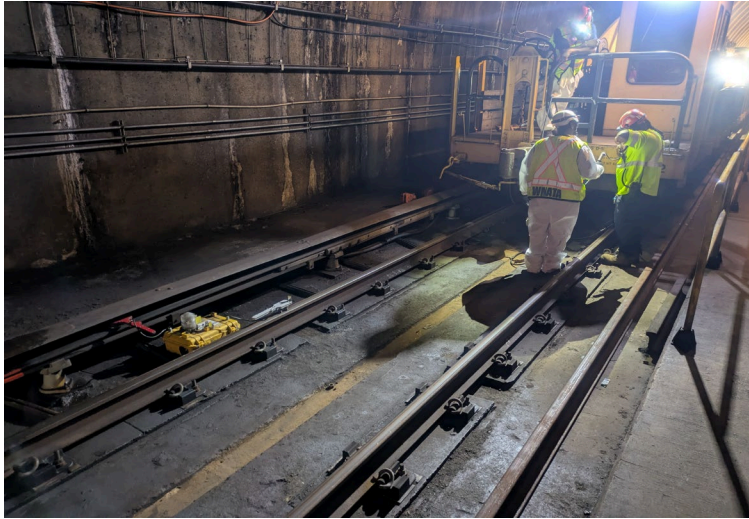
The WMSC Inspectors observed that the Roadway Worker in Charge (RWIC) was actively engaged in work duties:

RWPM section 1.4 (Roadway Worker In Charge Responsibilities)

“The RWIC must serve only the function of maintaining on-track safety for all members of the roadway work crew and perform no other unrelated job function while designated for duty.”

**Hazard Rating: 1D**

Photo 3: RWIC engaged in crew work duties.
