**W-0436 – Collision at Rhode Island Ave-Brentwood Station - November 19, 2025****Document Purpose**

**FINAL REPORT OF INVESTIGATION A&I E252272**

# Rhode Island Avenue Station – Collision Resulting in Injury

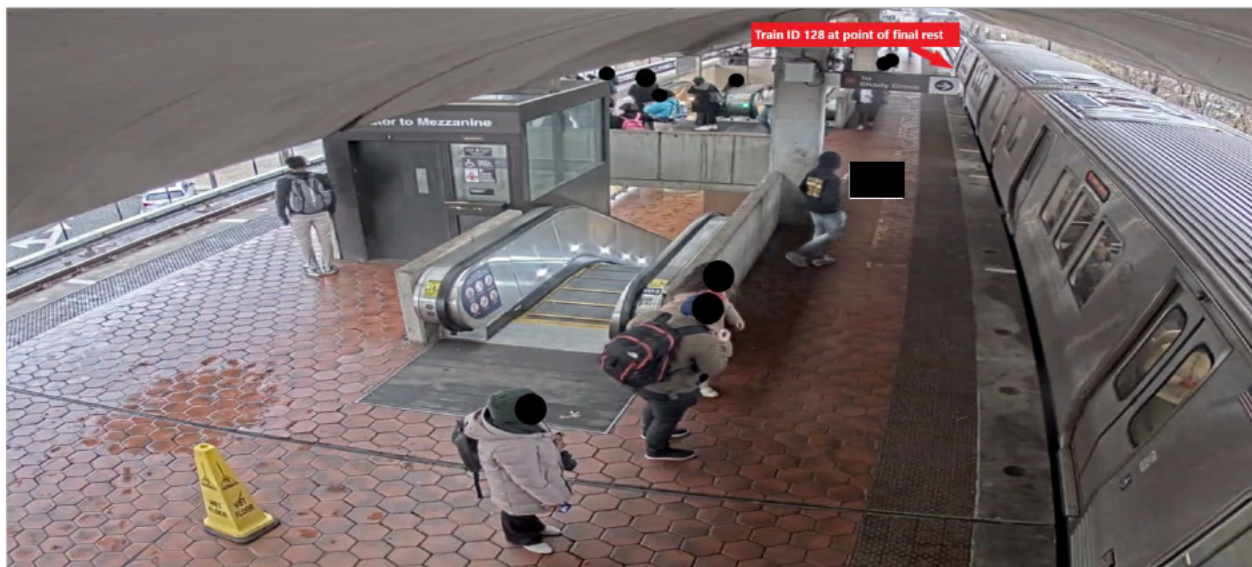
Figure 2 - Depicts the location where Train ID 128 came to a point of final rest.

At 08:31 hours, as Train ID 128 entered the Rhode Island Avenue Station, Track 2, the person leapt from the center platform to the right-of-way into the path of the train. The Office of Vehicle Program Services – Rail Fleet (CENV) Investigation Data revealed that RVO moved the Master Controller (MC) to the Emergency Braking position and pressed the Emergency Stop pushbutton. The train came into contact with the person, knocking them to the roadway, beneath the stopping train. The RVO notified the Radio RTC of a person entering the roadway and being struck by their train. The Radio RTC halted train movement on Track 2 and requested ROSs to respond to Rhode Island Avenue Station. The Button RTC notified the Rail Section AOM and was instructed to de-energize third rail power on Track 2. At 08:31 hours, an SPO on the station platform also reported the incident to MTPD via the MTPD Radio Talk group. MTPD officers were dispatched to the station.

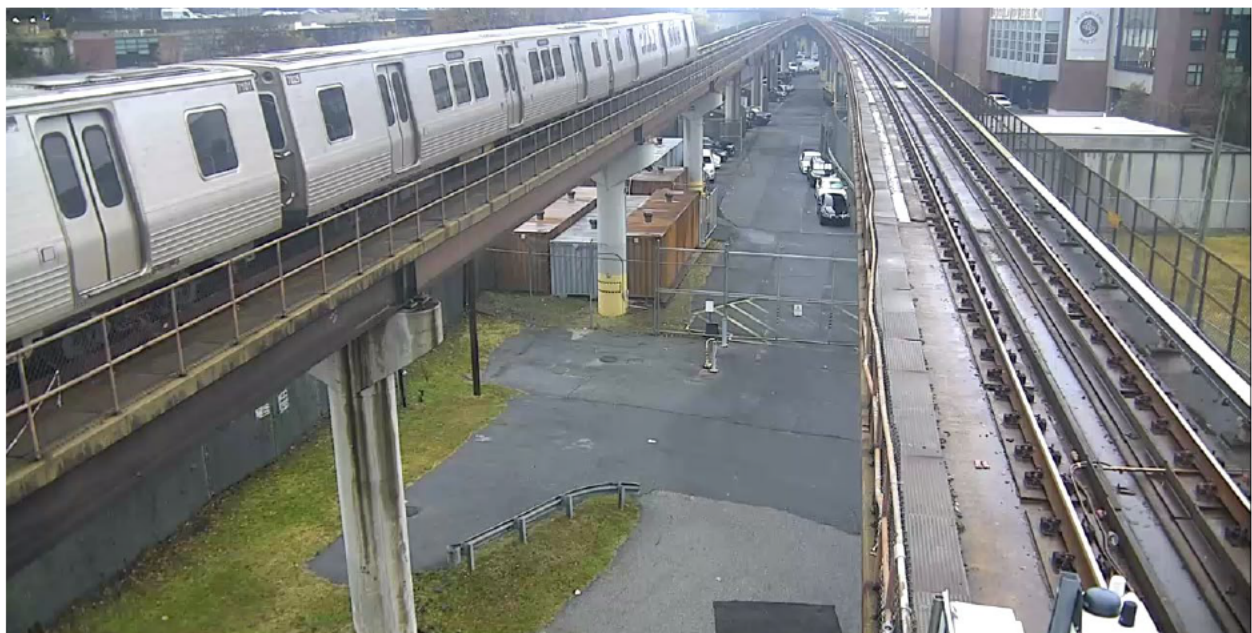
Figure 3 - Train ID 128 at a point of final rest with 3 trailing cars outside of the platform limits.

At 08:43 hours, DCFEMS personnel arrived at Rhode Island Avenue Station, and Unified Command was established. Rescue efforts were performed, and at 09:13 hours, the person was extricated from beneath the train. It was discovered that the person was a minor and was transported to the Children's National Hospital.
