## **W-0442 – Collision near Judiciary Square – April 3, 2023**

**FINAL REPORT OF INVESTIGATION A&I E23222**

## Between Judiciary Square & Union Station – Fatality

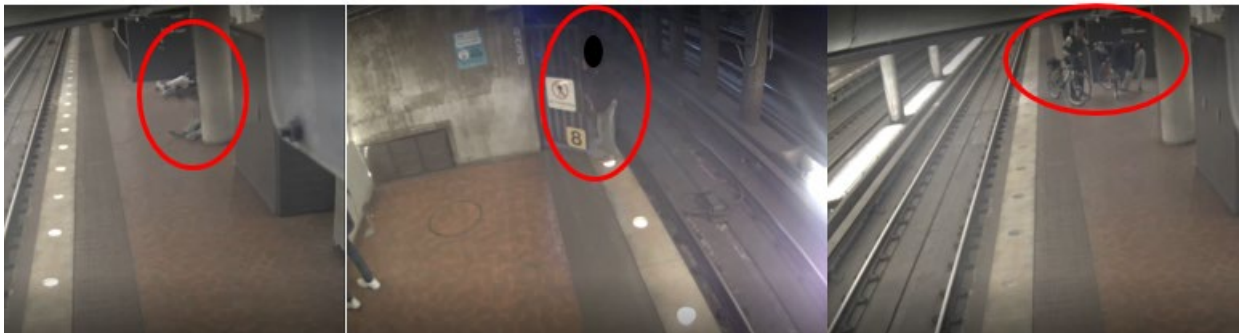
Closed Circuit Television (CCTV) indicated that Person #1, wearing a black jacket and blue jeans with brown shoes, entered Judiciary Square Station at 08:01 hours and fare evaded before heading to the platform on track 2. The Station Managers followed Person #1 onto the platform and had a brief conversation with them. Person #1 walked to an area behind the escalator, positioned themselves beside a pylon, then sat down on the platform. Person #1 began to kick and roll around on the platform, then was lying still on the platform next to the pylon.

Person #2 arrived on the platform pushing a bicycle and was wearing a black jacket and gray pants. Person #2 reached down and took something from Person #1. Person #2 stood near the escalator control cabinet and appeared to inject something. Person #2 sat on the platform, the began to kick and roll around on the platform near Person #1.

Person #1 then returned to their feet and walked beyond the end gate onto the roadway on track 2. Person #2 returned to their feet and was met on the platform by an MTPD Officer with a bicycle.

*Image 1 – CCTV images of Persons 1 and 2 on the platform at Judiciary Square Station, track 2.*

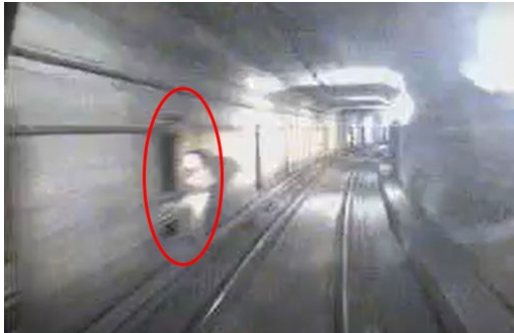
At 08:22 hours the Train Operator of Train ID 111 located between Union Station and Judiciary Square Station, track 2 reported to ROCC that a person was observed on the roadway wearing a black shirt with blue jeans, and they crossed over to track 1. The Radio RTC acknowledged the report from Train ID 111. The Button RTC notified the AOM and ROIC of the report.

*Image 2 – CCTV from Train ID 111 lead car 7306 depicting Person #1 crossing from track 2 to 1 through a gap of the tunnel wall.*

The probable cause of this safety event was a person trespassing onto the roadway. Contributing factors included: the person crossing from track 2 to track 1 through a gap in the tunnel wall, confusion among control center management regarding the location of person #1, and MTPD reporting the roadway was clear.

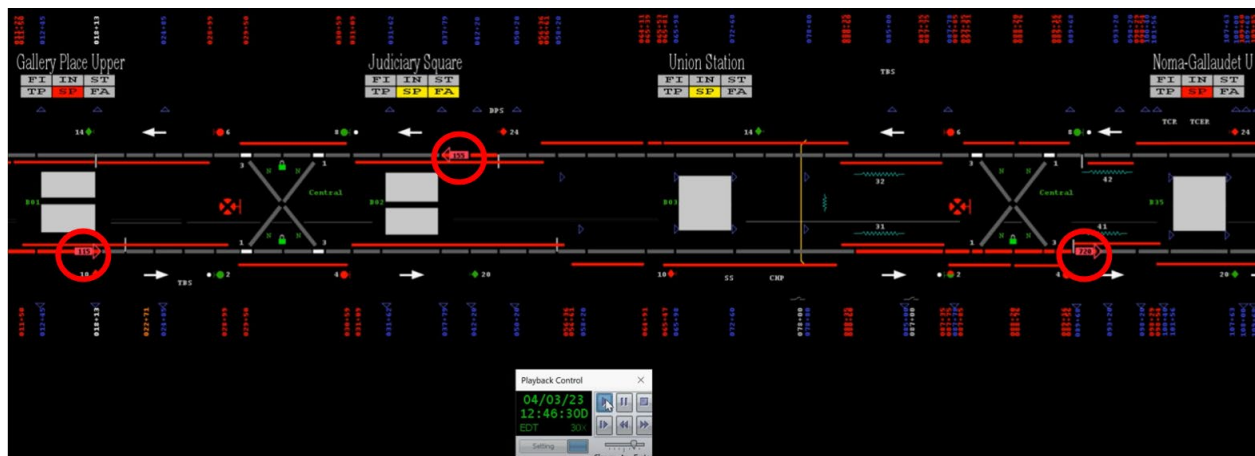
Figure 9 – Third rail power energized, and normal service resumed at 12:46:30 hours.
