## **W-0444 – Collision at Reston Town Center Station – December 31, 2023**

**FINAL REPORT OF INVESTIGATION A&I E23924**

## Reston Town Center – Collision

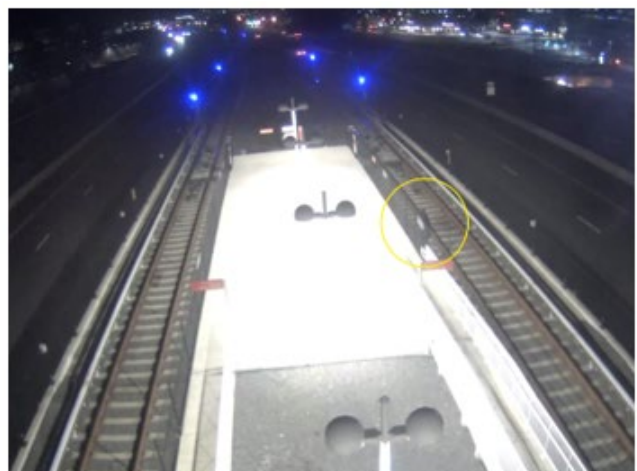
On December 31, 2023, at 22:57 hours, CCTV captured a customer walking towards the 8-car marker, jumping from the platform and onto the roadway at Reston Town Center Station on track 2. The person continued walking towards Herndon Station.

*Image 1 - Images of the customer entering the roadway from the platform at Reston Town Center Station on track 2 at 22:57 hours; and the customer walking on the roadway passing the refuge area on track 2 near Reston Town Center Station at 22:58 hours.*

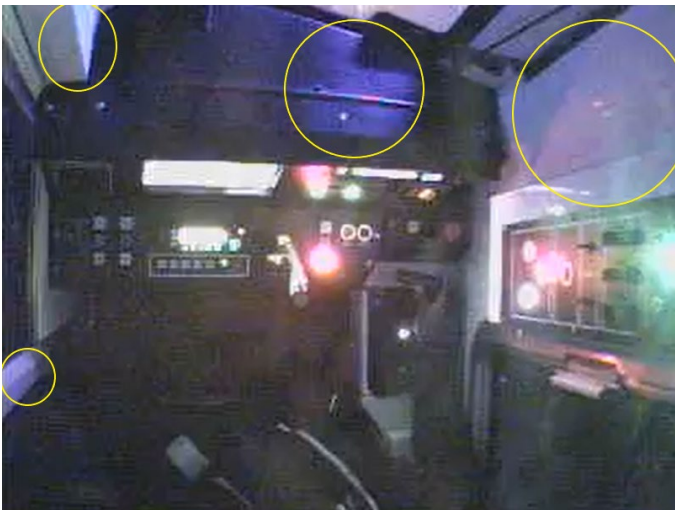
Consultation of the forward-facing camera from the lead car of Train ID 604 revealed that it was after dark prior to the collision, an Emergency Trip Station (ETS) Box light located at CM N2 1151+39 was observed glaring as the train approached the area where the person was lying.

*Image 3 – Image from the console camera depicting the Train Operator operating the train while glaring lighting from the ETS Box pierced through the windshield prior to the collision.*

The probable cause of the Collision event that occurred on December 31, 2023, at CM N2 1152+00 was the intentional action of the person to trespass onto the rail right-of-way, and subsequent strike by the train. An additional causal factor was that the event occurred at night, and visibility for the Train Operator was reduced.

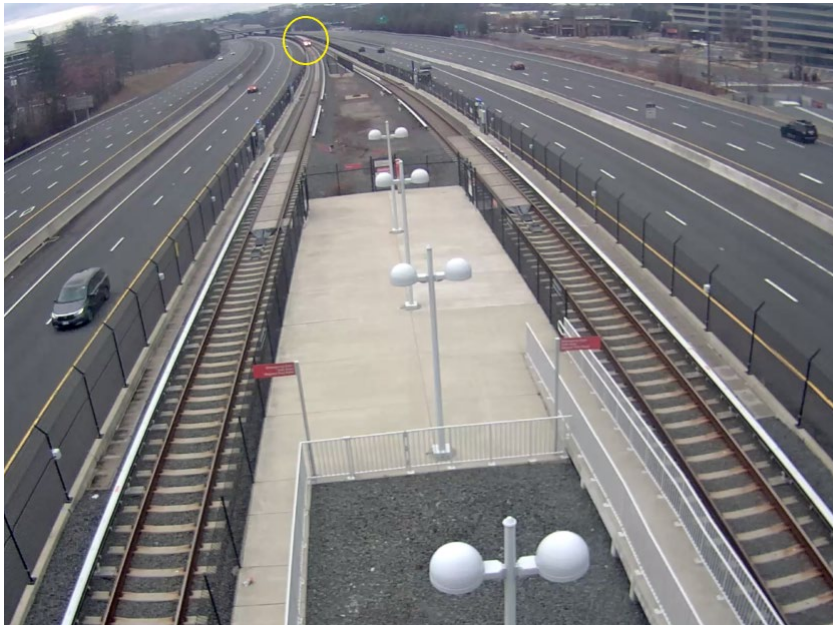
*Image 4 – Image of Train ID 603 traversing between Herndon Station and Reston Town Center Station on track 1, and near CM N1 1152+00 at 09:29 hours.*

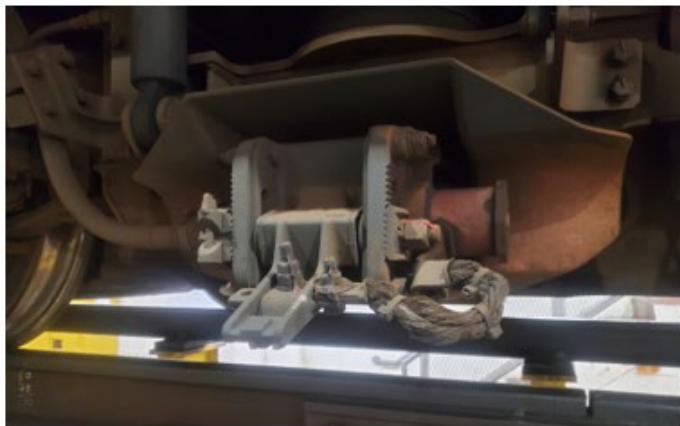
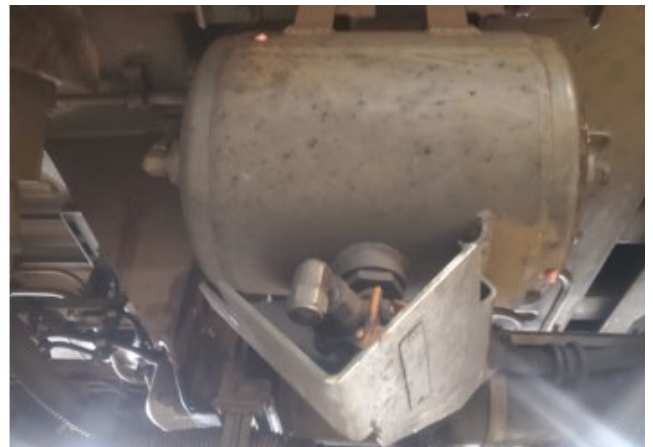
The Office of Car Maintenance (CMNT) performed an under-car inspection of Train ID 604 (L7306/07x7225/24x7726/27x7441/40T) and determined that on rail car 7306 collector shoe #1 was missing, and there was no physical damage to the train. On rail car 7307, the left suspension reservoir draincock bracket was bent. The consist was sent through the car wash, and a thorough under-car cleaning was performed.

*Image 5 – Photos of R7306 missing collector shoe #1; and R7307 bent left suspension reservoir draincock bracket.*

Repairs were made to damage found on Train 604, including a missing collector shoe on railcar 7306, and railcar 7307 had a bent left suspension reservoir draincock bracket.
