**W-0446 – Collision at Stadium-Armory Station – April 8, 2024****Document Purpose**

**Safety event summary:**

The probable cause of this safety event was unauthorized access to the top of the train by the customer, resulting in their fall between railcars onto the roadway.

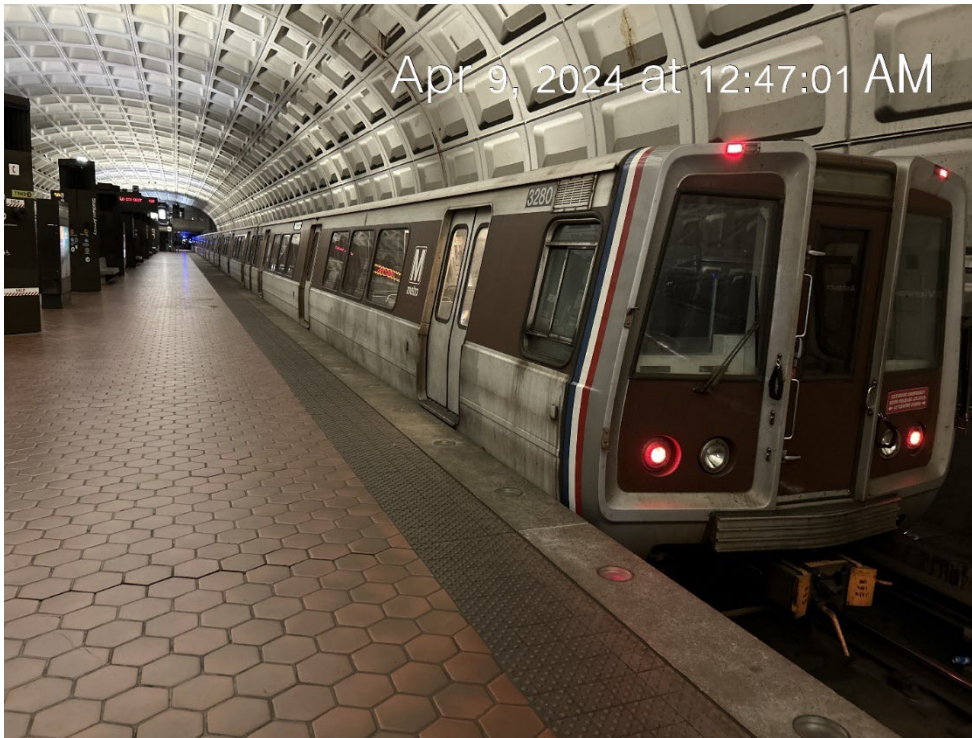
*Figure 12- Trailing railcar of Train ID 648 at Stadium-Armory Station*

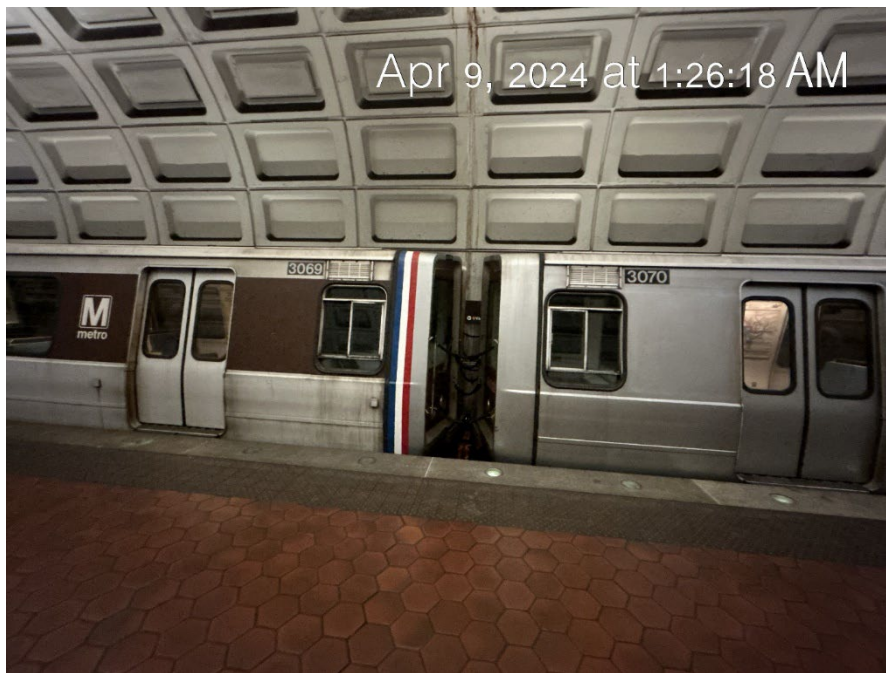
Figure 13 - depicts the location where the customer climbed to the roof of the train

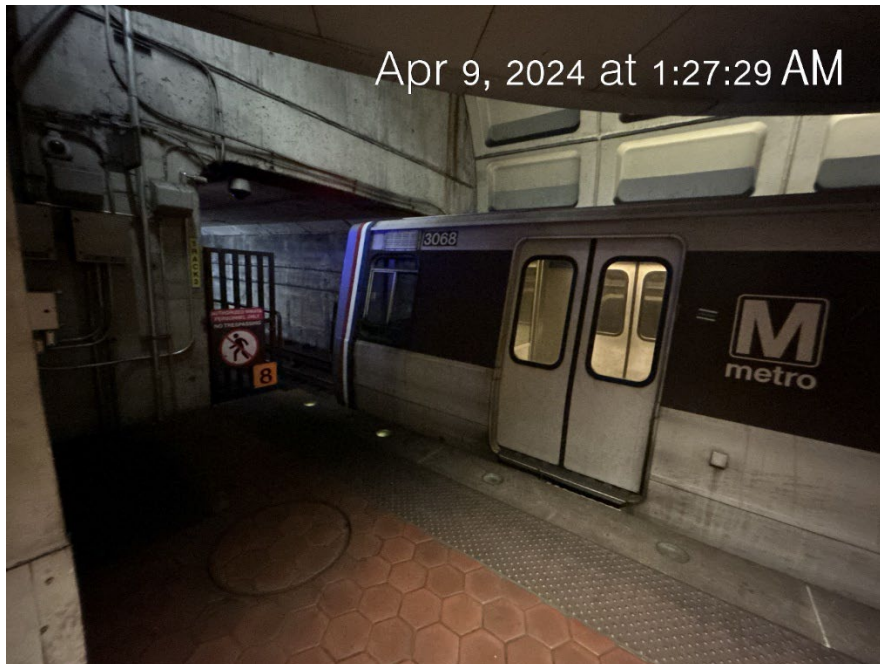
Figure 14 - Lead railcar of Train ID 648

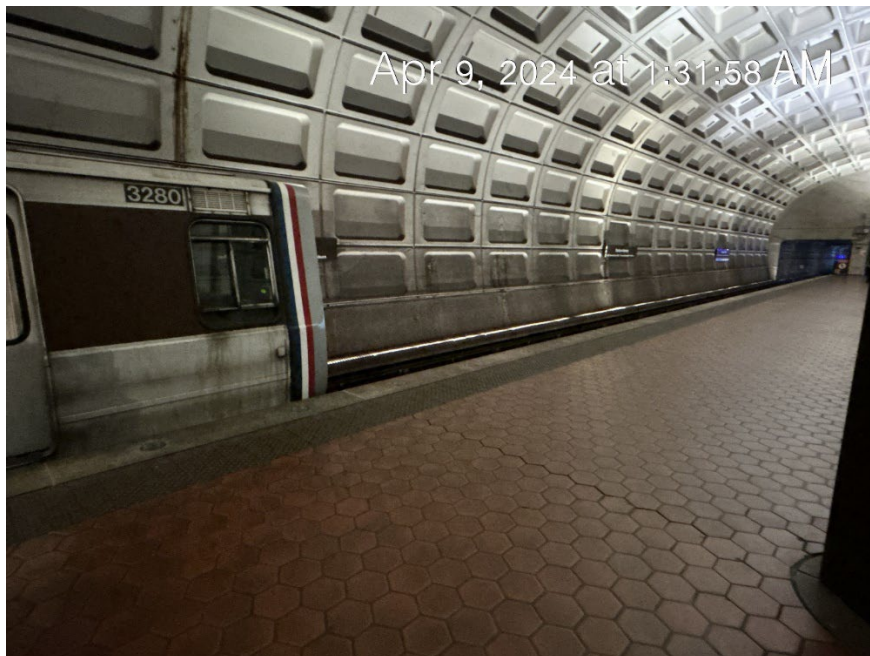
Figure 16 - depicts tail railcar and roadway on track 2 at Stadium-Armory Station

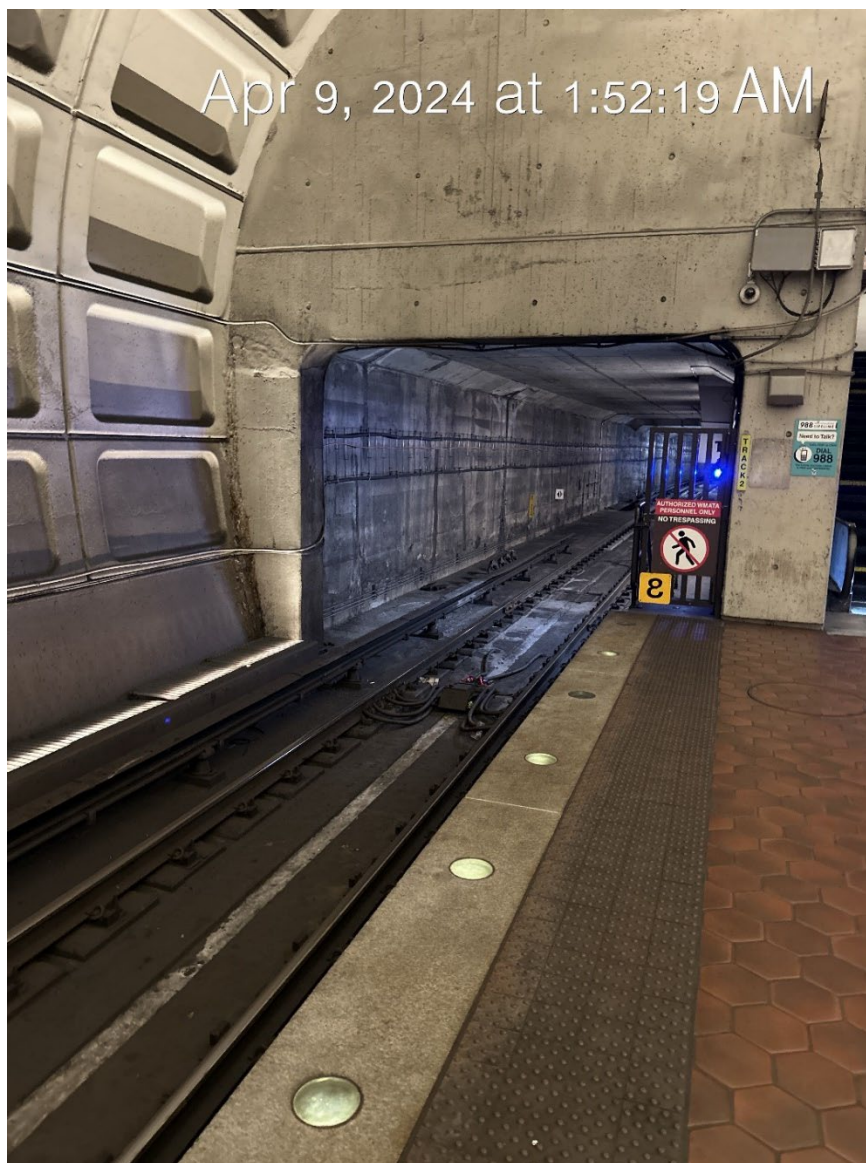
Figure 17 - track 2, Stadium-Armory Station in the direction of the D&G Junction

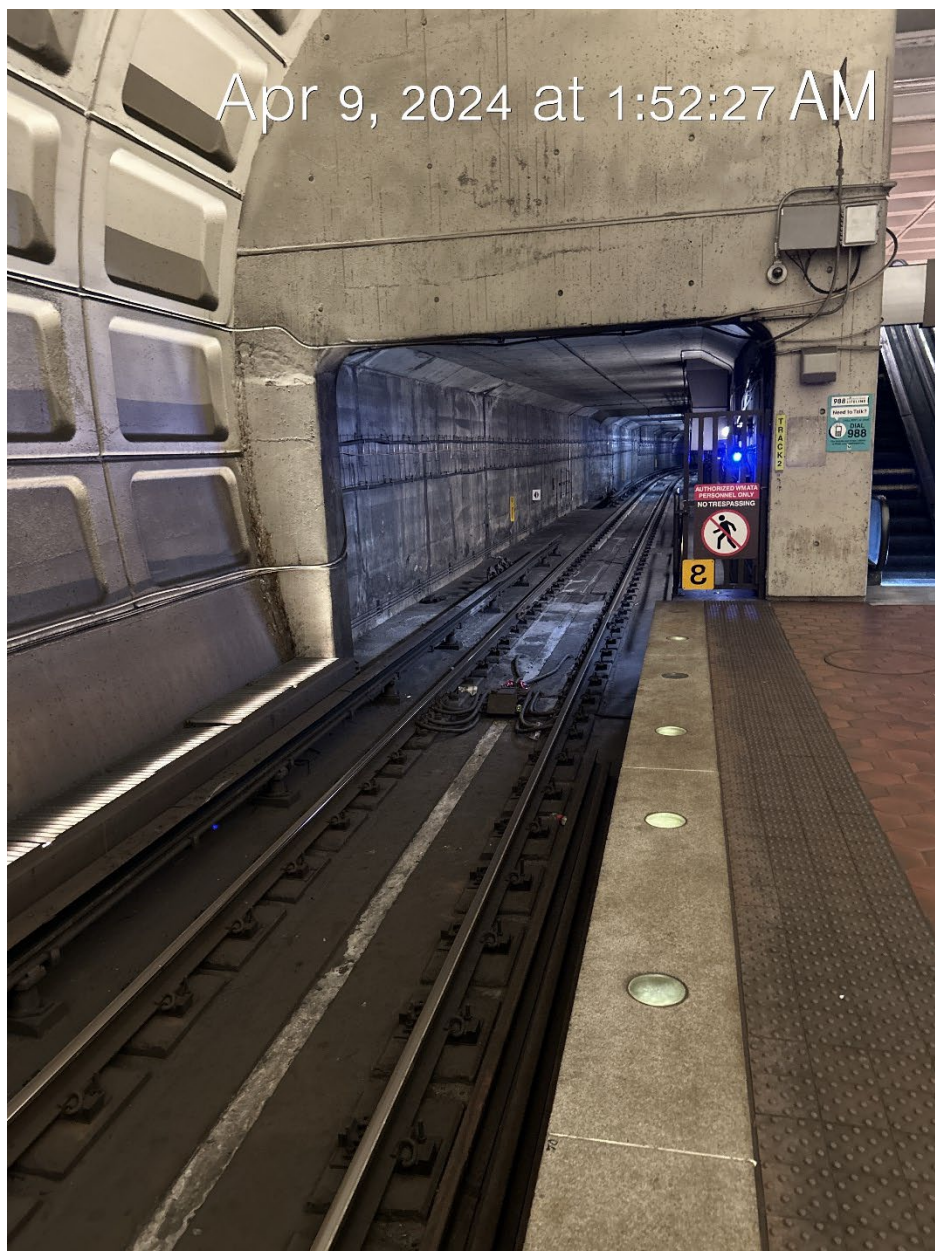
Figure 18 - track 2, Stadium-Armory Station, tunnel view in the direction of the D&G Junction

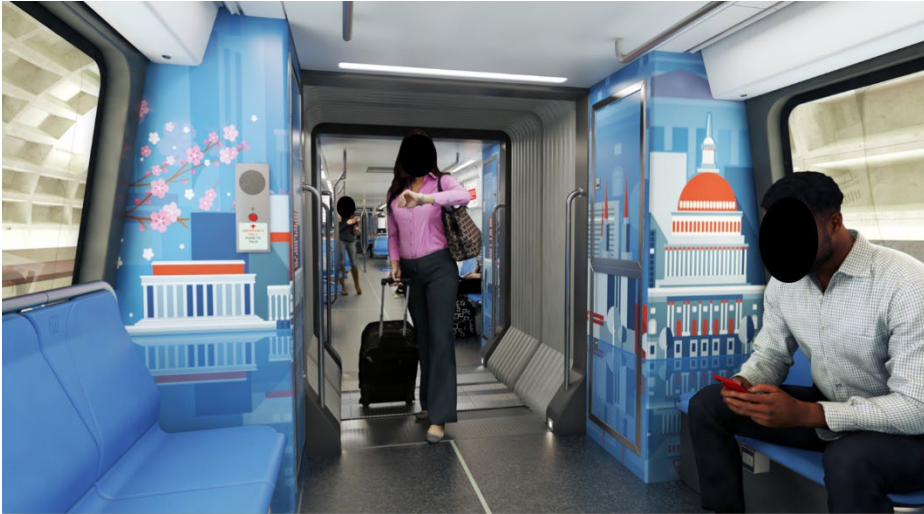
Figure 42 - Digital mockup of proposed 8000 series railcars with an enclosed open gangway design

- WMATA proposed that the 8000 series railcars will have an enclosed open gangway design to prevent any future unauthorized roof access. A pilot railcar projected to be in service in 2025. Please note that the date is subject to change as the production schedule is finalized.
