## **W-0450 – Collision at Fort Totten Station – July 31, 2024**

**FINAL REPORT OF INVESTIGATION A&I E24601**

## Fort Totten Station – Collision

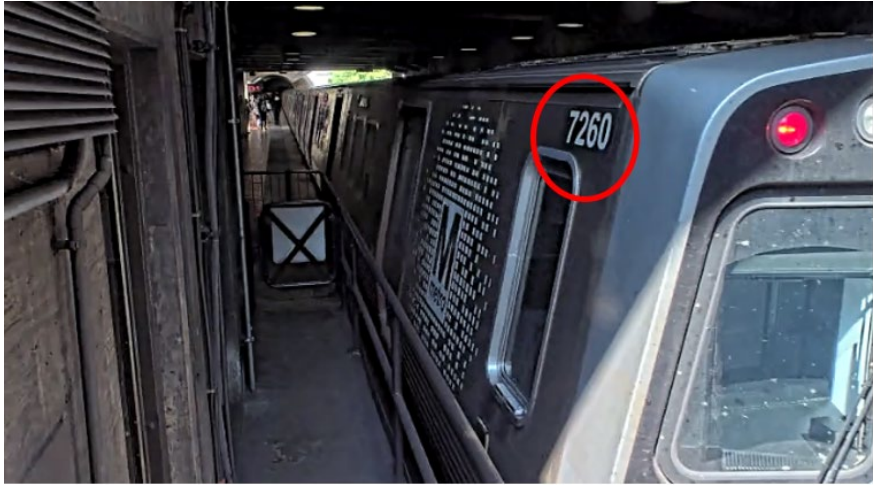
Image 1: 11:00 hours - Train ID 502 (7260T) entered Fort Totten Station.

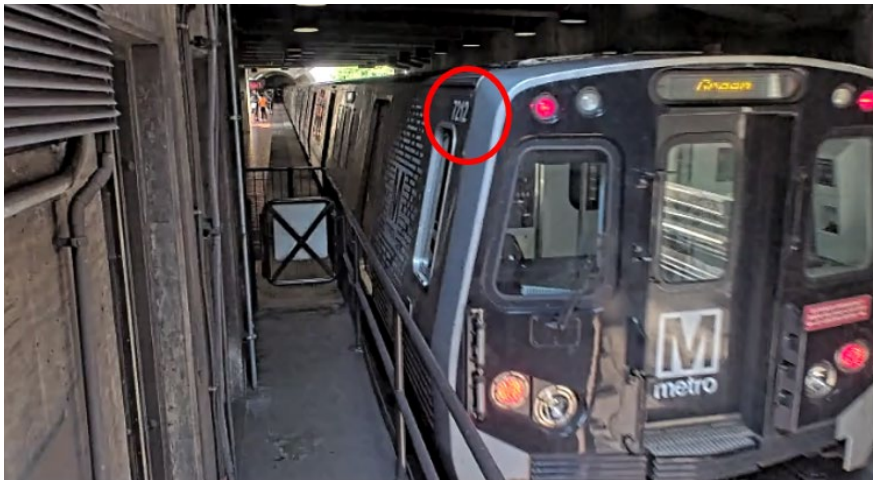
Image 2: 11:09 hours - Train ID 504 (7212T) entered Fort Totten Station.

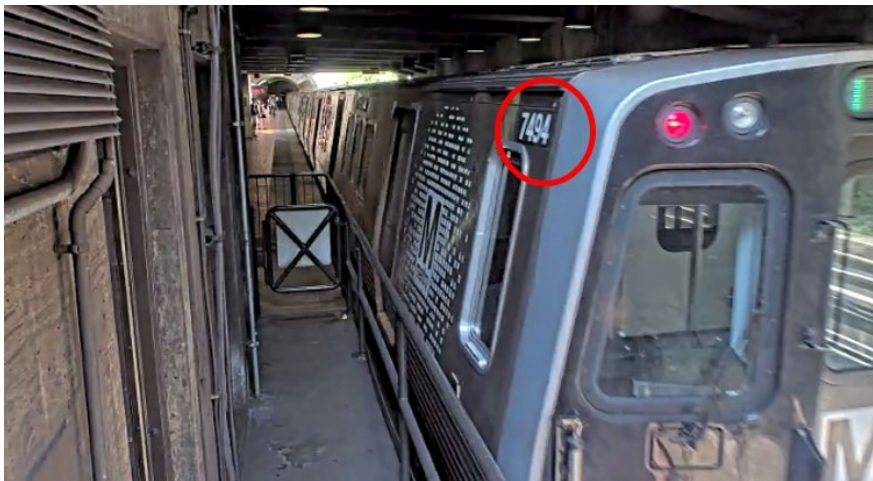
Image 3: 11:17 hours - Train ID 506 (7494T) entered Fort Totten Station.

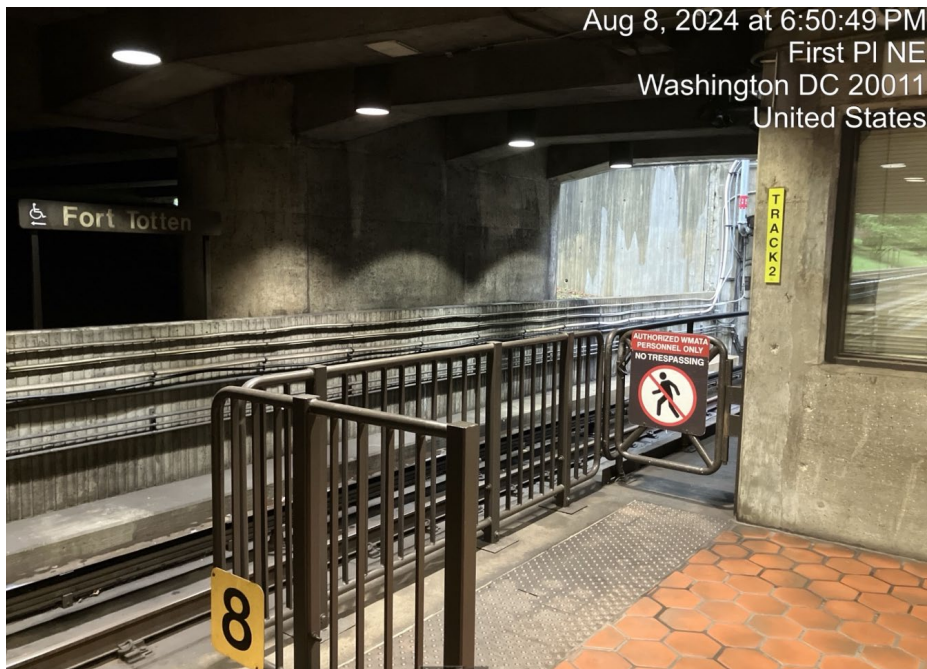
Image 4: End gate of the 8-car marker for track 2 at Fort Totten Station.

The end gate of the 8-car marker at Fort Totten displayed clear signage, communicating no trespassing for unauthorized personnel. The suicide and crisis 988 lifeline information was available near the end gate at Fort Totten Station.

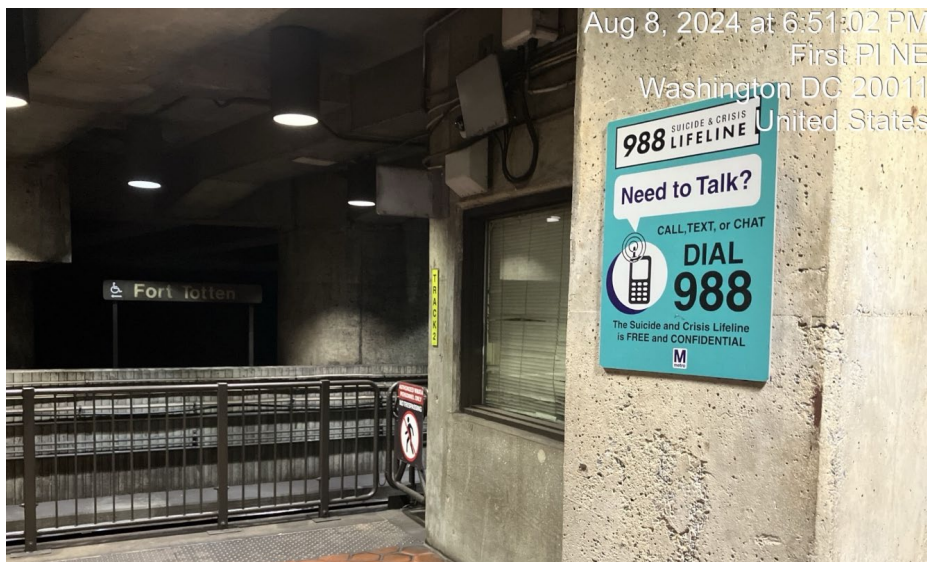
Image 5: Public information displaying the "988 Lifeline" near the end gate at Fort Totten Station.

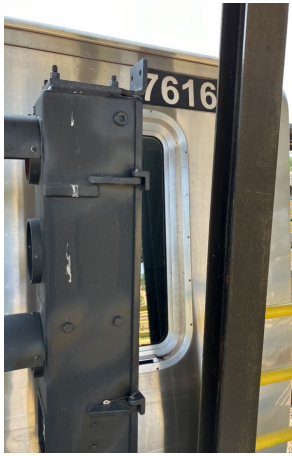
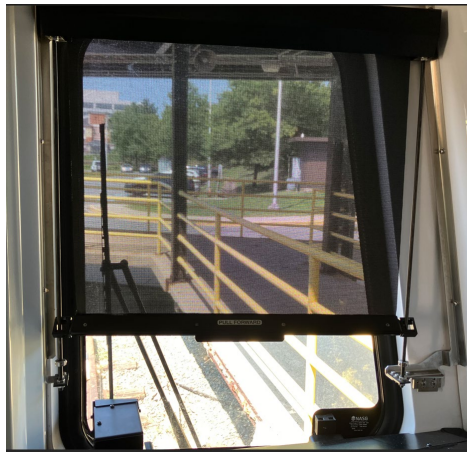
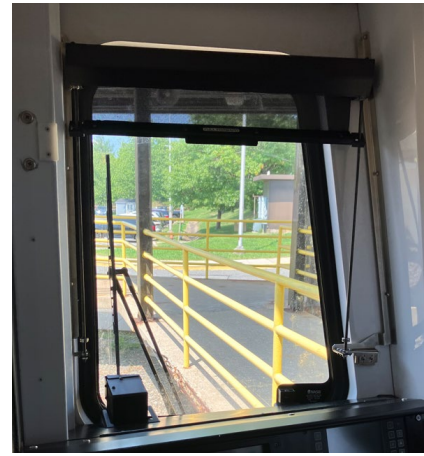
7000 Series Train Sunshade

*A sunshade of a randomly selected 7000 series train (L7616) was inspected for its functionality as designed. The train sunshade sporadically retracted by itself, not staying in place for appropriate use.*

The train operators of trains 502 and 504 described a sun glare on the windshield that could have prevented them from seeing the person on the roadway. The sun visor on the 7000-series railcars did not function as designed. They retracted sporadically, not staying in place for appropriate use. An inspection of a random sample of 7000-series railcar operating cab sun visors also showed similar malfunctions.

Investigation W-0450 led to specific recommended corrective actions (RCA), including Metrorail adding the 7000-series railcar sun visor to the Daily Inspection, which is an inspection performed by car maintenance before any train can be used in revenue service. The Daily Inspection is completed once a day and includes an interior and exterior inspection of each rail car along with inspections of other systems in the rail cars such as the Automatic Train Control System.

The RVOs of Train IDs 502 and 504 explained they were exposed to a sun glare when they came out of the tunnel entering Fort Totten Station on track 2. The RVO of Train ID 504 focused on the platform with the sun glare. Both RVOs stated that they did not attempt to use sun visors in the cab because they do not operate properly.
