## **W-0451 – Collision at Rockville Station – August 30, 2024**

Washington Metropolitan Area Transit Authority  
Department of Safety (SAFE)  
Office of Safety Investigations (OSI)  
**FINAL REPORT OF INVESTIGATION A&I E24685**

## Rockville Station, Track 2 – Collision

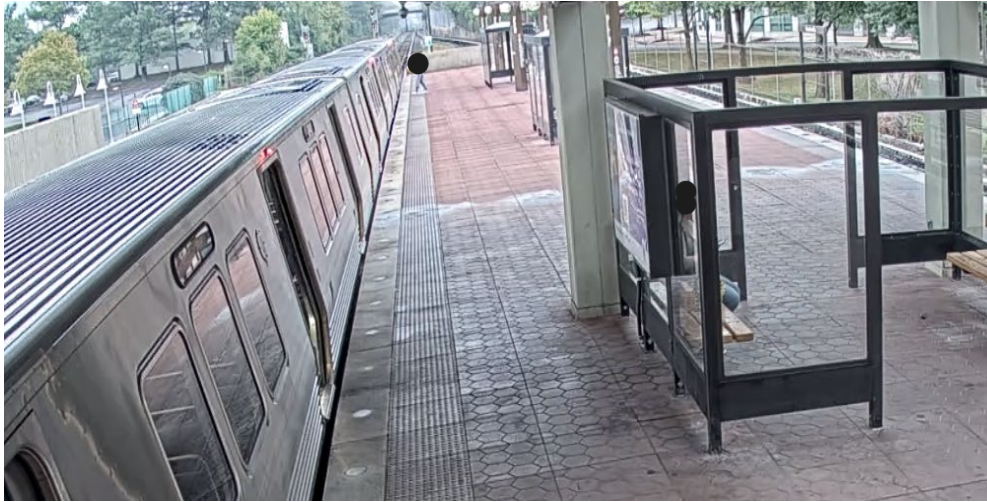
*Image 1 – Depicts the customer boarding Tran ID 110, car 7021 at Rockville track 2.*

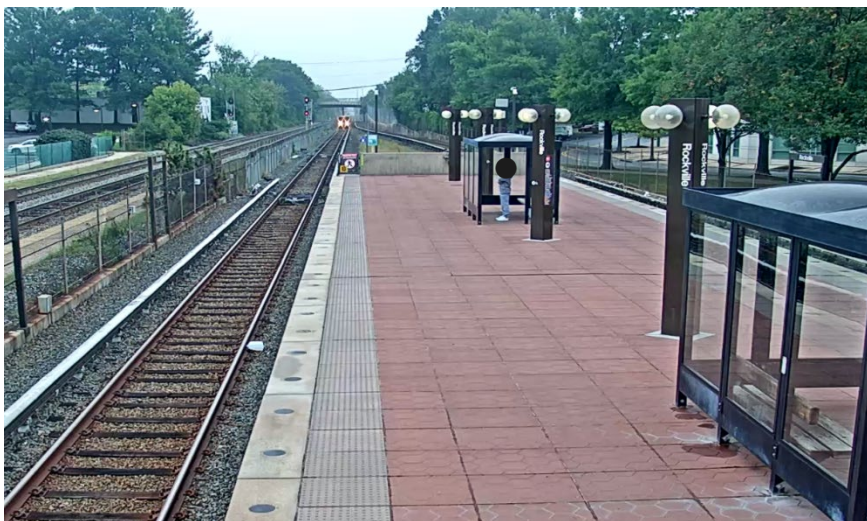
*Image 2 – Shows the customer standing at the Bus Shelter.*

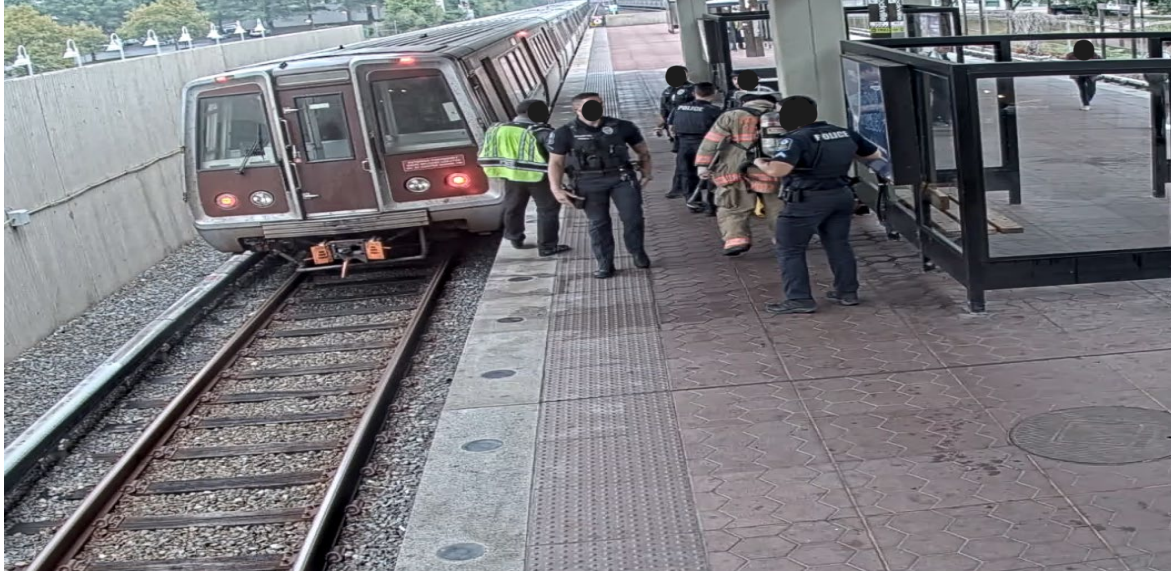
*Image 3 – Depicts MCFD and MTP Officers on the scene at 09:05 hours.*

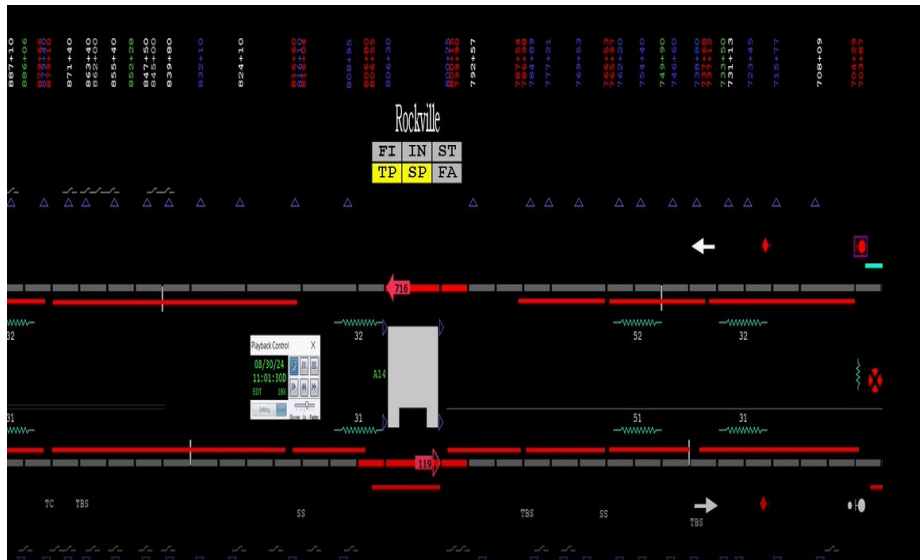
Figure 1 – Depicts third rail power re-energized at Rockville Station on track 2.

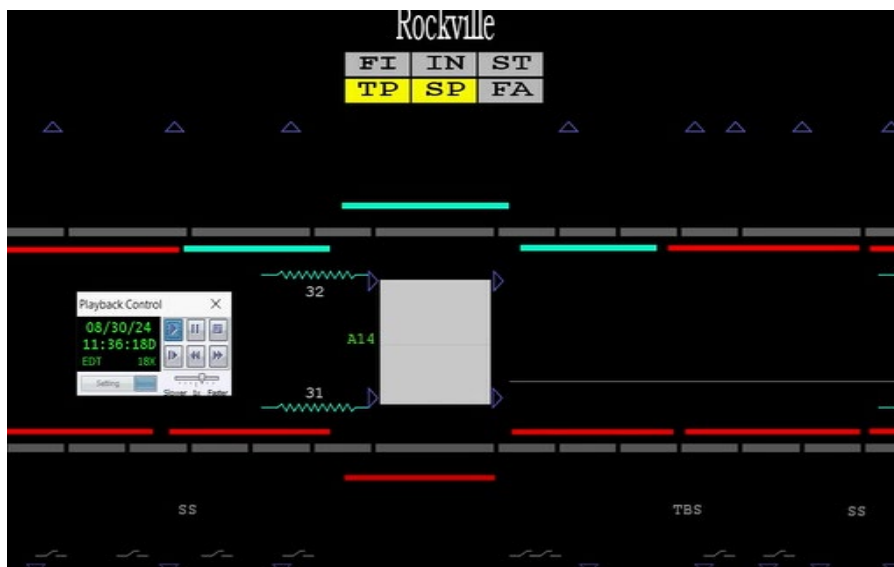
Image 5 – Third rail power de-energized at Rockville Station, track 2 to remove the customer from the roadway.

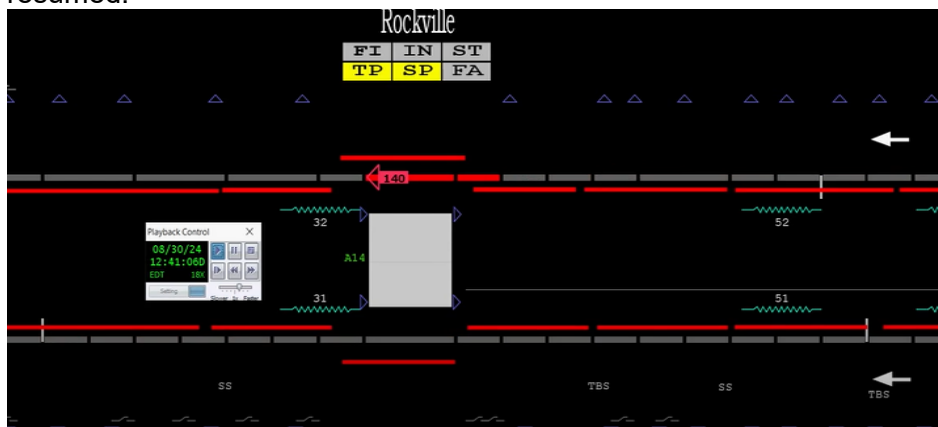
Image 7 – Power restored Rockville Station, track 2 normal operations resumed.

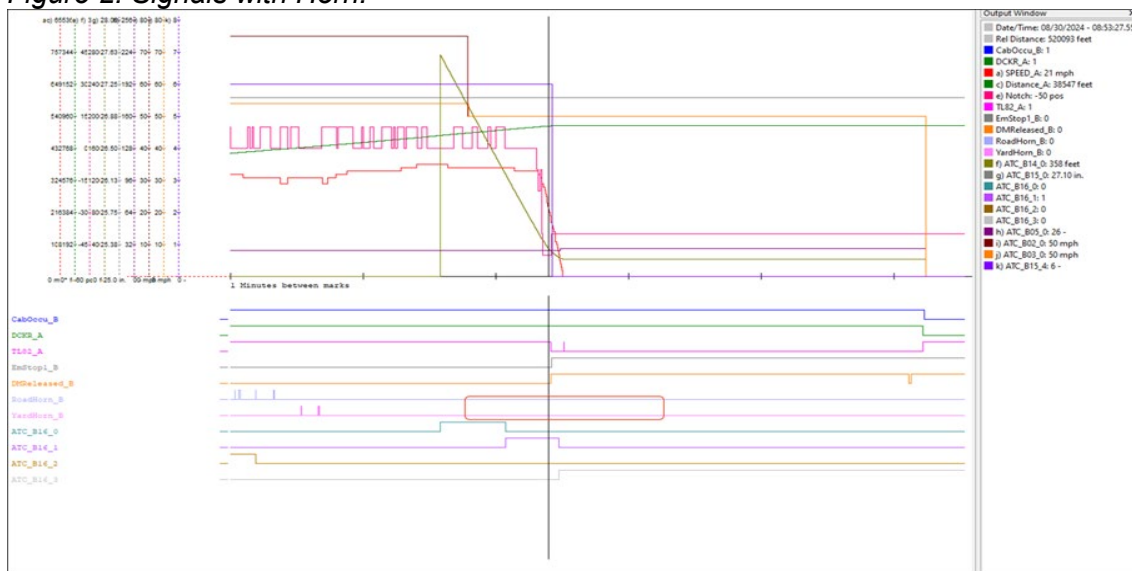
Figure 2. Signals with Horn.
