**W-0453 – Red Signal Overrun at Alexandria Rail Yard - October 3, 2025****Document Purpose**

**FINAL REPORT OF INVESTIGATION A&I E251750**

# Alexandria Yard – Red Signal Overrun

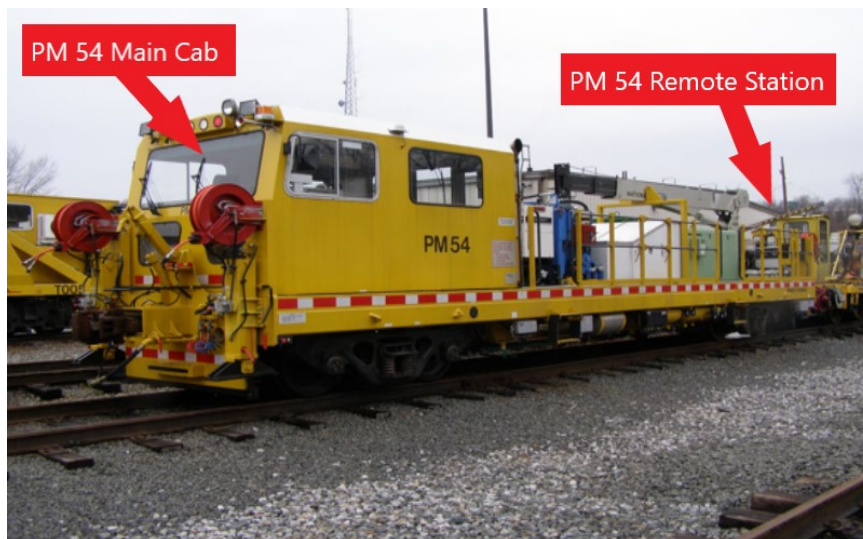
*Figure 1 – Depicts Prime Mover (PM) 54, a Plasser PMC-50 Rail Maintenance Machine.*

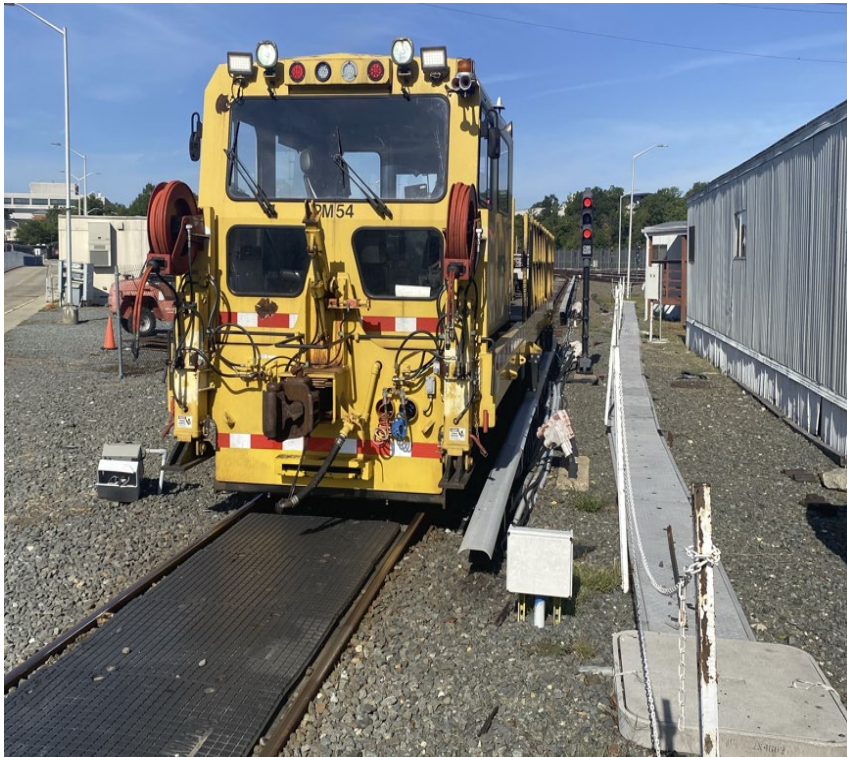
At 09:28 hours, the Button RTC informed the MICC Rail Section AOM of the incident. SAFE, ATCM, and TRST personnel were dispatched to the scene. After a comprehensive inspection of the RMM, track, signal C99-220, and interlocking switch 223, it was determined that there was no damage to any infrastructure or equipment. There were no injuries as a result of this incident.

*Figure 6 - Depicts PM 54 past signal C99-220 displaying a red aspect.*

- CTEM Mechanic #1 was removed from service.
- CTEM Mechanic #2 was removed from service.
- PM 54 was inspected, and no damages were found.
- Signal C99-220 was inspected, and no damages were found.
- Interlocking Switch 223 was inspected, and no damages were found.

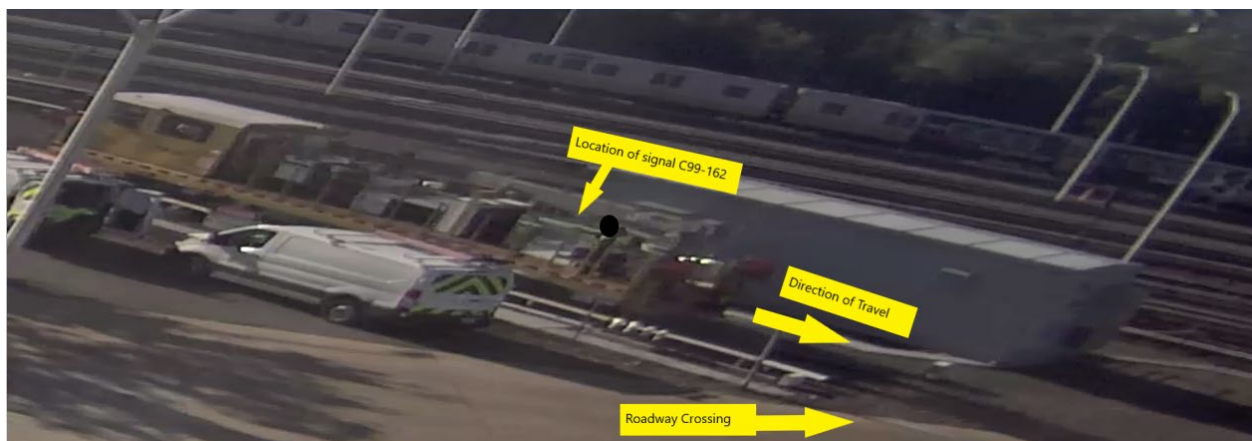
Figure 7 - Depicts PM 54 moving past signal C99-162 into their permitted block.

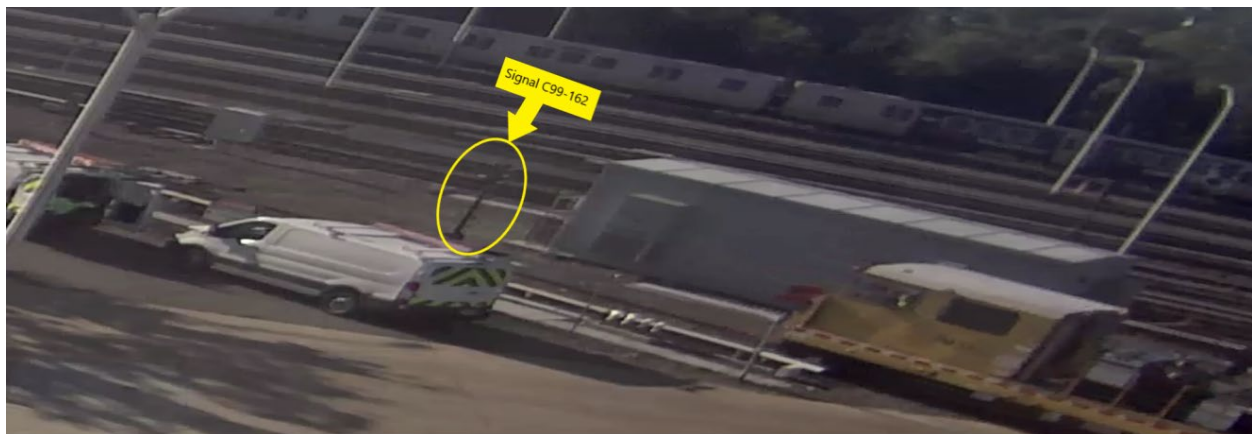
Figure 8 - Depicts PM 54 continuing to move past its permitted block.
