FINAL REPORT OF INVESTIGATION A&I E18368

August 25, 2018

Train Pull Apart

FINAL REPORT OF INVESTIGATION A&I E18368**SMS 20180825#73780MX**

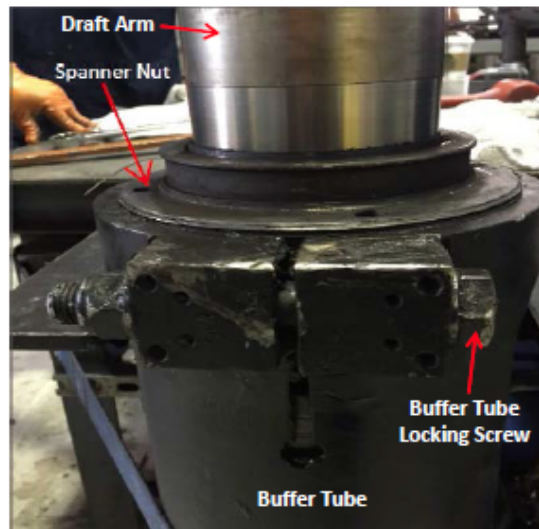
Figure 10 – Buffer Tube/Draft Arm Assy installed in MRO shop rebuild fixture

The semi-permanent coupler of 6038, the associated Buffer tube and the Drawbar/Draft bar assembly (from 6039) were removed and transported to the overhaul shop for further analysis and testing. The tube was placed in the MRO shop rebuild fixture, where the draft bar was inserted (into the Buffer tube) and the spanner nut screwed in, without loosening the Buffer Tube locking screw and nut, (Fig 10). During the next step of the testing, it was discovered that the lock screw and nut were moving freely. After removing the lock nut and screw, the screw threads were found with signs of galling which were consistent with that of a cross-threaded bolt, (Fig. 11). Although it was demonstrated that the torque of the locking screw exceeded the required 226 ft-lbs, the cross-threads provided a false reading. The false reading resulted in a torque value which was less than the required value and ultimately resulted in a reduced clamping force (of the buffer tube), which allowed the spanner nut to back out over time.

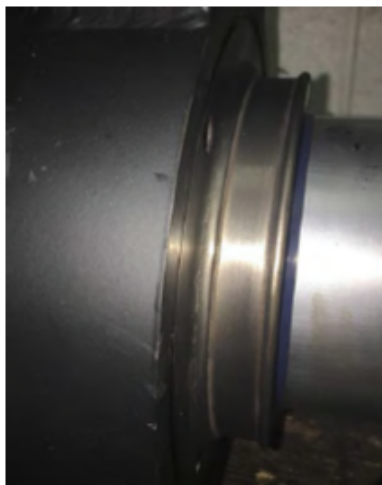
Figure 1.

1. Ensure (Gland) nut is properly mounted e.g., one thread maximum can be visible with the face of the coupler, as indicated in Figure 1 below.

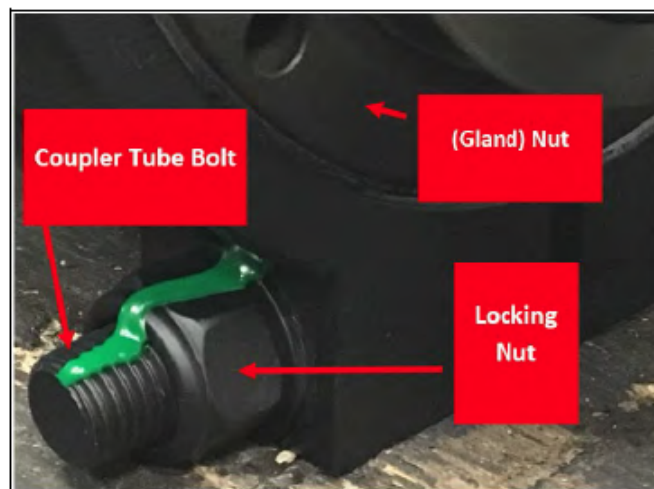
Figure 2.

2. Any (Gland) nut inspected and found to have more than one thread showing, the (Gland) nut shall be re-inspected by the on-duty Supervisor.
3. If the on-duty Supervisor determines the (Gland) nut to be more than one thread out, the rail vehicle shall be taken out-of-service.
4. A Maximo work order shall be opened to document any discrepancies found and all the repair work performed.
5. If the (Gland) nut is properly installed, ensure torque stripe is applied to the coupler tube bolt (C18-36-6091), lock nut (C18-36-6087) and washer (C18-36-6089) as shown in 2.

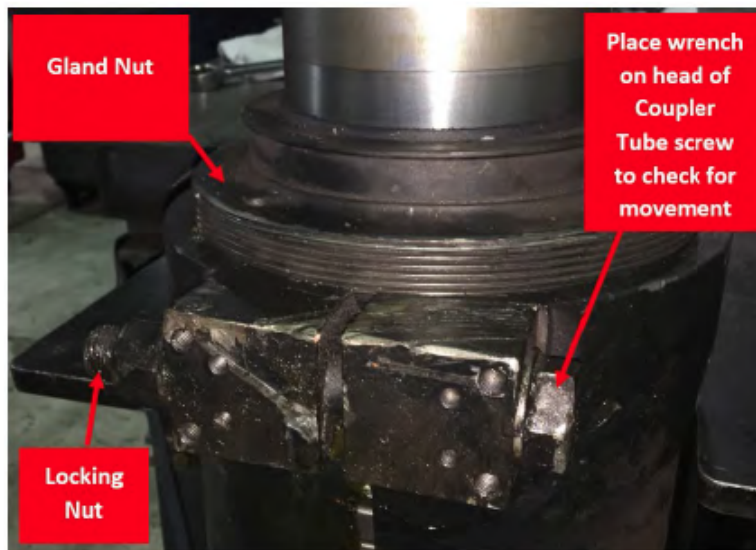
Figure 3.

6. If no torque stripe is visible and/or is broken, place a wrench on the bolt head to determine if the bolt assembly can rotate, figure 3.

7. If the bolt assembly can be rotated, the nut shall be re-torqued to 226 ft-lbs.
8. After the torque is applied, place a wrench on the bolt head to determine if the bolt assembly can rotate, figure 3.
9. If rotation of the bolt assembly is noticed after the torque is applied, all the hardware MUST be changed out and/or the vehicle shall remain OOS.
