**FINAL REPORT OF INVESTIGATION A&I E18479**

November 1, 2018

Employee Injury

**FINAL REPORT OF INVESTIGATION A&I E18479****SMS 20181101#75442**

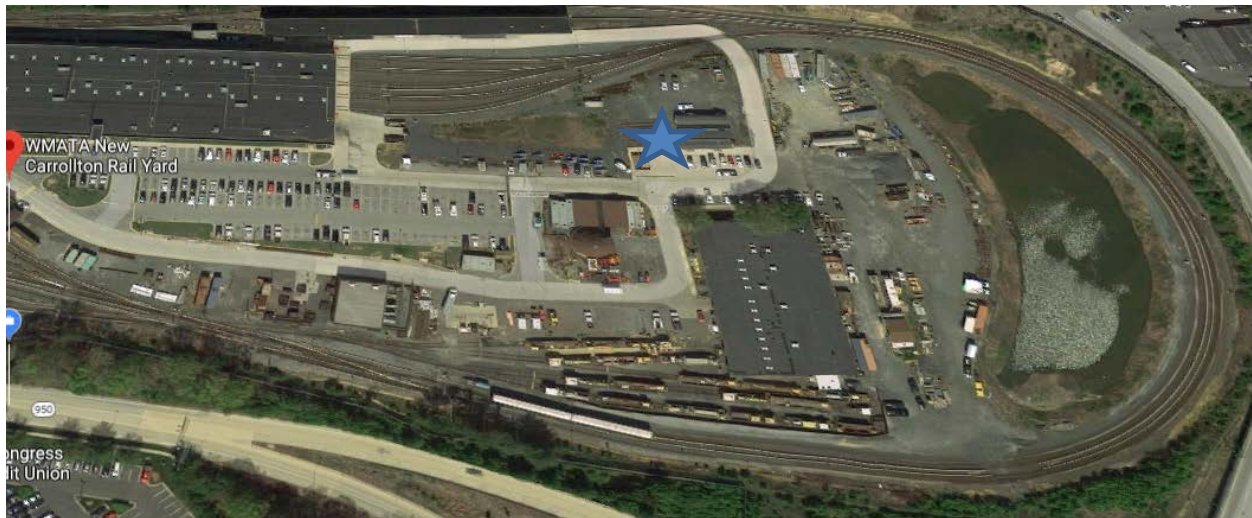
### **Field Sketch/Schematics**

On Thursday, November 1, 2018 at approximately 10:00 hrs., a Track and Structures (TRST) employee assigned to New Carrollton Yard was injured while dumping trash into a dumpster located at yard. The employee was removing trash from the flat of Prime Mover (PM)-39 with a Swingmaster with a fork attachment. The employee placed the trash container on top of the dumpster and climbed up to remove the contents by hand.

damaged prior to the incident. The damaged ladder rungs served for poor footing climbing on and off the dumpster. However, the dumpster's ladder is intended for inspection purposes only not to climb on the container notated on the fall hazard sign on the container.

Based on the salient facts, the employee climbed on top of the dumpster to remove contents from a container. As he descended from the dumpster, he lost his balance and fell to the ground fracturing his wrist. The step ladder rungs on the dumpster was damaged (See photo 5). The damaged ladder rungs served for poor footing climbing on and off the dumpster. However, the dumpster's ladder is intended for inspection purposes only not to climb on the container (See photo 6). The container was removed and replaced with an undamaged container. TRST created a "Memorandum" on this incident (see attachment 2), letting employees know the hazards of standing on top of the dumpster container. SAFE is also creating a JHA for TRST on the procedures of dumping trash and debris from the work flats into the dumpster (see attachment 2).

TRST created a "Memorandum" for this event, emphasizing to employees the hazards of standing on top of the dumpster container. SAFE is also creating a JHA for TRST on the procedures of dumping trash and debris from the work flats into the dumpster.

- The employee was transported for medical attention
- The dumpster was removed and replaced with a container in good condition.
