FINAL REPORT OF INVESTIGATION A&I E19252

Train Movement with Doors Open

Adopted by the Washington Metrorail Safety Commission at its meeting on October 8, 2019.

FINAL REPORT OF INVESTIGATION A&I E19252**SMS #20190521#80061**

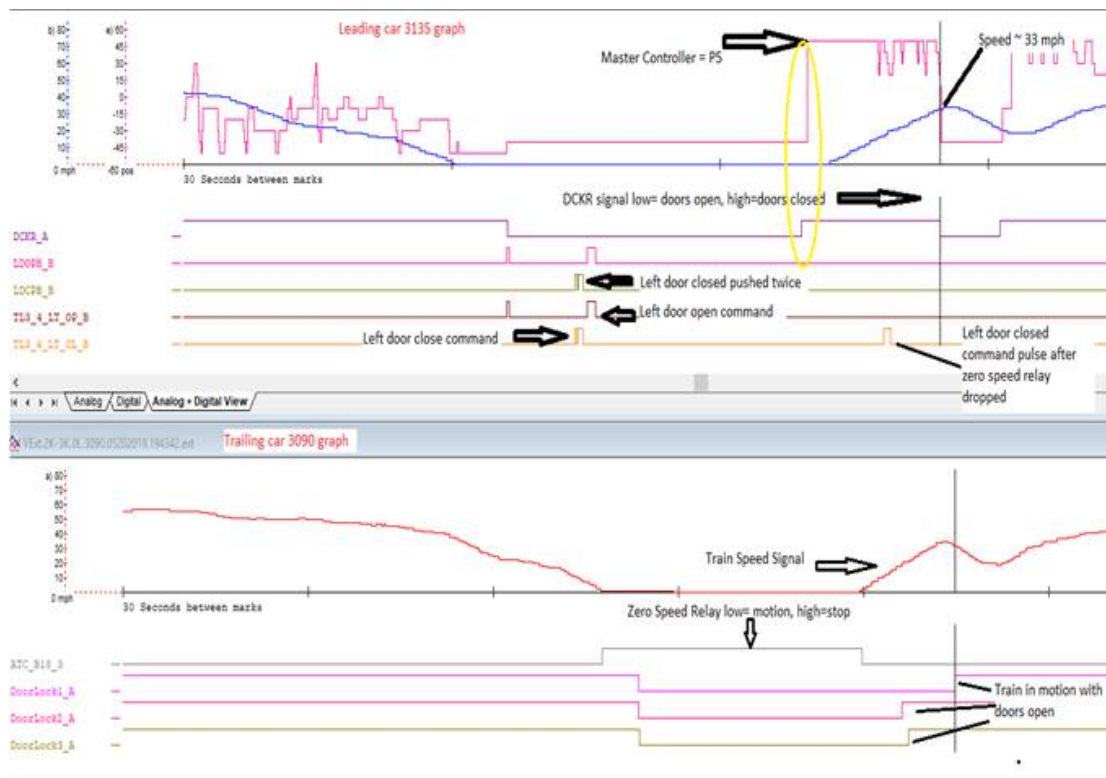
During the investigation, the incident event was duplicated when on leading car 3135 “All Doors Closed” condition was achieved with all doors open and MC commanded only to any power rate (P1 to P5 positions).

The fault was isolated to the MC of car 3135.

- Remove and replace the MC on the car 3135 and send the original MC to MRO shop for failure analysis.
- Perform a test on the new MC installed on the car 3135.
- Perform fleet-wide inspection of MC for 2-3K railcars before releasing cars to service. Emergency **Service Bulletins (SB) B-624** submitted to proceed with the MC safety inspections.
