FINAL REPORT OF INVESTIGATION A&I E19188

Undesired uncoupling

W-0021

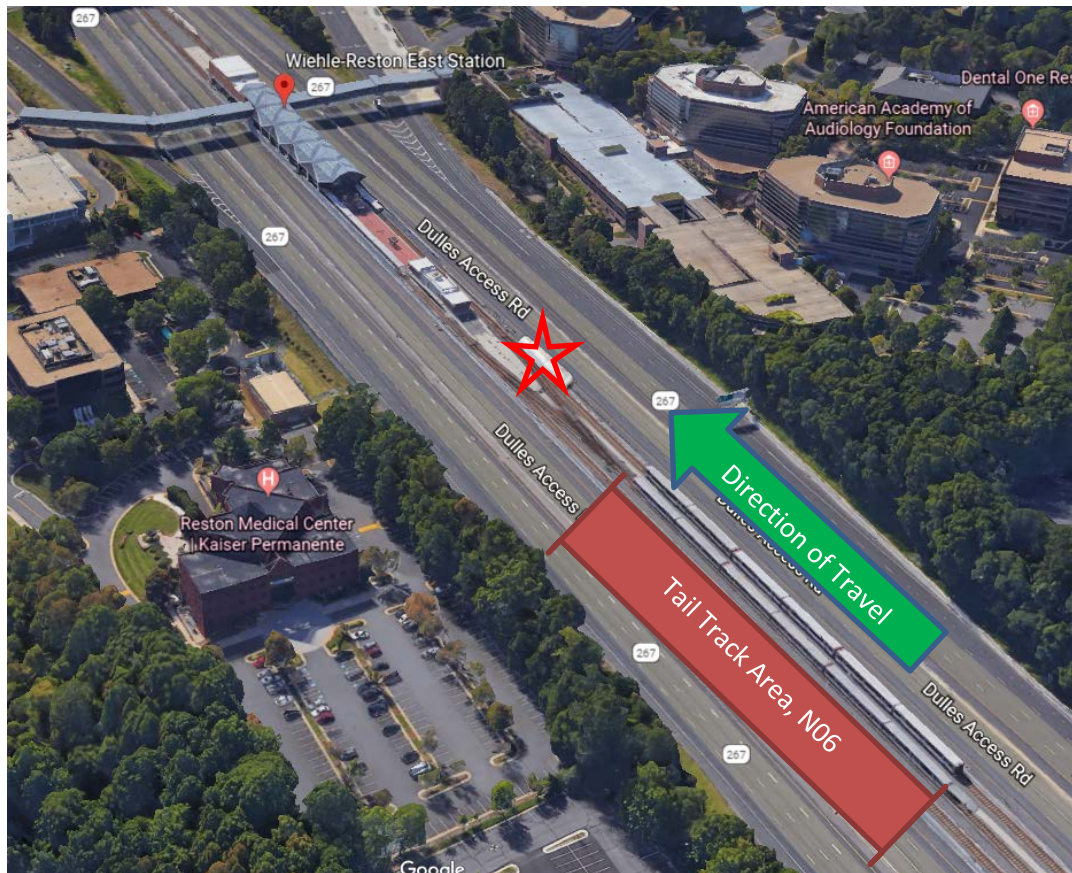
Field Sketch/Schematics

- Ballasted Track
- Approximately 634 feet inbound of N06 platform limits
- Blind Spot as defined in Roadway Access Guide
