FINAL REPORT OF INVESTIGATION A&I E19151, E19152, and E19159
March 25 and 28, 2019
Incorrect Route

W-0026

FINAL REPORT OF INVESTIGATION A&I**E19151, E19152, and E19159****SMS 20190326#78749****20190326#78750****20190328#78807**

D&G Junction (D98), Track 1, D98-36 Signal

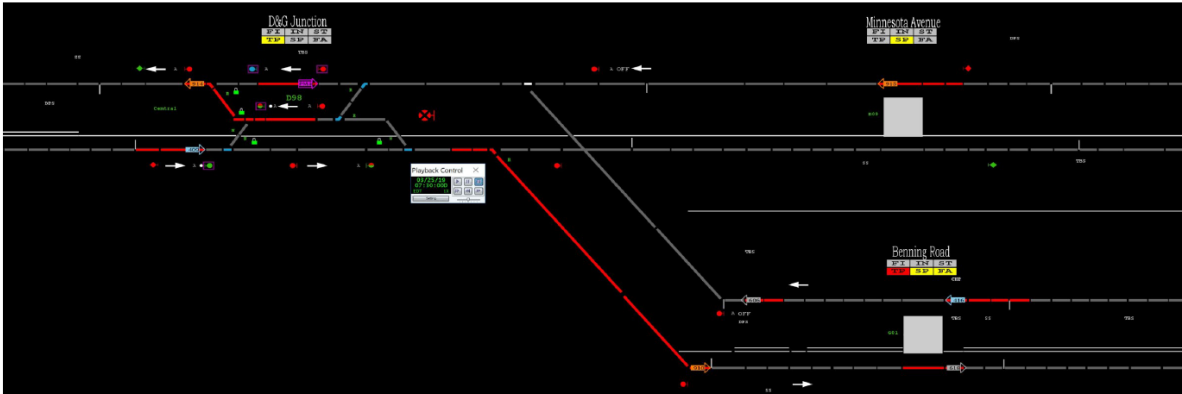
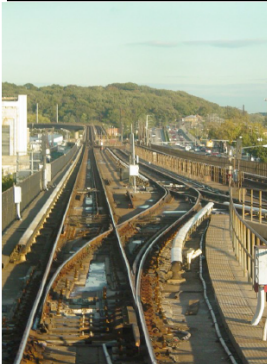
Incorrect Leads

On Monday, March 25, 2019 at 07:30, D98-36 signal was fleeted to allow a blue and silver line train to be routed to the G line. The Ops #2 Train Controller failed to remove the fleet at D98-36 signal and Train #910 accepted the incorrect lead to the G Line; in the direction of Largo.

While there was not any damage to equipment or injury to personnel, setting incorrect routes is a concern to the ROCC Management team. Setting incorrect leads causes major delays and an inconvenience to our customers.
