WMSC Commissioner Brief: W-0043 – Serious Injury (Employee) on Red Line on October 19, 2019

Prepared for Washington Metrorail Safety Commission meeting on August 4, 2020

FINAL REPORT OF INVESTIGATION A&I E19557

SMS 20191019#83739

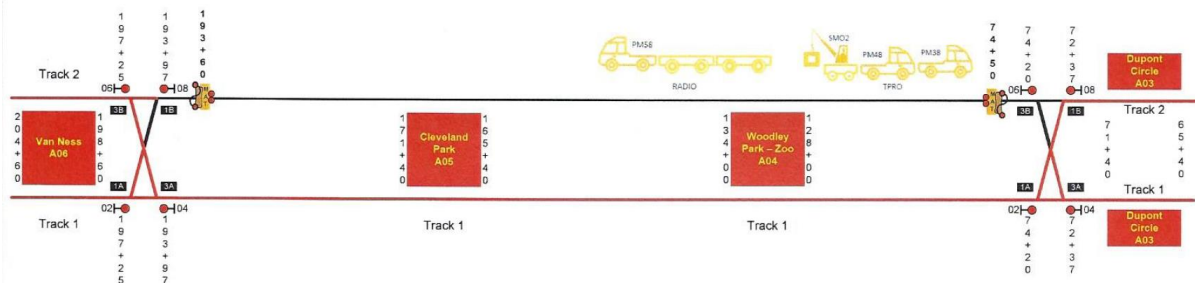
Department	Location of Work	Description of Work
RADIO	A2 (74+50 to 193+60)	Installing struts, standoffs, and radiating cable
TPRO	A2 (74+50 to 92+70)	Replacing 6 stringers (both rails)

Department	Units	Location of Units
RADIO	PM58 + 2 flats (out of A99)	A2 131+00 (facing A99)
TPRO	PM49+PM39+SMD2	A2 76+00
