WMSC Commissioner Brief: W-0053 – Improper Door Operation at Largo Town Center – August 25, 2020

FINAL REPORT OF INVESTIGATION A&I E20313

**Largo Town Center Station, Track 1
Improper Door Operation
August 25, 2020**

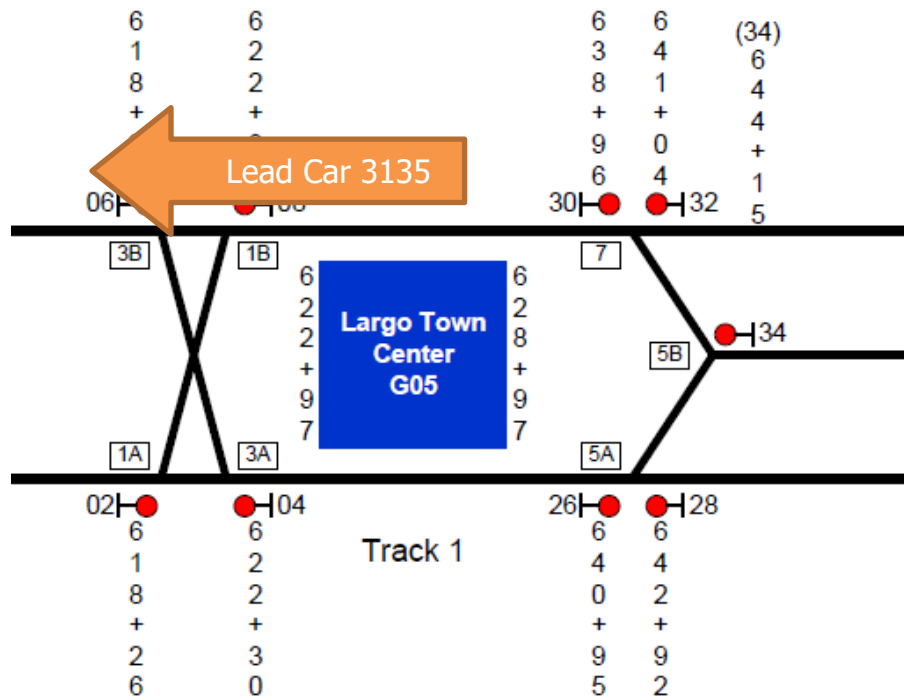
Figure 1: Largo Town Center Station, Track 1 Chain Marker G1-629+00

Largo Town Center Station, Track 1 Chain Marker G1-629+00
