WMSC Commissioner Brief: W-0060 – Fire/Smoke at Capitol Heights Station – June 6, 2020

FINAL REPORT OF INVESTIGATION A&I E20214

Date of Event:	6/6/2020
Type of Event:	Fire/Smoke
Incident Time:	18:07 hrs.
Location:	Capitol Heights Station, Track 2
Time and How received by SAFE:	18:26 hrs. - Phone Call
WMSC Notification Time:	19:31 hrs.
Rail Vehicle:	N/A
Injuries:	No
Damage:	Damaged Insulators

Capitol Heights Station – Fire and Smoke Arcing Insulator

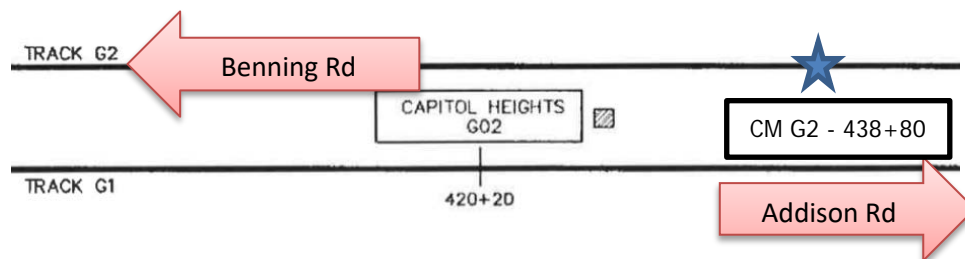
Field Sketch/Schematics

SAFE determined the probable cause of the incident was as an arcing insulator in the vicinity of Capitol Heights Station [approximately 1260 feet from platform limits], CM G2-438+80 and G2-438+70 [approximately 10 feet from each other], which created a smoke condition on the roadway in the tunnel, which subsequently reached the station limits. It is most probable; the insulator was oxidized from environmental tunnel deposits and moisture/water intrusion from a previous rainstorm, which resulted in an arcing event igniting the insulator as the train traversed the area.
