WMSC Commissioner Brief: W-0066 – Fatality – Gallery Place-Chinatown Station – September 14, 2020

FINAL REPORT OF INVESTIGATION A&I E20346

Gallery Place Station – Person Struck by Train

September 14, 2020

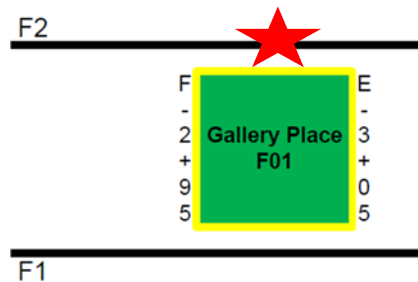
Field Sketch/Schematics

SAFE conducted a site assessment and determined no slip or trip hazard present would have contributed to this event. All platform emergency notification equipment was working as designed. Based on further investigation, SAFE determined the point of train and customer contact; please refer to the description below:
