## **WMSC Commissioner Brief: W-0075 – Improper RWP – Takoma Station Interlocking – October 20, 2020**

**FINAL REPORT OF INVESTIGATION A&I E20406**

Takoma Station – Improper Roadway Worker Protection

October 20, 2020

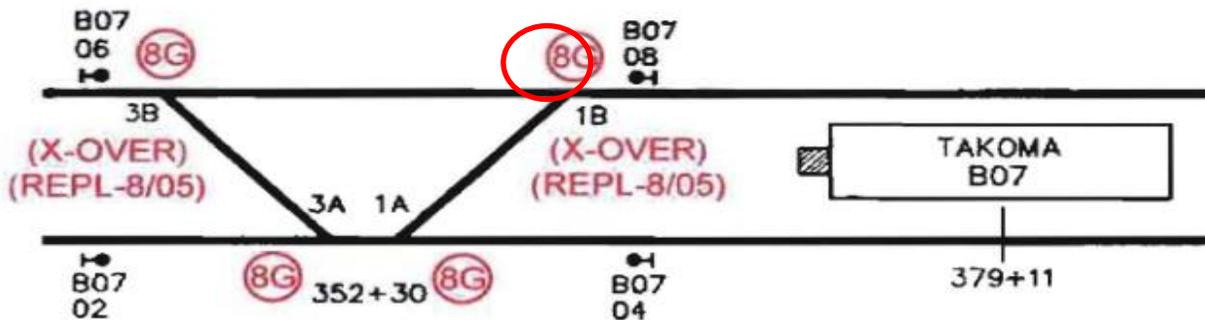
### Field Sketch/Schematics

On Tuesday, October 20, 2020, ATCM personnel were dispatched to Takoma Station due to a bobbing track circuit located at CM B1 349+00 and B1 350+00 that caused a red aspect at B07-02 signal with an extended lockout for trains holding outside the associated signal. At approximately 11:03 hrs., the Radio RTC granted permission to the RWIC at Takoma Station to perform a TCW utilizing ETO, LSC protection and notify ROCC when personnel and equipment are clear from the roadway. At approximately 11:56 hrs., the LCP Operator contacted the Radio
