WMSC Commissioner Brief: W-0079 – Pull-Apart – outside Union Station – October 9, 2020

Prepared for Washington Metrorail Safety Commission meeting on May 18, 2021

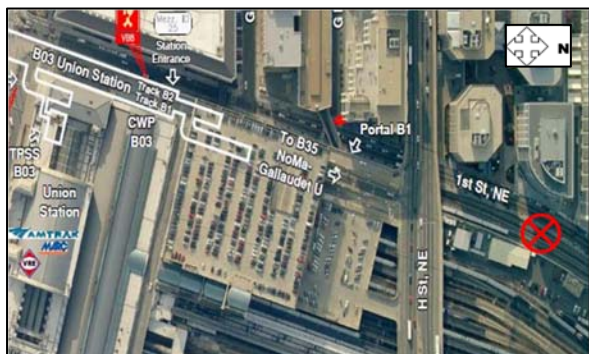
Figure 1: Top-down view of incident area.

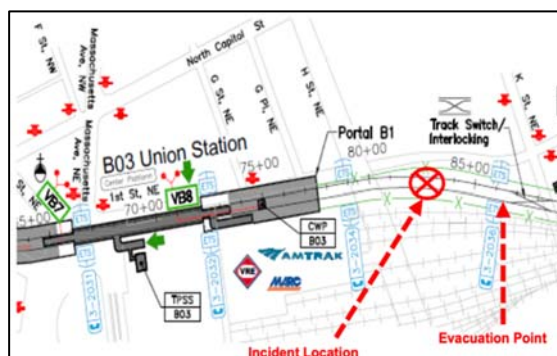
Figure 2: Track diagram of incident area.

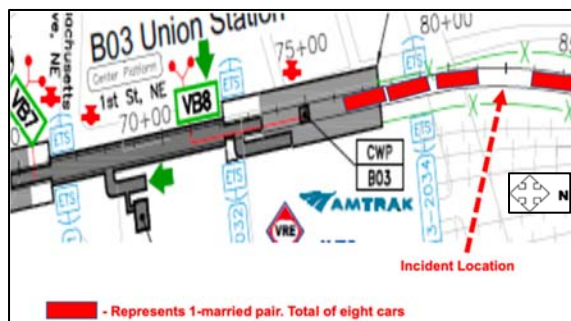
Figure 1: Close up of incident area, focus on consist locations.

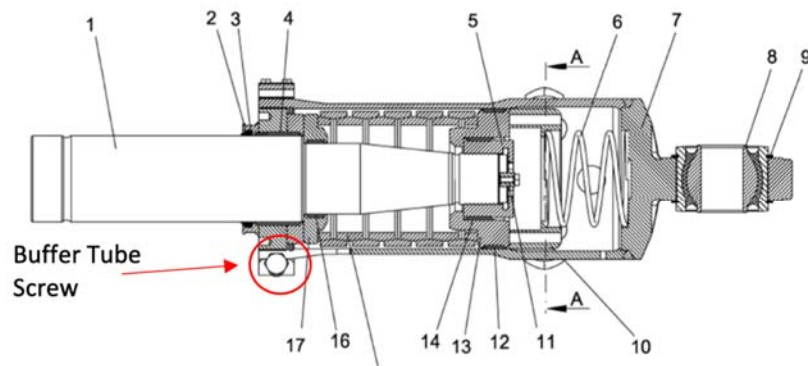
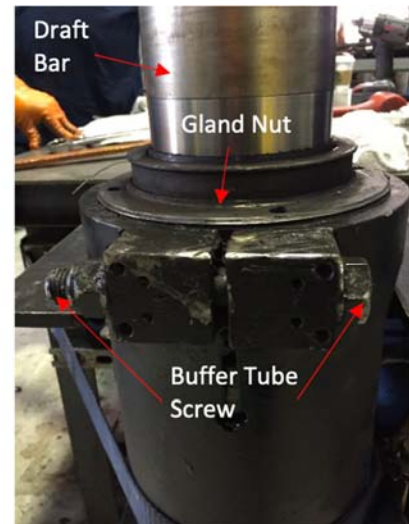
As seen below, the draft gear consists of the drawbar (1), buffer tube (7), gland nut (2), buffer tube screw, various bearings, guide rings, and a spring pack which utilizes horizontal and vertical articulation as well as resilience for buff (push) and draft (pull) forces. The gland nut holds the drawbar in place and encloses the spring pack within the buffer tube. In turn, the buffer tube screw provides the clamping force required to secure the gland nut.

Figure 17a: Left – Exploded view of Front-End Draft Gear.

Figure 17b: Right – Photo of Draft Gear

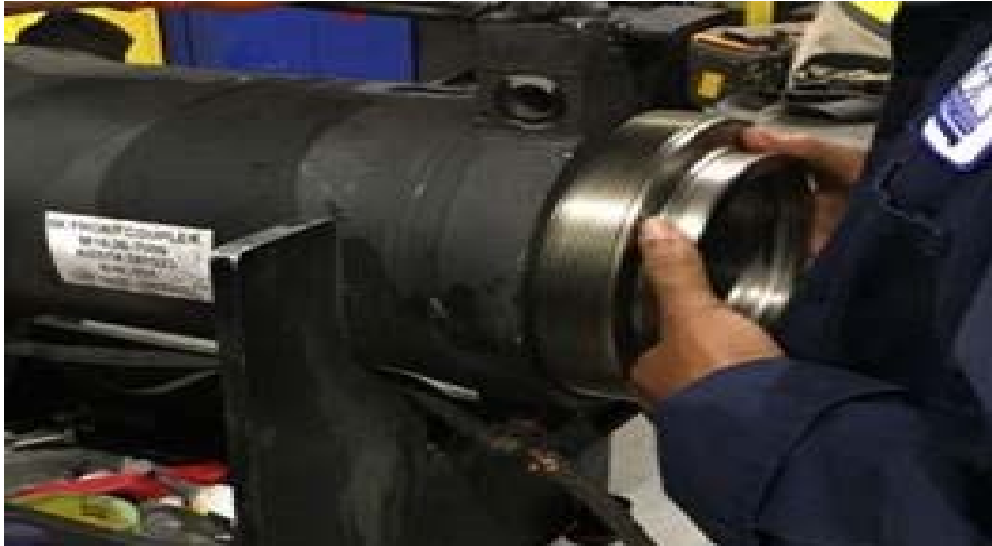
Next, the state of the buffer tube and draft gear gland nut threads were inspected. The locking bolt and nut were removed to release the clamp, and the buffer tube threads were cleaned. A new gland nut was installed into the buffer tube. No anomalies were noted.

Figure 23: Gland nut application

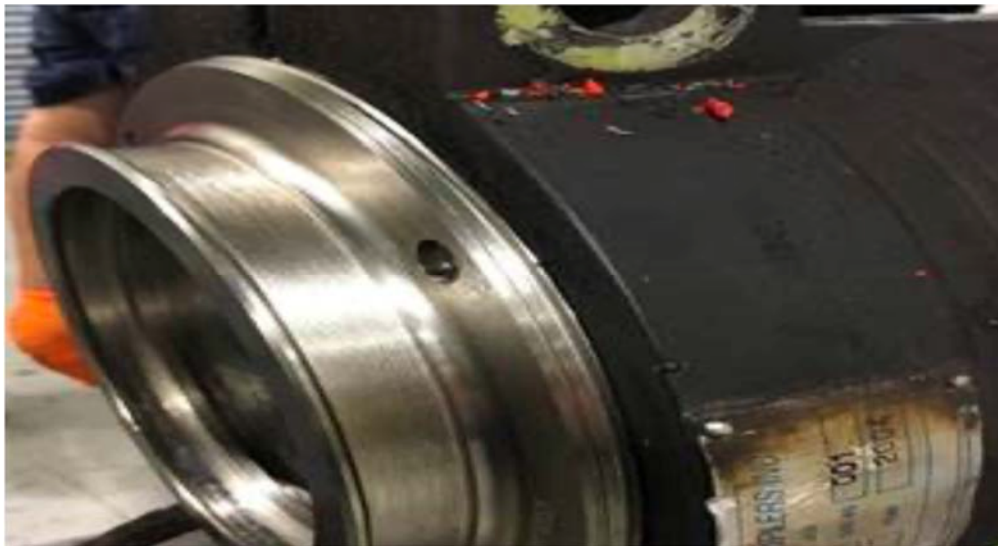
Figure 24: Locking bolt and nut installed

A new A4-80 buffer tube screw was installed and torqued to 226 ft-lbs. to ensure the gland nut was not able to move (see below).
