## **WMSC Commissioner Brief: W-0080 – Pull-Apart – outside Glenmont Station – November 24, 2020**

*Prepared for Washington Metrorail Safety Commission meeting on May 18, 2021*

**FINAL REPORT OF INVESTIGATION A&I E20464**

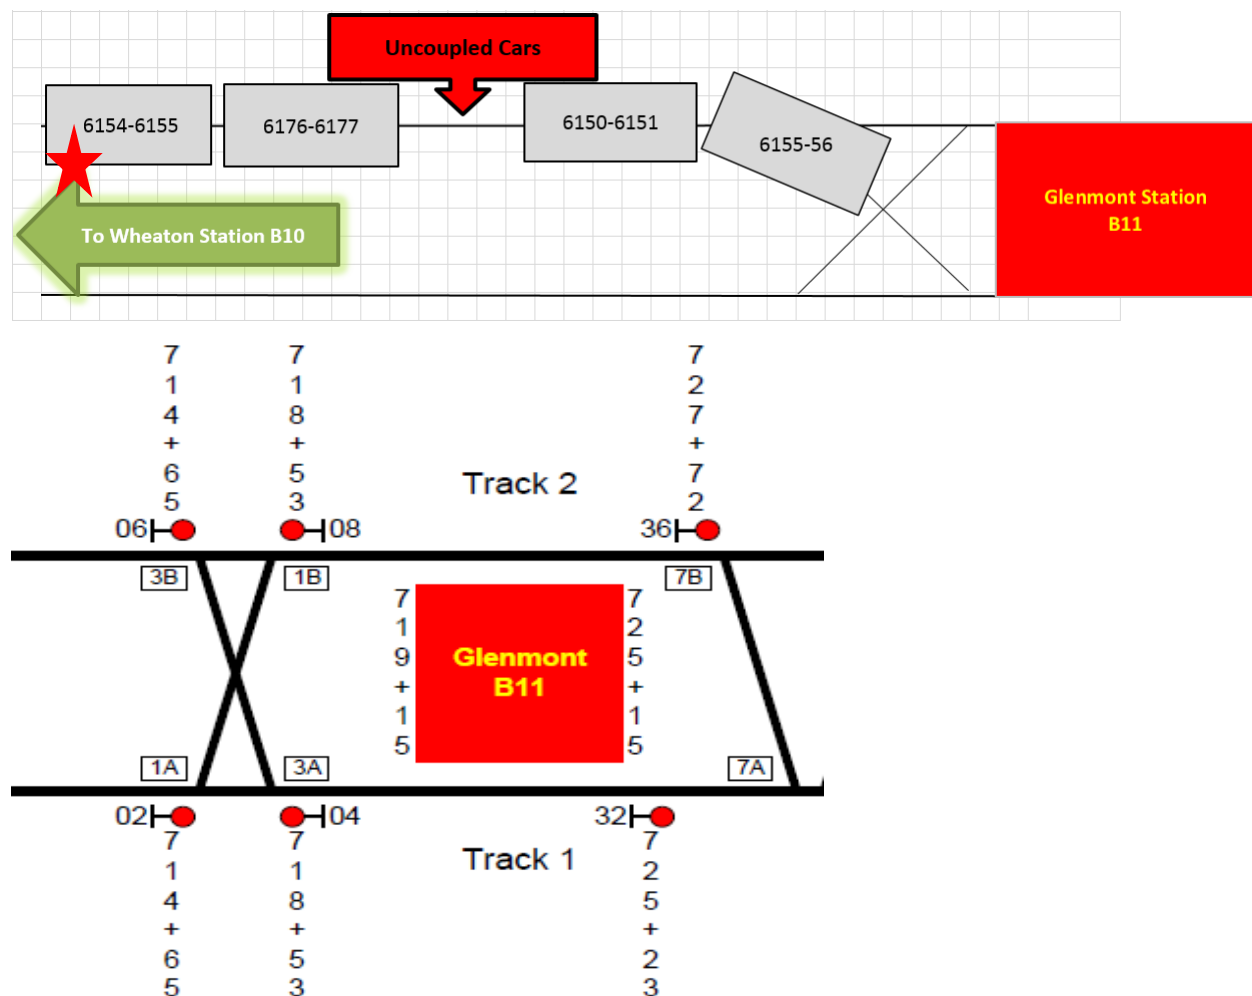
## FIELD SKETCH/SCHEMATICS

Outside Glenmont Station, Track 2

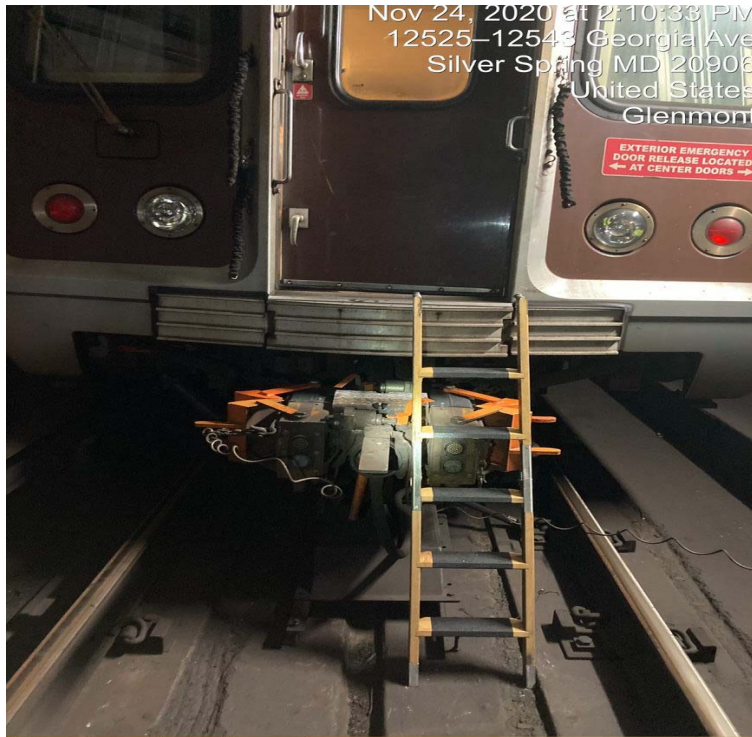
Figure 4 – The train emergency ladder stored on the car was positioned between the end door of the cars' anti-climber and the concrete roadbed.
