**WMSC Commissioner Brief: W-0081 – Derailment – Outside Silver Spring Station – July 7, 2020**

FINAL REPORT OF INVESTIGATION A&I E20244

Date of Event:	7/7/2020
Type of Event:	Derailment
Incident Time:	11:20 hrs.
Location:	Silver Spring Station, Track 1
Time and How received by SAFE:	11:26 hrs. - SAFE Email Notification
WMSC Notification Time:	7/7/2020 at 12:49 hours – Email
Rail Vehicle:	Train ID 108, L7502-03x7561-60x7592-93x7567-66T
Injuries:	None
Damage:	\$413,981.12

Silver Spring - Derailment

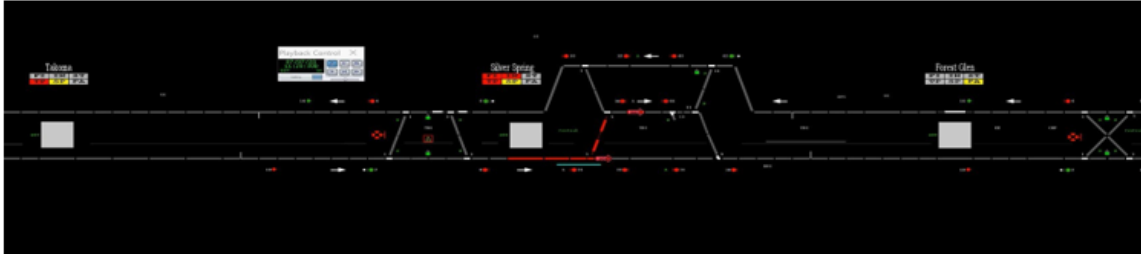
Train Derailment

On Tuesday, July 7, 2020, ROCC removed the automatic from B08-26 signal and canceled the lunar signal to establish routing for non-revenue Train 880 to enter the pocket track. After Train 880 entered the pocket track, routing from B08-26 to B08-28 was never established and switch 5 was still in the reverse position. Train 108 operator continued on from Silver Spring track one; passing B08-26 signal red, with switch 5A was in the reverse position. This caused the second car in the consist (7053) to derail. At 11:24 Train 108 derailed.
