## **WMSC Commissioner Brief: W-0086 – Improper Vehicle Movement – Red Line – December 30, 2020**

**FINAL REPORT OF INVESTIGATION A&I E20513**

Union Station – Improper Movement of any Rail Vehicle  
on the Mainline or in a Yard, including Over Improperly Aligned Switch(es)

December 30, 2020

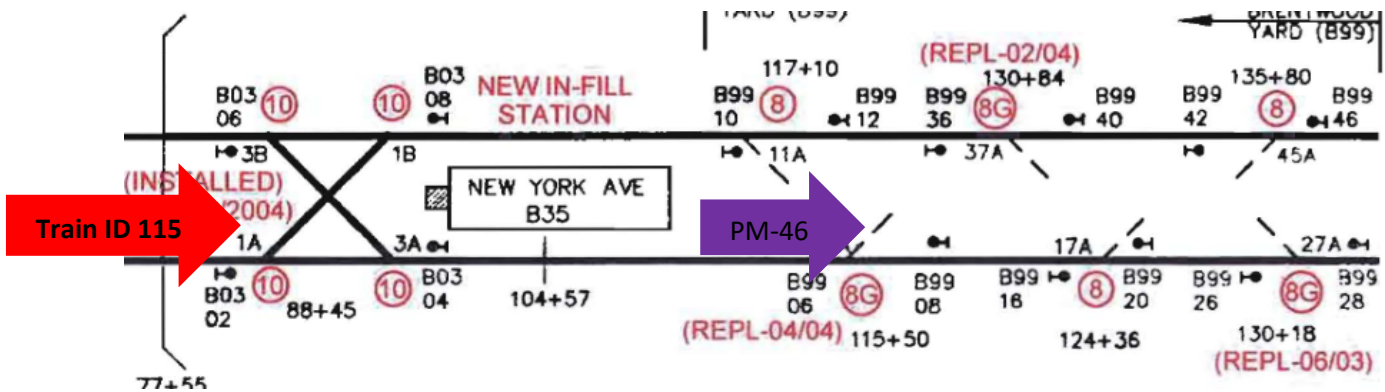
## Field Sketch/Schematics

At approximately 05:25 hrs., Non-revenue Train ID 115 destined for Glenmont was approaching NoMa-Gallaudet U Station while PM-46 continued to stand by B99-06 signal awaiting entrance into the Brentwood Yard. The Button RTC removed the prohibited exit from the B03-04 signal and set a lunar at B03-02 signal to allow Train ID 115 access to NoMa-Gallaudet U Station. The Rail Operations Control Center (ROCC) Superintendent was notified of the incident by another RTC who observed the incident from another console. Upon investigation utilizing the Advanced Information Management System (AIMS), the ROCC Superintendent confirmed the rail vehicle's improper movement.
