WMSC Commissioner Brief: W-0087 – Improper Door Operation – Capitol Heights Station – December 29, 2020

FINAL REPORT OF INVESTIGATION A&I E20511

Capitol Heights Station
Improper Door Operation

December 29, 2020

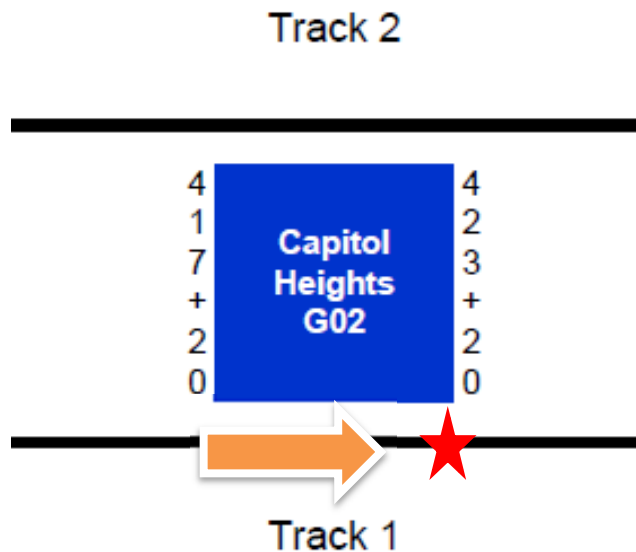
Field Sketch/Diagram

Capitol Heights Station, Track 1

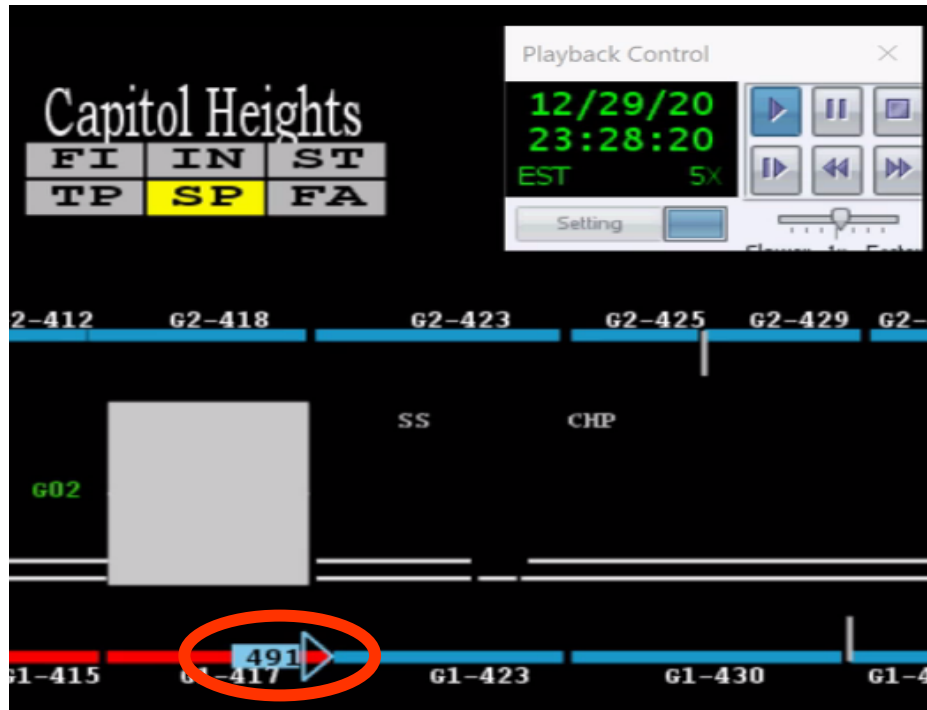
Diagram 1 - Based on the AIMS, at 23:28:20 hours, shows revenue Train ID 491 berthed at Capitol Heights Station, Track 1.

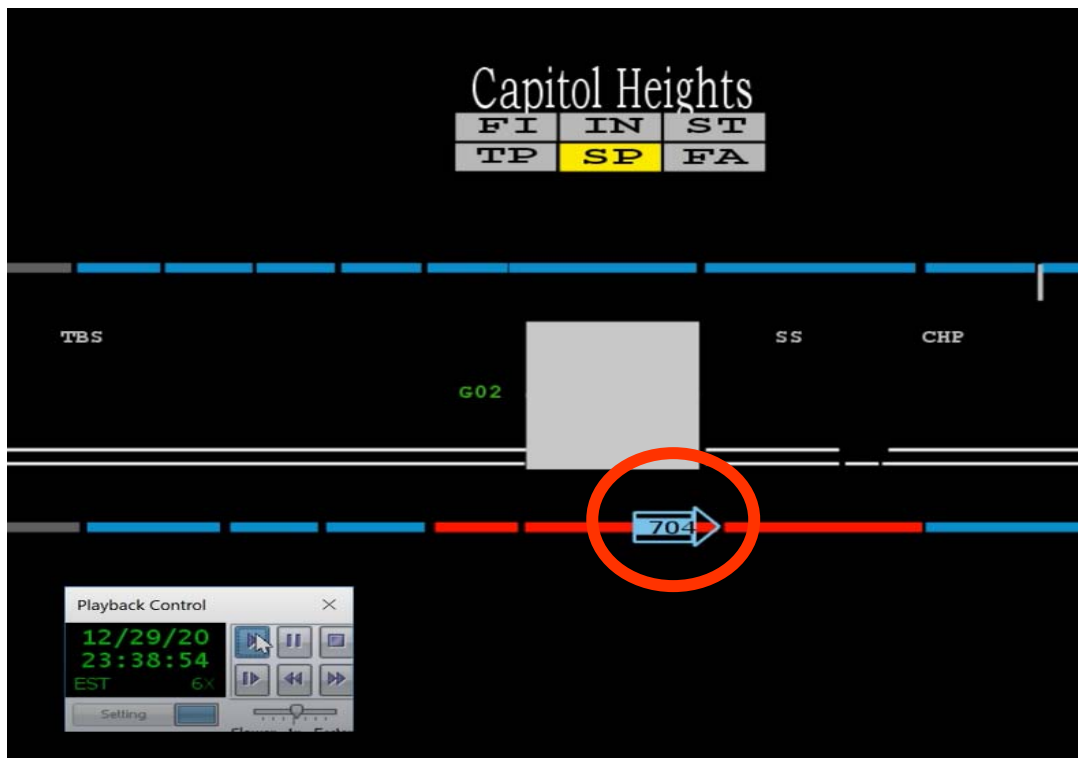
Diagram 2 - Based on the AIMS, at 23:38:54 hours, shows incident train's ID changed from 491 to 704.

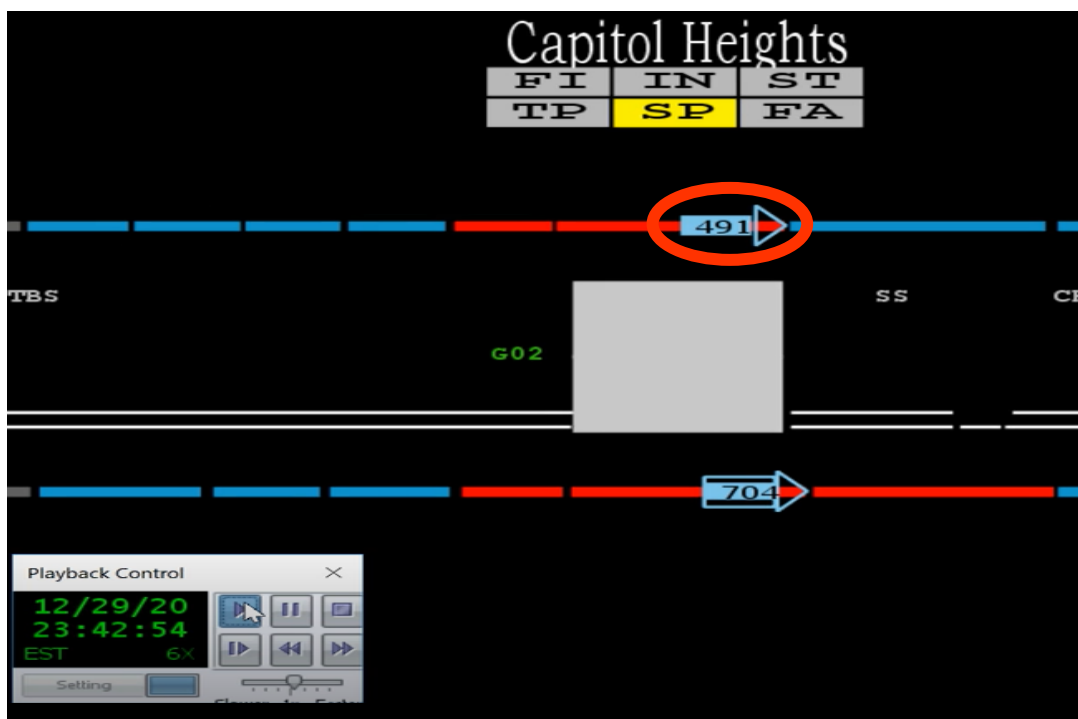
Diagram 3 - Based on the AIMS, at 23:42:54 hours, the new Train ID 491 serviced Capitol Heights Station, Track 2, and picked up customers to head towards Largo Station Track.

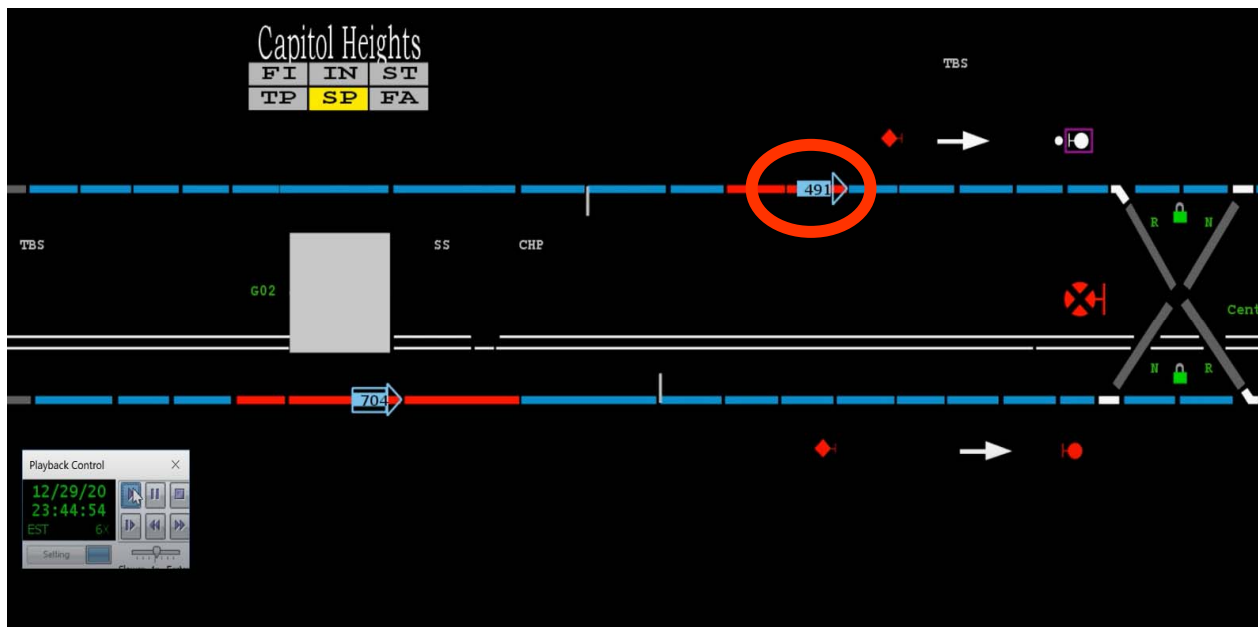
Diagram 4 - At 22:44:54 hours, the AIMS playback revealed the new revenue Train ID 491 in service is about to traverse through the interlocking from Track 2 to Track 1 in Largo Town Center Station direction.

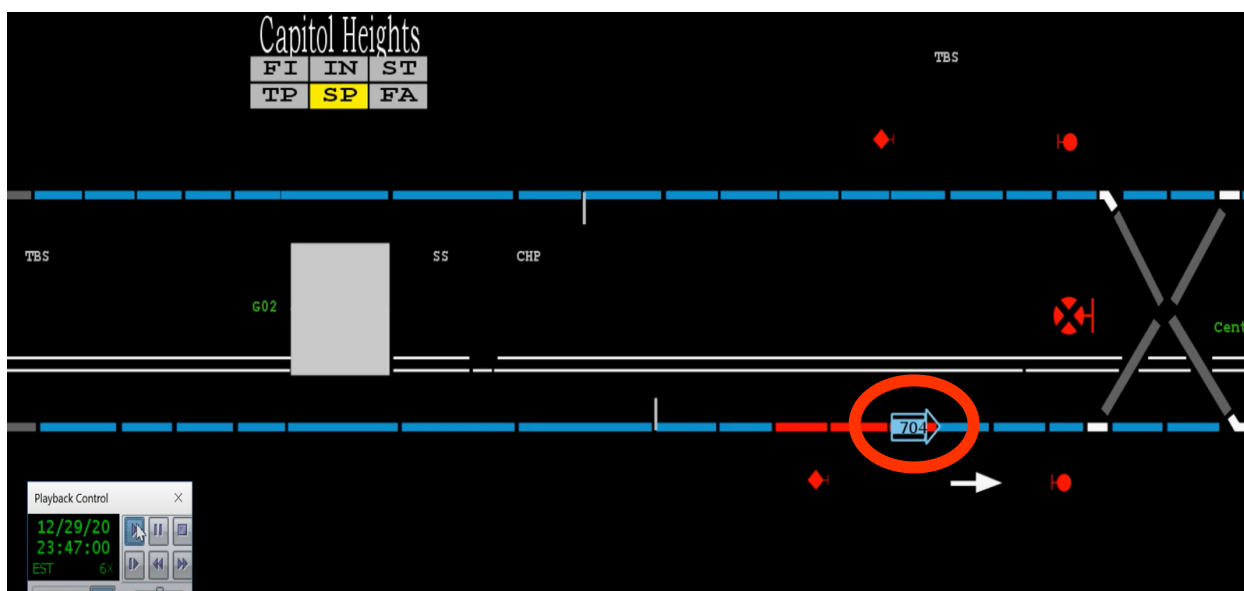
Diagram 5 - Based on the AIMS, at 22:47:00 hours, the incident Train ID 704 was en route, non-revenue to New Carrollton Yard for post-incident inspection.
