WMSC Commissioner Brief: W-0096 – Collision – Greenbelt Rail Yard Storage Tracks – March 9, 2021

FINAL REPORT OF INVESTIGATION A&I E21102

Greenbelt Yard – Collision Between Two or More Rail Transit Vehicles

Incident Date: March 9, 2021

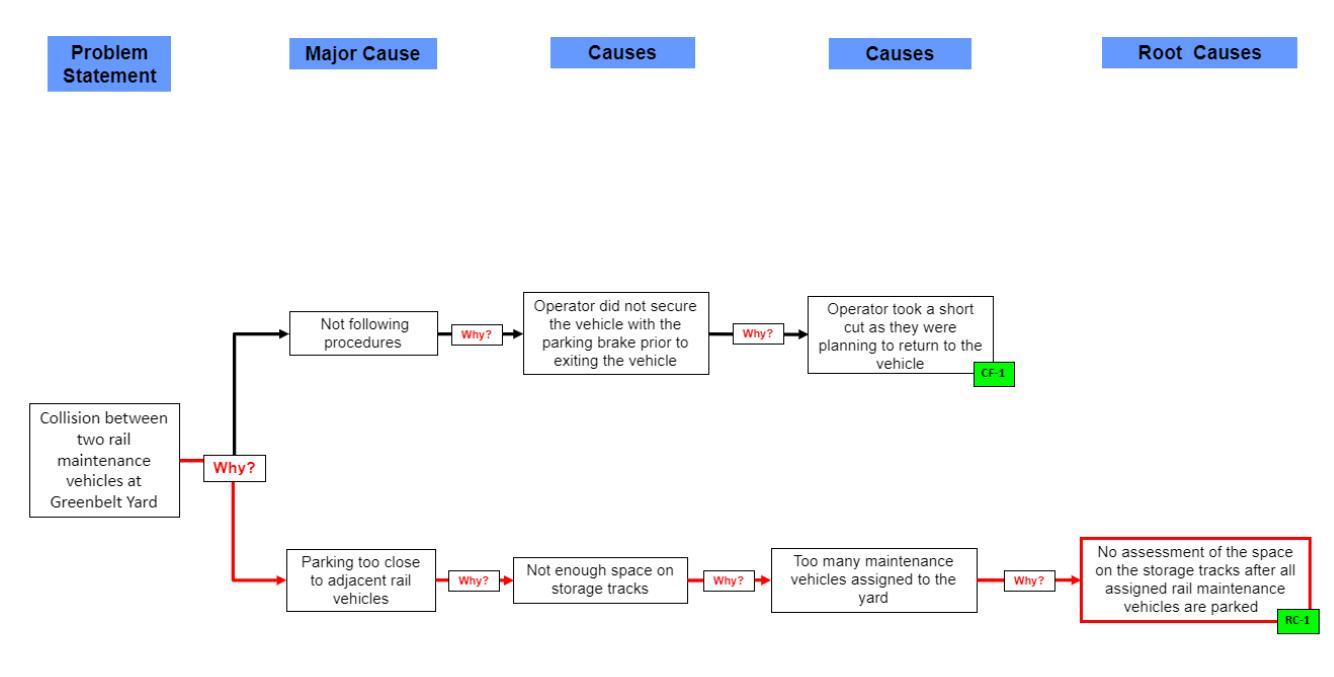
Appendix F – Root Cause Analysis

The probable cause was a lack of storage track space and procedures to properly store Class 2 vehicles within the rail yards, including identifying the appropriate distance separating stored units. A contributing factor was the handbrake not being set prior to the Operator exiting the rail vehicle. This is required per Metro Safety Rules and Procedures Handbook (MSRPH), SOP #17 – 17.5.3.6 – "The Operator shall initially secure the class 2 rail vehicle(s) with one operational set of handbrakes or the parking brake after positioning the vehicle(s) on the storage tracks."
