**WMSC Commissioner Brief: W-0098 – Improper Roadway Worker Protection – L’Enfant Plaza Station – January 25, 2021**

FINAL REPORT OF INVESTIGATION A&I E21029

Date of Event:	1/25/2021
Type of Event:	Improper Roadway Worker Protection
Incident Time:	02:35 hours
Location:	L'Enfant Plaza Station, Track 2
Time and How received by SAFE:	03:36 hours SAFE On-call Phone
WMSC Notification Time:	04:28 hours
Rail Vehicle:	None
Injuries:	None
Damage:	None
SMS I/A Incident Number:	20210125#91529

L'Enfant Plaza Station
Improper Roadway Worker Protection
January 25, 2021

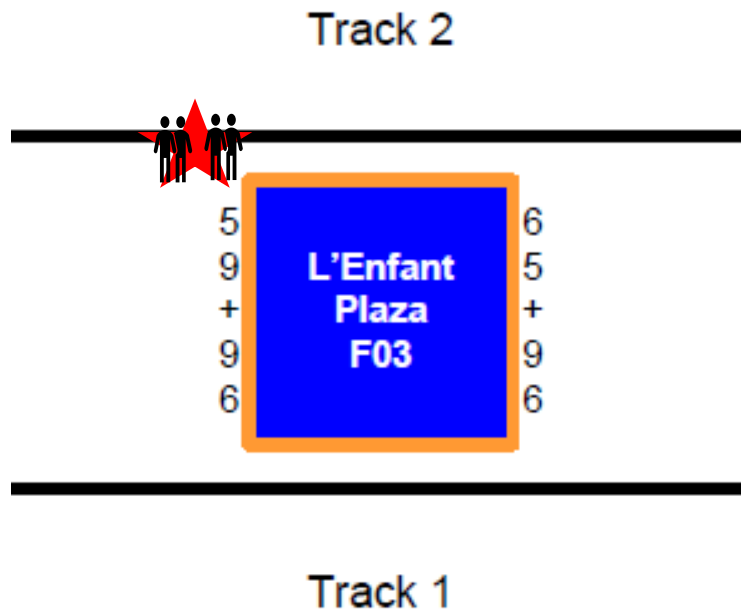
Field Sketch/Schematics

L'Enfant Plaza Station, Track 2
Actual – CM D2-059+00 to D2-066+00
Protected – CM D2-054+00 to D2-071+00
