**WMSC Commissioner Brief: W-0103 – Improper Door Operation – Court House Station – March 14, 2021**

Washington Metro Area Transit Authority  
Department of Safety and Environmental  
Management (SAFE)  
**FINAL REPORT OF INVESTIGATION A&I E21109**

# Court House Station – Improper Door Operation

March 14, 2021

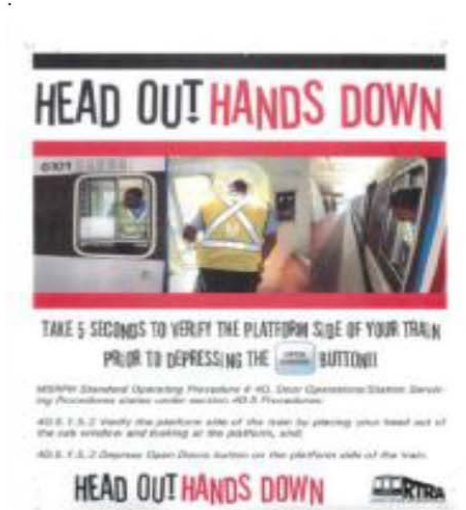
This incident's root cause was complacency and a failure to follow the proper door opening procedures outlined in SOP 40 and waiting five (5) seconds before initiating the door open button. It should be noted there were no reported discrepancies with the train that could have contributed to this occurrence. **ALWAYS REMEMBER, HEAD OUT HANDS DOWN!**

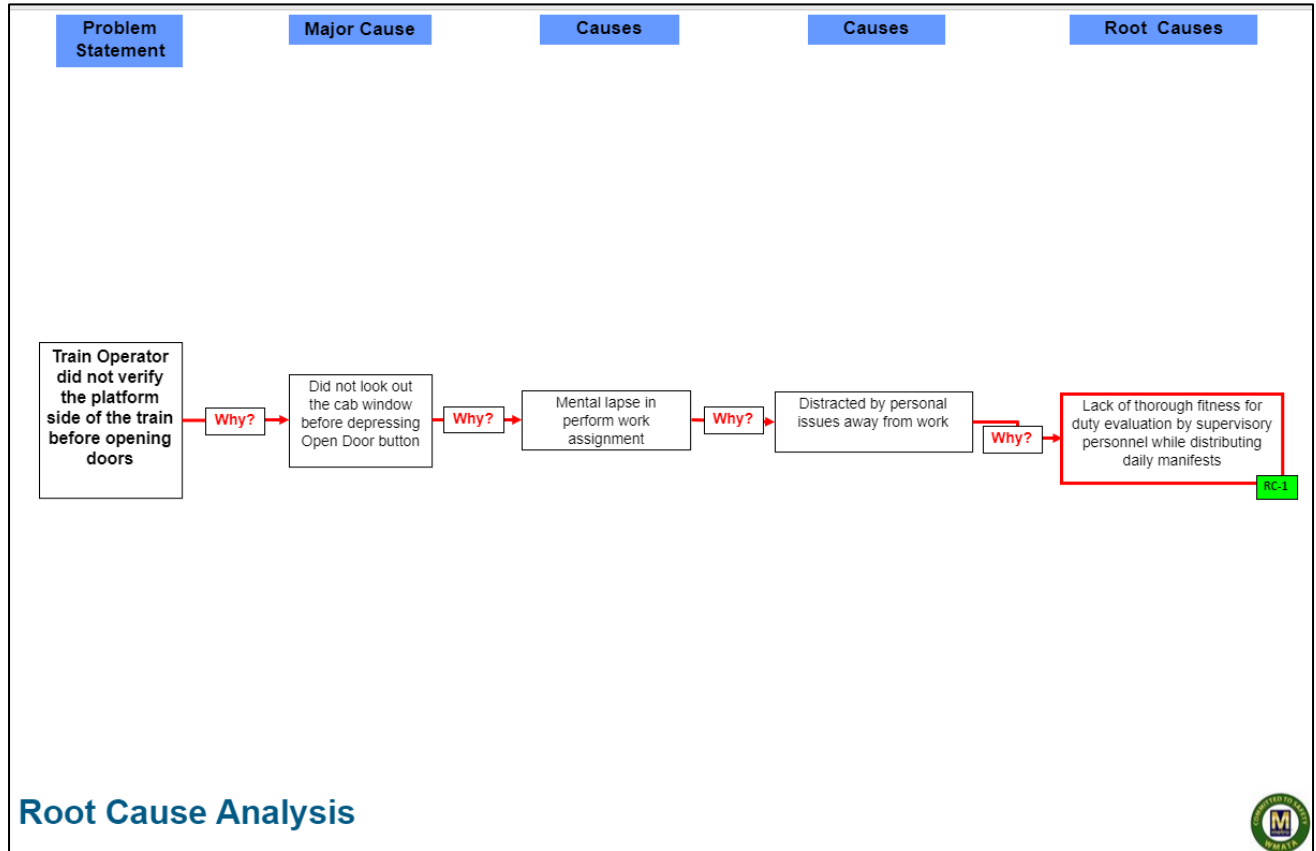
## Appendix D – Root Cause Analysis

The primary probable cause of the incident was the lack of a thorough fitness for duty evaluation by supervisory personnel while distributing daily manifests. Contributing to the incident was human performance difficulty as the Train Operator lost focus while operating the train and resulted in a failure to follow proper door operation procedures. The Train Operator depressed the doors open button on the non-platform side without placing their head out of the cab window to first look and identify the platform.
