## **WMSC Commissioner Brief: W-0106 – Improper Movement – Foggy Bottom Station – May 21, 2021**

**FINAL REPORT OF INVESTIGATION A&I E21204**

<b>Date of Event:</b>	May 21, 2021
<b>Type of Event:</b>	O-7 Improper movement of any rail vehicle on the mainline or in a yard, including over improperly aligned switch(es).
<b>Incident Time:</b>	18:52 hours
<b>Location:</b>	Foggy Bottom Station, Track #1
<b>Time and How received by SAFE:</b>	19:55 hours, SAFE Phone
<b>WMSC Notification Time:</b>	20:50 hours
<b>Responding Safety Officers:</b>	N/A
<b>Rail Vehicle:</b>	L7234x7235-7227x26-7094x7095-7181x7180T
<b>Injuries:</b>	None
<b>Damage:</b>	None
<b>Emergency Responders:</b>	Office of Rail Transportation (RTRA)
<b>SMS I/A Number</b>	20210521#93434

Foggy Bottom – Improper movement

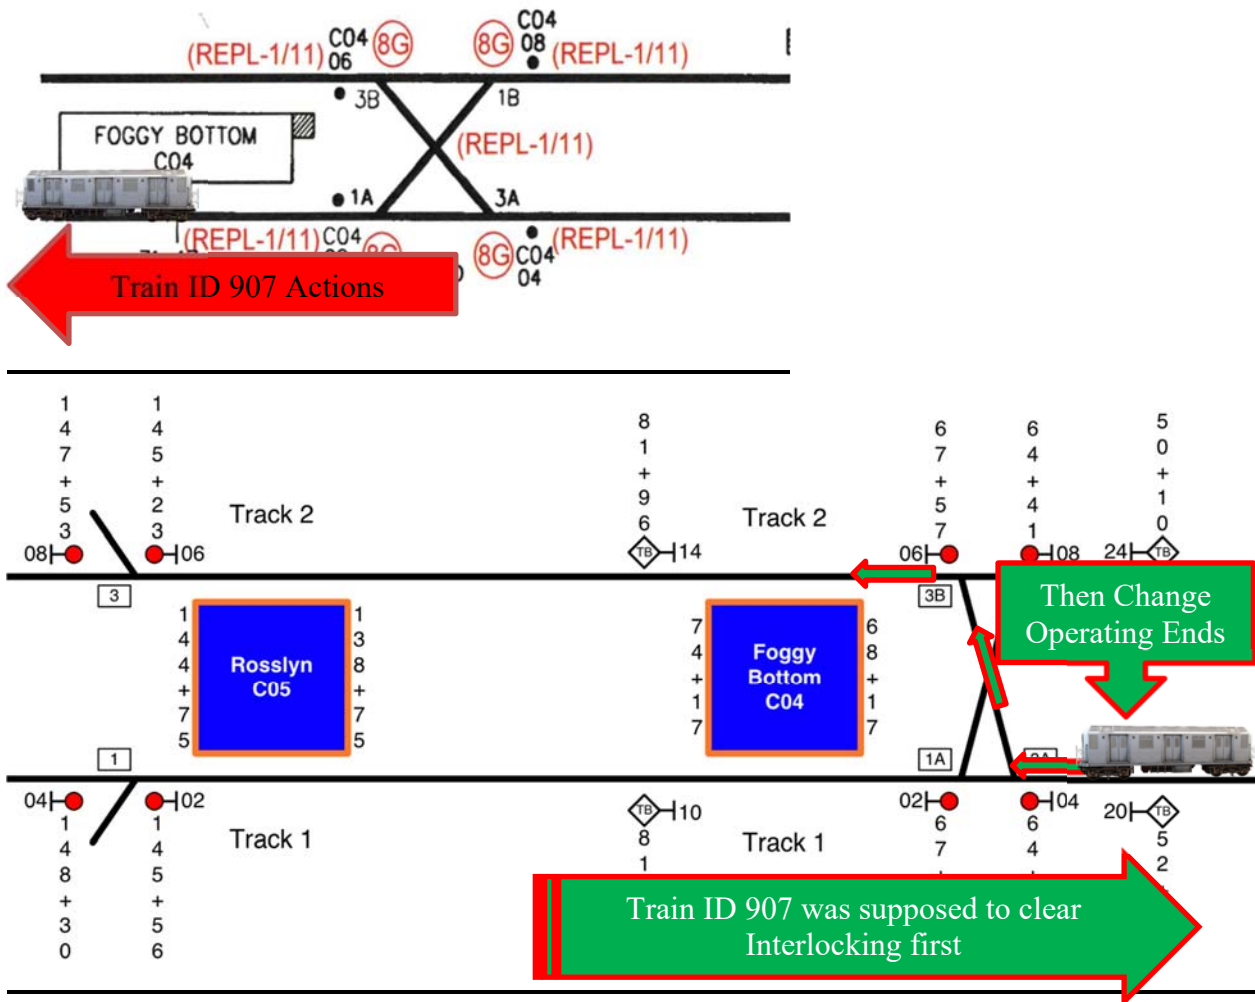
### **Field Sketch/Schematics**

The Train Operator moved the train without speed commands by entering stop and proceed mode. The train moved approximately 840 feet before the Train Operator stopped the train after being contacted by the ROCC Controller.

Foggy Bottom Track #1

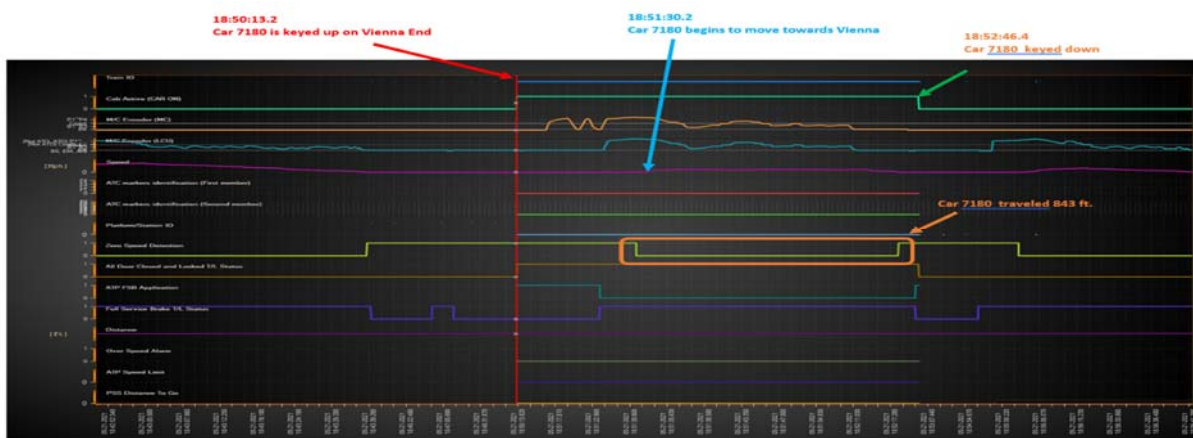
There were no faults observed in the train's VMDS and ER logs that may have contributed to the cause of this incident.

Perform Master Controller Checks on Car 7180.  
Successful Daily Inspection (DI)
