**WMSC Commissioner Brief: W-0109 – Derailment – near Farragut West Station – April 29, 2021**

Prepared for Washington Metrorail Safety Commission meeting on September 21, 2021

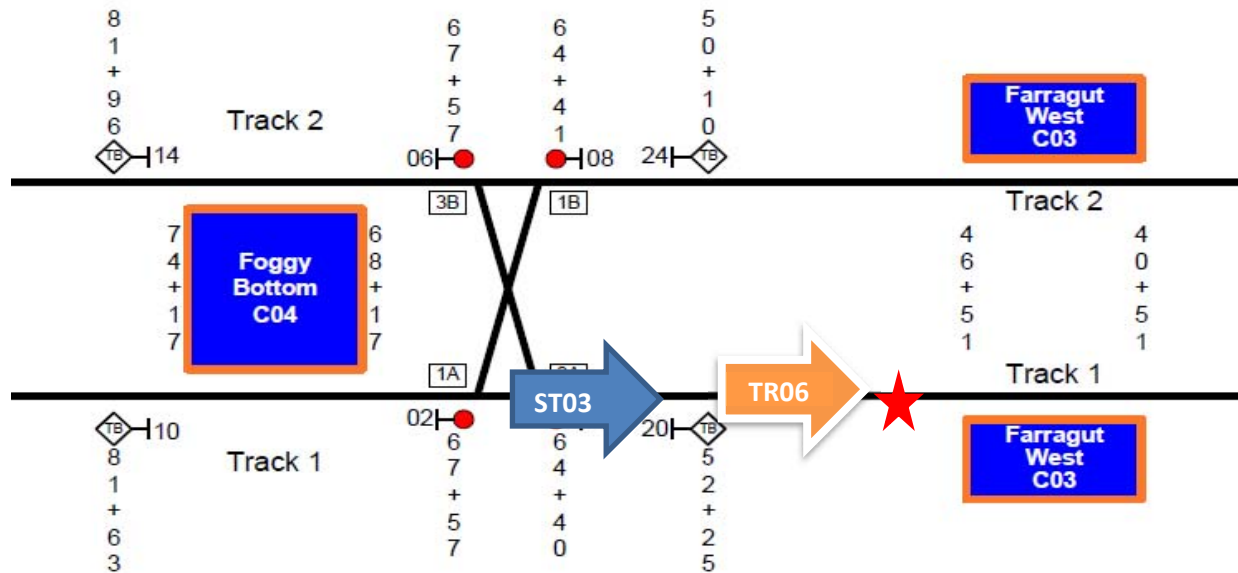
Field Sketch/Schematics

Diagram 1 - TR06 was the lead unit in a convoy block with ST03.

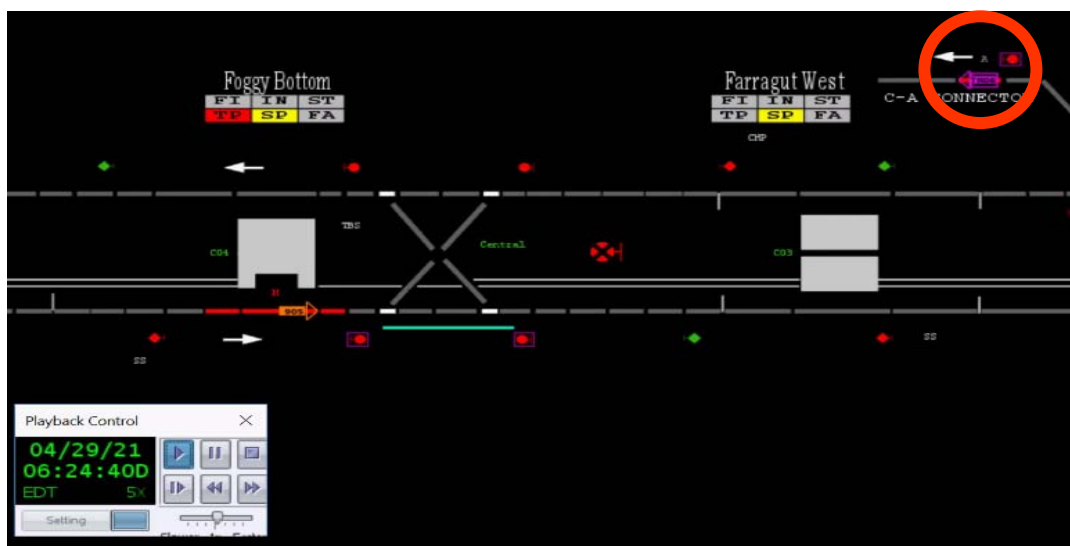
Diagram 3 – Based on the AIMS playback, at 06:24:40 hours after the re-rail operation, TR06 was chocked and secured in the C&A Connector.

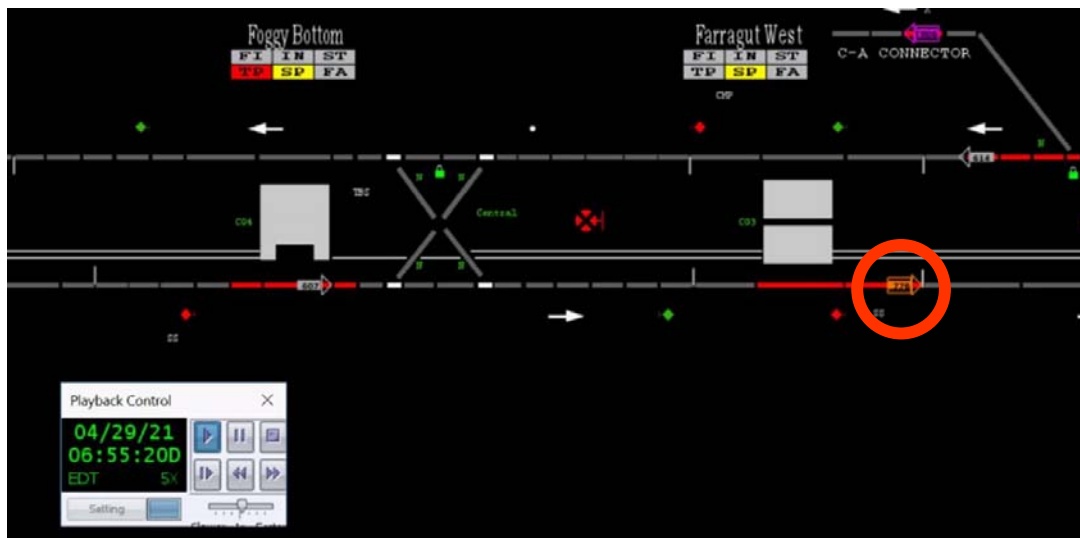
Diagram 4 - Based on the AIMS playback, at 06:55 hours, non-revenue Train ID 776 went through the affected area to perform inspection and was not occupied at the time of the inspection.

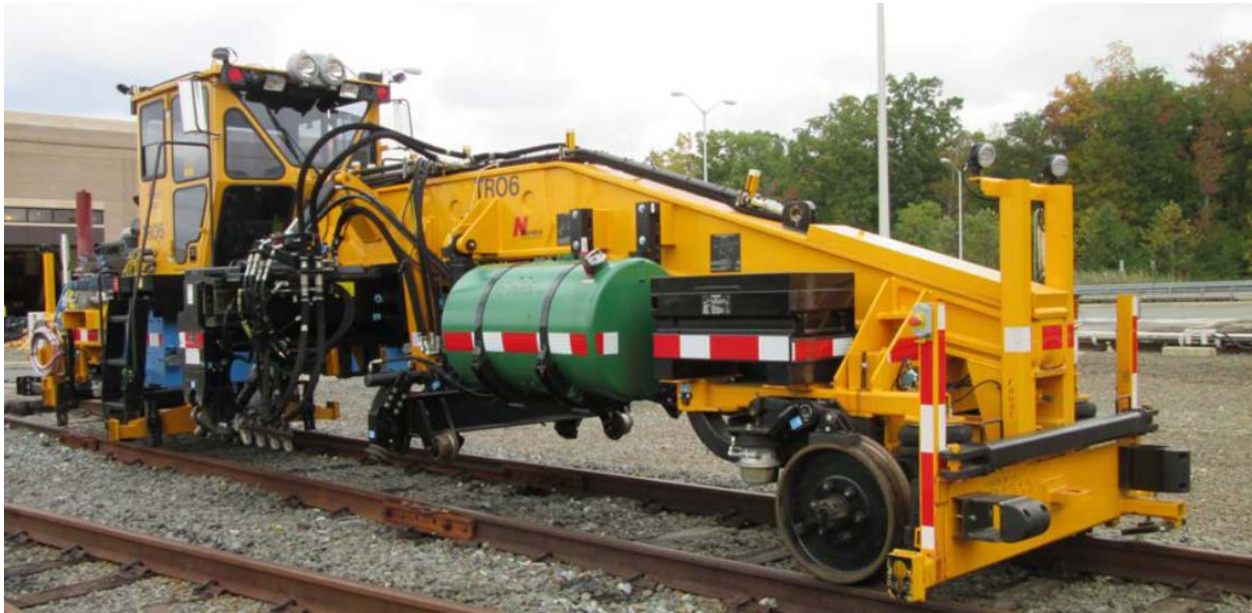
Figure 1 - TR06. This machine is a single-operator, climate-controlled, enclosed cab machine.
