WMSC Commissioner Brief: W-0111 – Serious Injury – Shaw-Howard U Station – April 12, 2021

Washington Metro Area Transit Authority
Department of Safety and Environmental
Management (SAFE)
FINAL REPORT OF INVESTIGATION A&I E21142

**Shaw Howard U Station – Serious Injury
April 12, 2021**

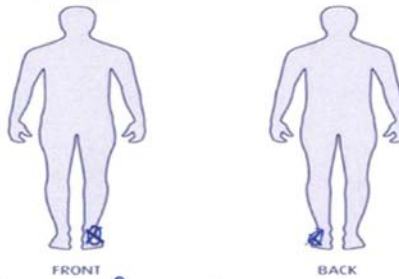
Incident Information			
Date	Incident Time	Date/Time Reported	Location
04/12/2021	2:00 am	04/12/2021	E02
Incident ID# (from OCC) – Completed by Supervisor		SMS Incidents/Accidents Report# Completed by Supervisor	
8533808			
Involved Person or Witness (Non-WMATA Involved Person or Witness)			
Name	Phone Number	E-Mail	
[REDACTED]	[REDACTED]	[REDACTED]	
Address			
[REDACTED]			
What happened prior to the incident/accident?			
I was performing a flow test of standpipe system VE-4 in the tunnel @ E-02.			
Describe the incident/accident			
I was attempting to pick up my equipment from out of the track bed when my left foot slipped and twisted up under water.			
What happened after the incident/accident?			
I immediately noticed pain in my left foot/ankle area which caused me pain when I tried walking on it.

Please indicate the area of the injury by placing an X on the corresponding body parts below. To specify which side of the body is involved, please use "L" for left and "R" for right.

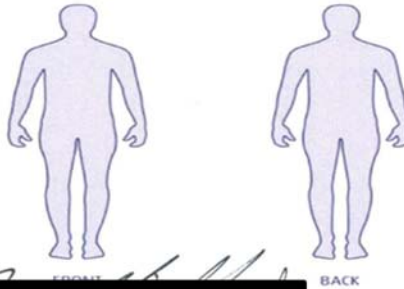
Incident Information			
Date	Incident Time	Date/Time Reported	Location
04/12/2021	2:00 am	04/12/2021	E02
Incident ID# (from OCC) – Completed by Supervisor		SMS Incidents/Accidents Report# Completed by Supervisor	
8533808			
In _____ or Witness (Non-WMATA Involved Per _____)			
Name	Phone Number	E-Mail	
_____	_____	_____	
Address _____			
What happened prior to the incident/accident? I was performing a flow test of standpipe system VE-4 in the tunnel @ E-02.			
Describe the incident/accident I witnessed my co-worker _____ twist his ankle while picking up equipment in the track bed.			
What happened after the incident/accident? My co-worker complained of pain in his left foot/ankle.

Please indicate the area of the injury by placing an X on the corresponding body parts below. To specify which side of the body is involved, please use "L" for left and "R" for right.
