**WMSC Commissioner Brief: W-0116 – Evacuation, Runaway Train – Near Rhode Island Ave Station – March 26, 2021**

Prepared for Washington Metrorail Safety Commission meeting on October 26, 2021

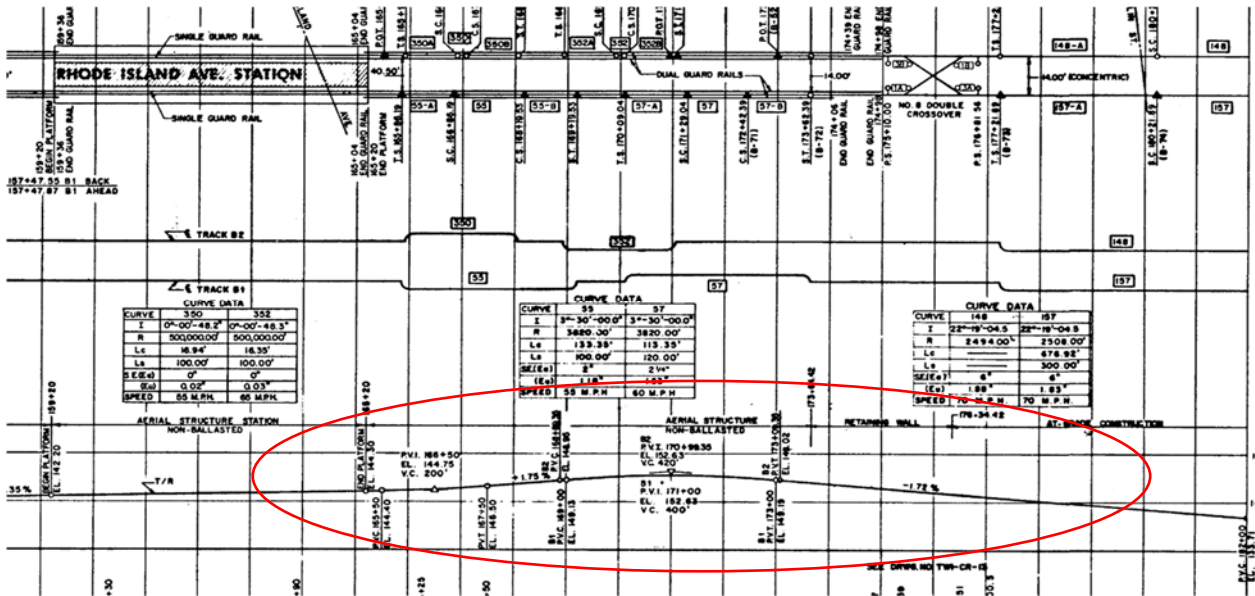
Rhode Island Avenue Station, Track 1

- Outside Station
- Point of Vertical Tangent Chain Marker (CM) B1 173+00
- Track Grade of -1.72% from CM B1-173+00 to CM B1-133+00
- Elevation 152.63 feet at CM B1-173+00 to 133.00 feet at CM B1-133+0033.71
- 44-foot grade
- Ballast Track
