## **WMSC Commissioner Brief: W-0121 – Collision, Customer Fatality – Union Station – June 23, 2021**

*Prepared for Washington Metrorail Safety Commission meeting on October 26, 2021*

**FINAL REPORT OF INVESTIGATION A&I E21255**

<b>Date of Event:</b>	6/23/2021
<b>Type of Event:</b>	Person Struck by Train
<b>Incident Time:</b>	12:29 hours.
<b>Location:</b>	Union Station, Track 1
<b>Time and How received by SAFE:</b>	13:39 hours. SAFE On-call Phone
<b>WMSC Notification Time:</b>	13:54 hours.
<b>Responding Safety Officers:</b>	WMATA SAFE: Yes WMSC: No Other: N/A
<b>Rail Vehicle:</b>	Train ID 118, <b>L7442-7443</b> . 7325-7324. 7284-7385. 7403-7402T
<b>Injuries:</b>	Fatality
<b>Damage:</b>	Train-to-Wayside Communication Antenna
<b>Emergency Responders:</b>	Office of Rail Transportation (RTRA), Metro Transit Police Department (MTPD), District of Columbia Fire and Emergency Services (DCFEMS), Office of Car Maintenance (CMNT), Emergency Response Team (ERT), and Office of Plant Maintenance (PLNT).
<b>SMS I/A Incident Number:</b>	20210623#94044MX

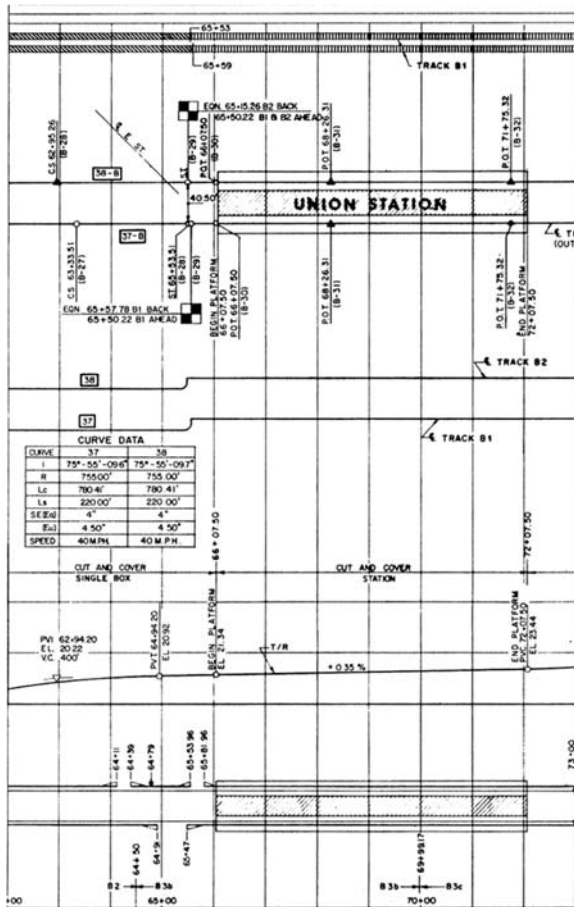
Union Station, Track 1  
Direct Fixation Track  
Length of Curve - 780-feet  
The radius of Curve - 755.00.'  
Elevation of 20.22  
Point of Vertical Intersect C1 - 62+94.20  
Point of Vertical Tangent Track C1 - 64+94.20  
Point of Tangent Track C1 66+07.50  
400-foot Vertical Curve at C1 - 62+95.26

Based on the system of record data, the Train Operator had a limited view of Union Station, Track 1, while on approach.

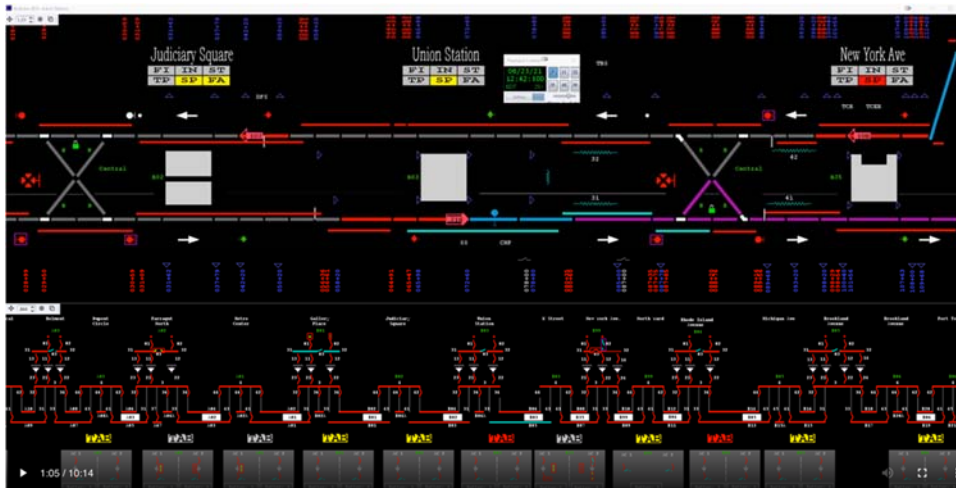
Diagram 3 – ROCC re-blocked Train ID 118 to Train ID 718 [non-revenue] at 12:42:30 hours.

The AIMS playback revealed the Radio RTC re-blocked the incident train from Train ID 118 to Train ID 718 at approximately 12:42:30 hours.

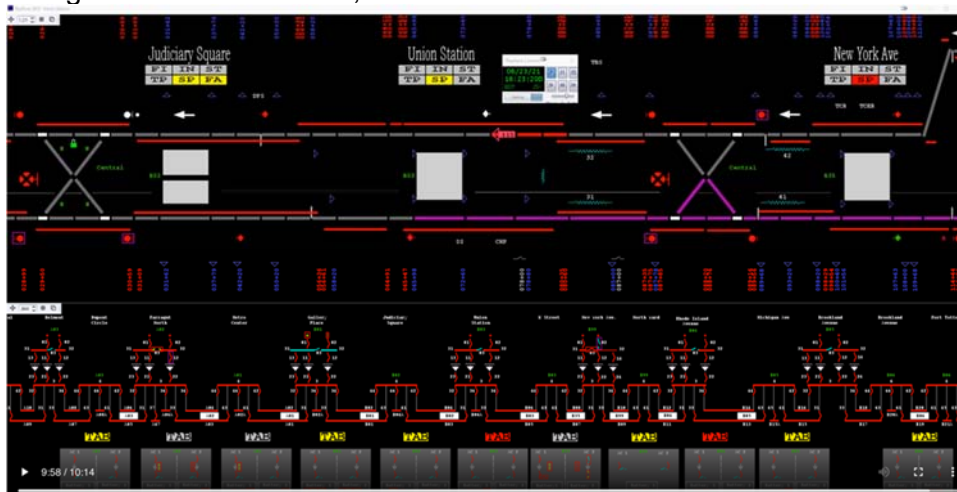
Diagram 8 – ROCC commanded, third rail power circuit breakers closed at approximately 16:23 hours.

At approximately 16:23 hours, ROCC commanded third rail power breakers closed and re-energized at Union Station, Track 1.

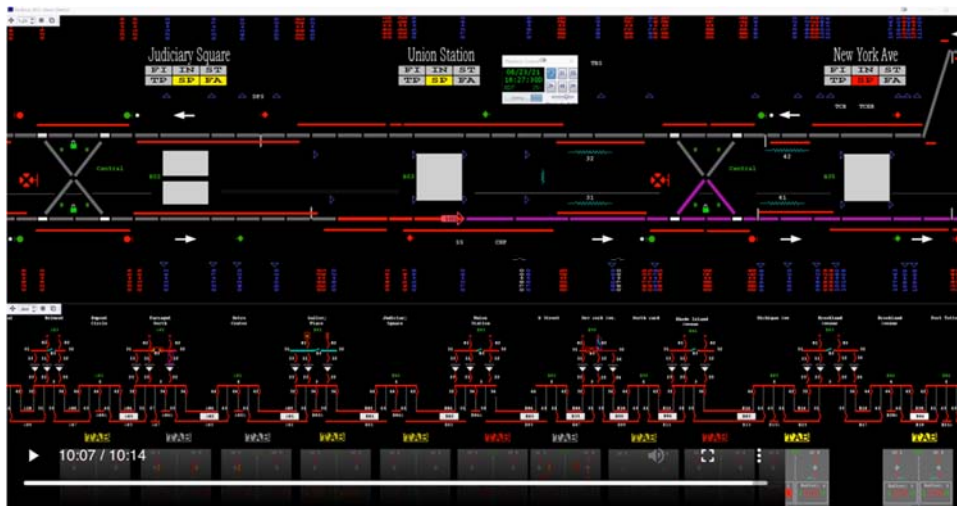
Diagram90 – Train ID 105 traversed the incident and serviced the station at approximately 16:27:30 hours.

ROCC resumed normal service, and Train ID 105 was the first train to continue in revenue service from Judiciary Square to Glenmont.

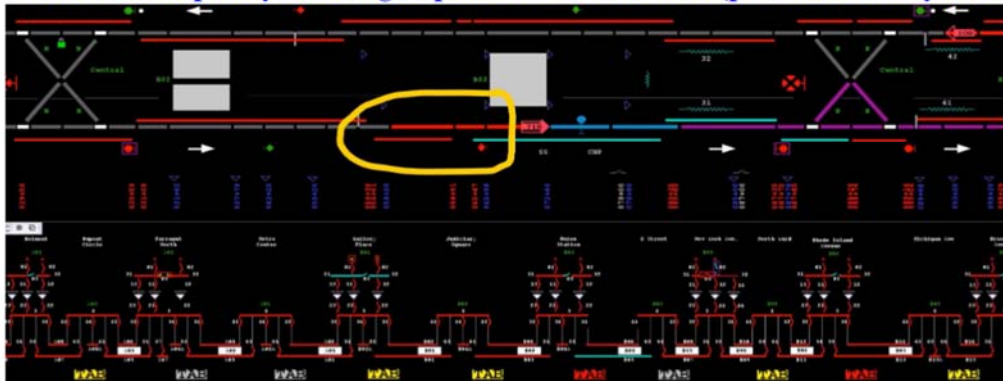
### Failure to completely de-energize power in affected area (person struck by train)

On Wednesday, June 23, 2021 at 12:29.31 hours, ROCC received a report from train #118, Track #1, Union Station (B03) that a person had jumped in front of their train. During this initial radio exchange the train operator communicated that "about 2-3 cars" were on the platform. The controller asked the operator if they were able to complete a ground walkaround, to which they replied, "yes". At 12:31:10 hours the operator was instructed that they are the OSC, to perform a ground walkaround, and to advise central if they saw any signs of life. AIMS playback indicated that 3rd rail power was de-energized at 12:33:20 in the area affecting the front of the incident train, but not the area affecting the rear of the train, which was still in the tunnel (as indicated by the AIMS display above). Power was not completely de-energized in the entire affected area until 12:55, when Safety Truck 4 notified the Incident Command Post that power was still energized 300 feet into the tunnel and that they were using an ETS box to de-energize power. Power was confirmed de-energized at 12:57 hours.
