WMSC Commissioner Brief: W-0123 – Improper Roadway Worker Protection – Ronald Reagan Washington National Airport Station – June 21, 2021

Washington Metro Area Transit Authority
Department of Safety and Environmental
Management (SAFE)
FINAL REPORT OF INVESTIGATION A&I E21252

National Airport Station – Roadway Worker Protection (RWP) Violation

June 21, 2021

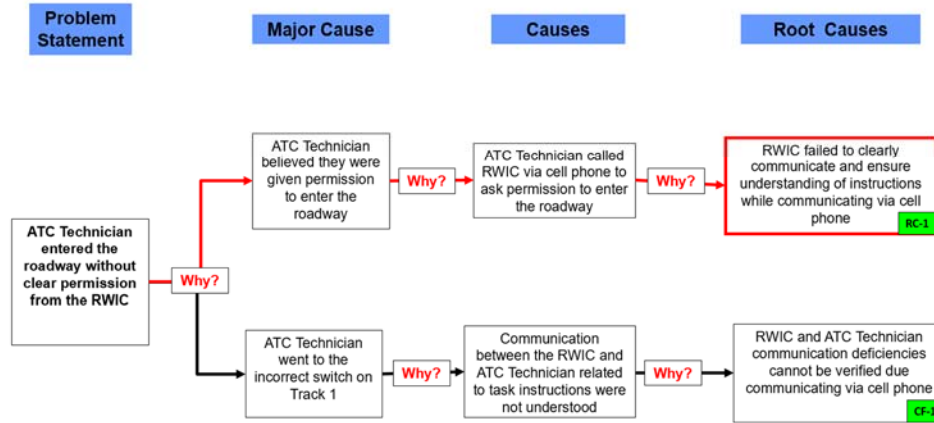
Appendix A - Root Cause Analyses

The primary probable cause of the incident was inadequate communication between the RWIC and the ATC Technician. The ATC Technician assumed they received confirmation to access the roadway to perform their work assignment. However, the RWIC stated they did not give the ATC Technician permission to access the roadway. Due to the use of cellular communications between the ATC Technician and RWIC, the root cause of the communication deficiencies could not be determined.

| Corrective Action Code | Description | Responsible Party | Due Date |
|---|---|---|---|
| 94243_SAFE CAPS_ATC_001 | (RC-1, CF-1) ATC management will ensure supervisors are aware of procedures for removal of personnel from service following a safety violation and Policy Instruction 7.7.3/6 Drug & Alcohol Policy And Testing Program concerning Post-Incident Testing. | ATC SRC | 11/1/2021 |
| 94243_SAFE CAPS_TRST_001 | (RC-1, CF-1) TRST management will ensure supervisors are aware of procedures to removal personnel from service following a safety violation and Policy Instruction 7.7.3/6 Drug & Alcohol Policy And Testing Program concerning Post-Incident Testing. | TRST SRC | 11/1/2021 |
