WMSC Commissioner Brief: W-0070 – Red Signal Overrun – U Street Station – November 27, 2020

FINAL REPORT OF INVESTIGATION A&I E20469

Date of Event:	11/27/2020
Type of Event:	Red Signal Overrun
Incident Time:	12:47 hrs.
Location:	U Street Station, Track 2 (E03-08)
Time and How received by SAFE:	12:47 hrs. SAFE On-Call Phone
WMSC Notification Time:	14:33 hrs.
Responding Safety Officers:	WMATA SAFE: Yes WMSC: No Other: N/A
Rail Vehicle:	L7062.7063X7201.7200X7016.7017X7155 7154T
Injuries:	None
Damage:	None
Emergency Responders:	ATCM, MTPD, RTRA, SAFE and TRST.

U. Street Station – Red Signal Overrun

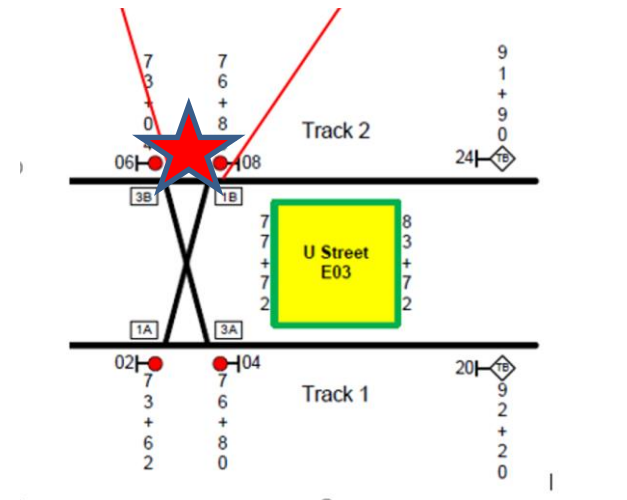
Field Sketch/Schematics

U Street Station Track 2 – E03-08 Signal.

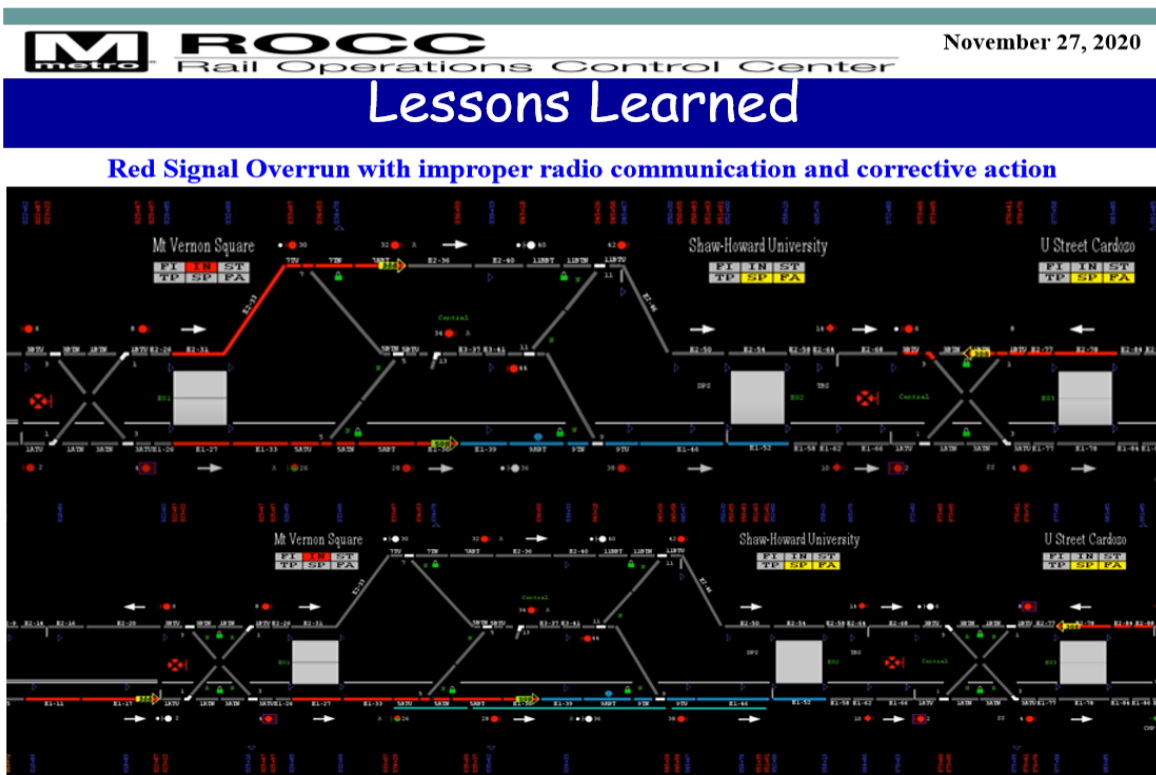
Appendix B – ROCC Lessons Learned

Red signal overrun with improper radio communication

On Friday 27 November 2020 at 1243hrs, while single tracking between Mt. Vernon Sq. (E01) and U St. (E03) by way of track 2, due to a police investigation. There were duplicate ID's for train 308; one located at E01, one located at E03 and both trains were traveling on track 2 towards E01 simultaneously. The Radio RTC gave a permissive block to train 308 at E01 to the platform without identifying the location and track of the train. Train 308 located at E03 track 2 stated they were holding at a red signal. Train 308 track 2 at E03 moved passed a red signal towards E01. This improper radio communication contributed to a red signal overrun at E03 interlocking. Additional contributing factors were revealed when the Button RTC acknowledged that there were duplicate ID's and did not attempt to change or communicate this with the Radio RTC.
